Subject Morwell Mine Fire Submission

Organisation represented (if applicable): Environment Victoria

## *Submission to Hazelwood Mine Fire Inquiry*

## To what extent did inadequate and/or delayed rehabilitation of exposed coal batters at the Hazelwood coal mine contribute to the rapid spread of the 2014 fire?

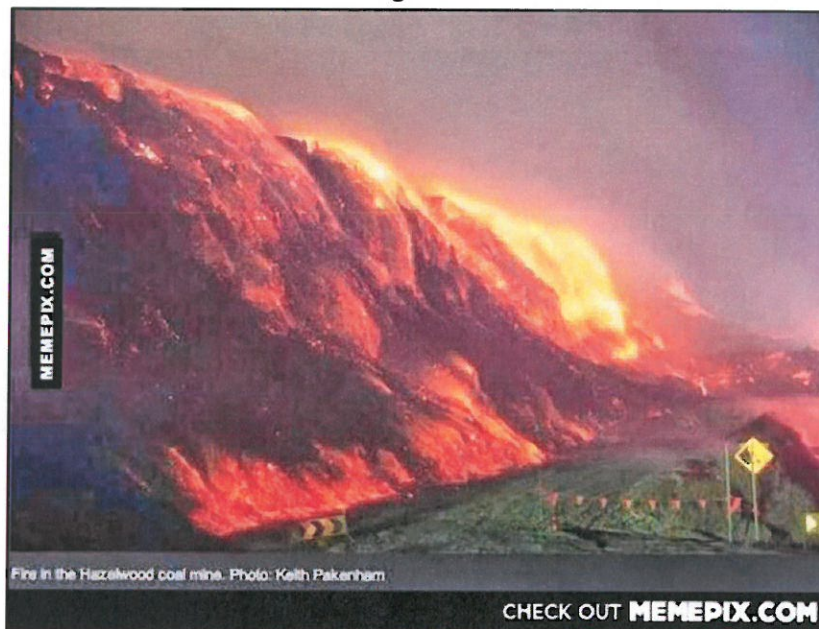
Image E1.

**Auditor's comments:** The fire is burning on a coal batter that appears not to have been covered with protective overburden.

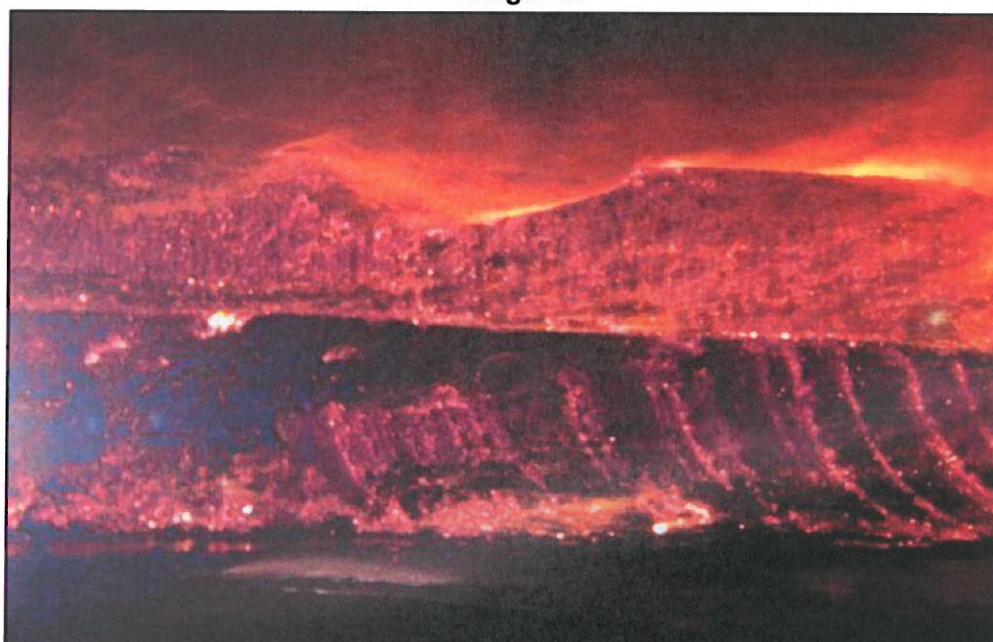
Image E2.

**Auditor's comments:** Coal burning in what appears to be a series of erosion gullies that have developed in the protective overburden. This may be due to the dispersive (sodic) nature of the clay material. The upper batter slope appears to be steeper than 3H:1V. Some of the overburden appears to have moved to the lower part of the batter.

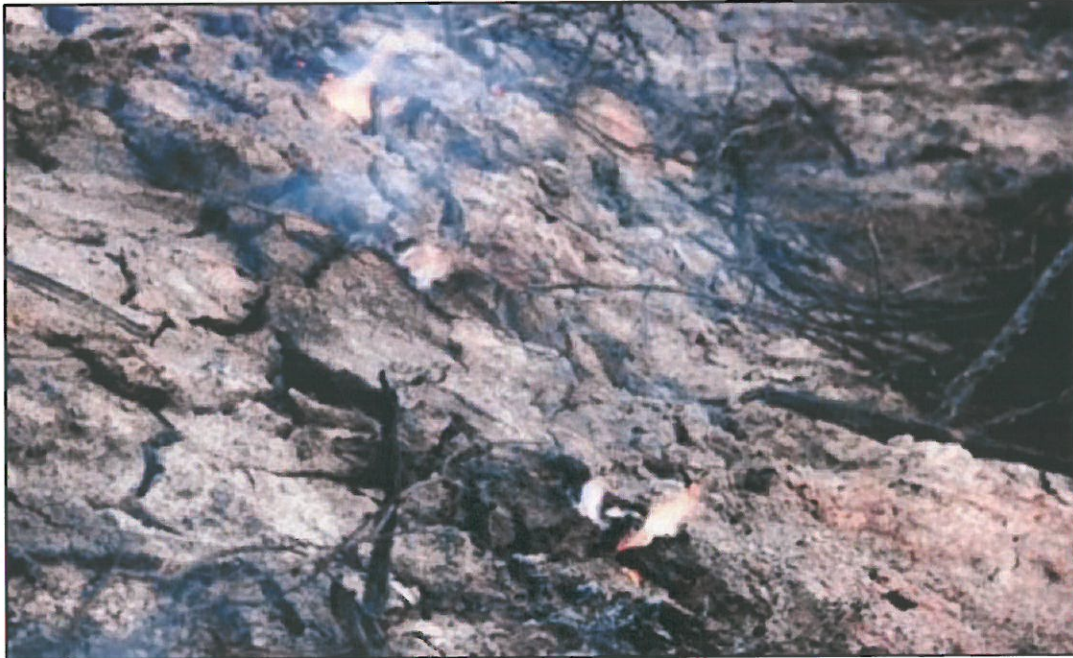
Image E3.

**Auditor's comments:** Flames rising through cracks in the montmorillonite-type clay capping.

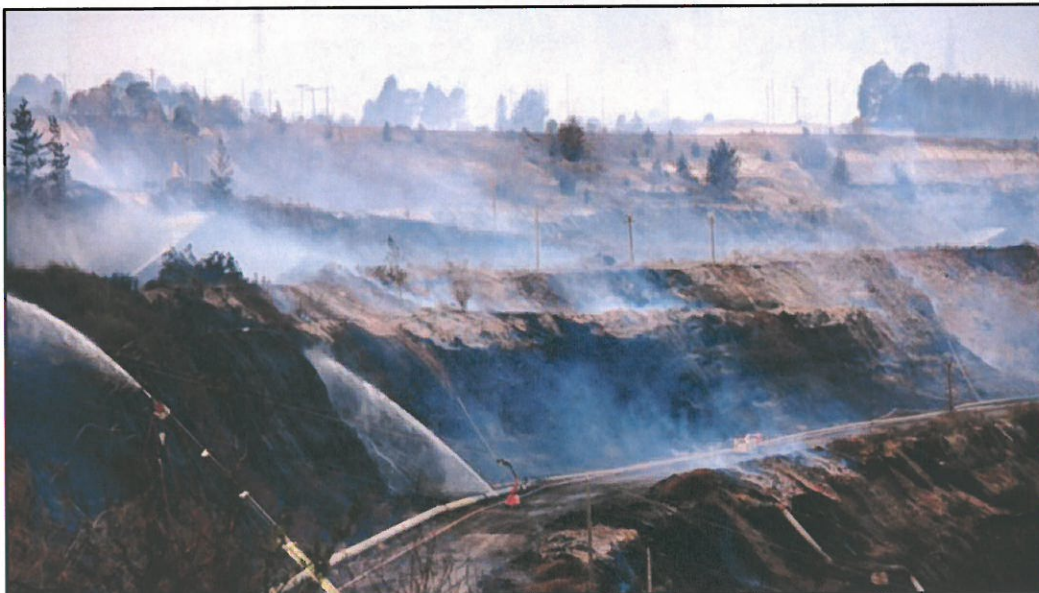
Image E4.

**Auditor's comments:** These batters have been rehabilitated but it appears that the slope is much steeper than 3H:1V - in fact, steeper than the angle of repose of the protective overburden.
