**FIRE RISK ANALYSIS OF  
THE WORKED-OUT AREAS OF  
MORWELL OPEN CUT**

**JUNE 1992**

**Richard Oliver International Pty Ltd**  
(ACN 006 256 908)  
71 Queens Road, Melbourne Vic. 3004  
Telephone: (03) 529 5122  
Facsimile: (03) 521 1634

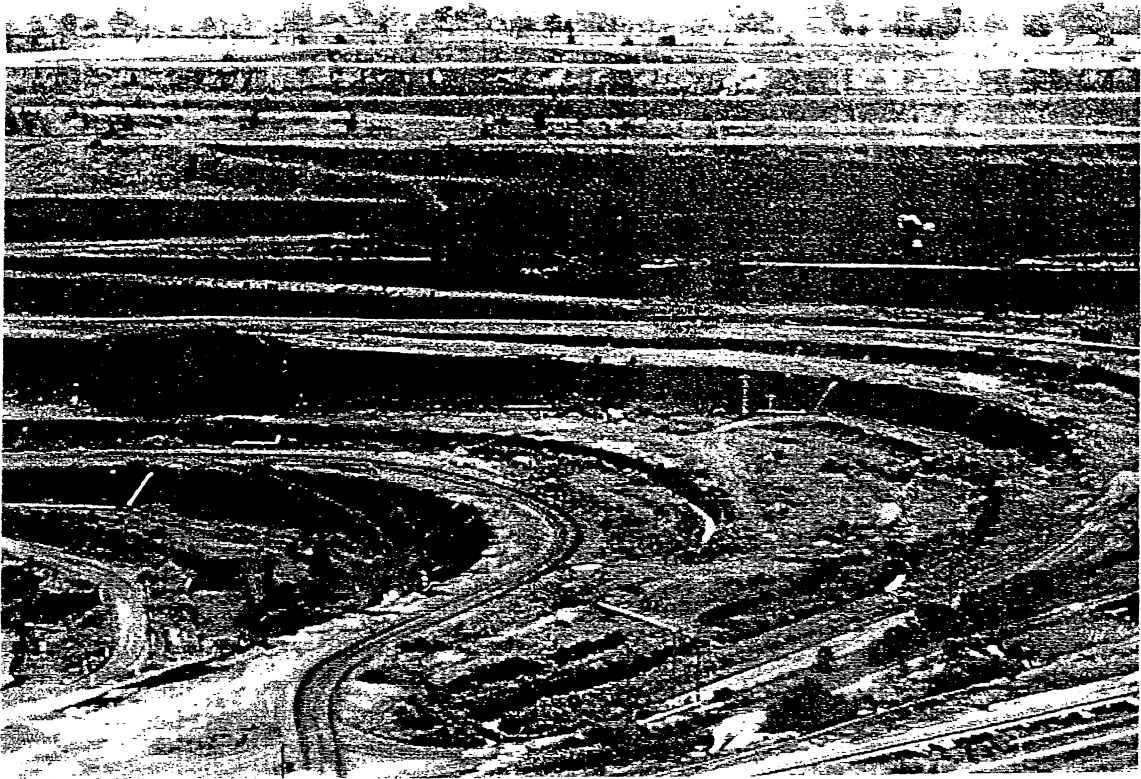
FIGURE 3: Coal winning operation using mobile plant and haul trucks located in north-east corner of the worked-out area.

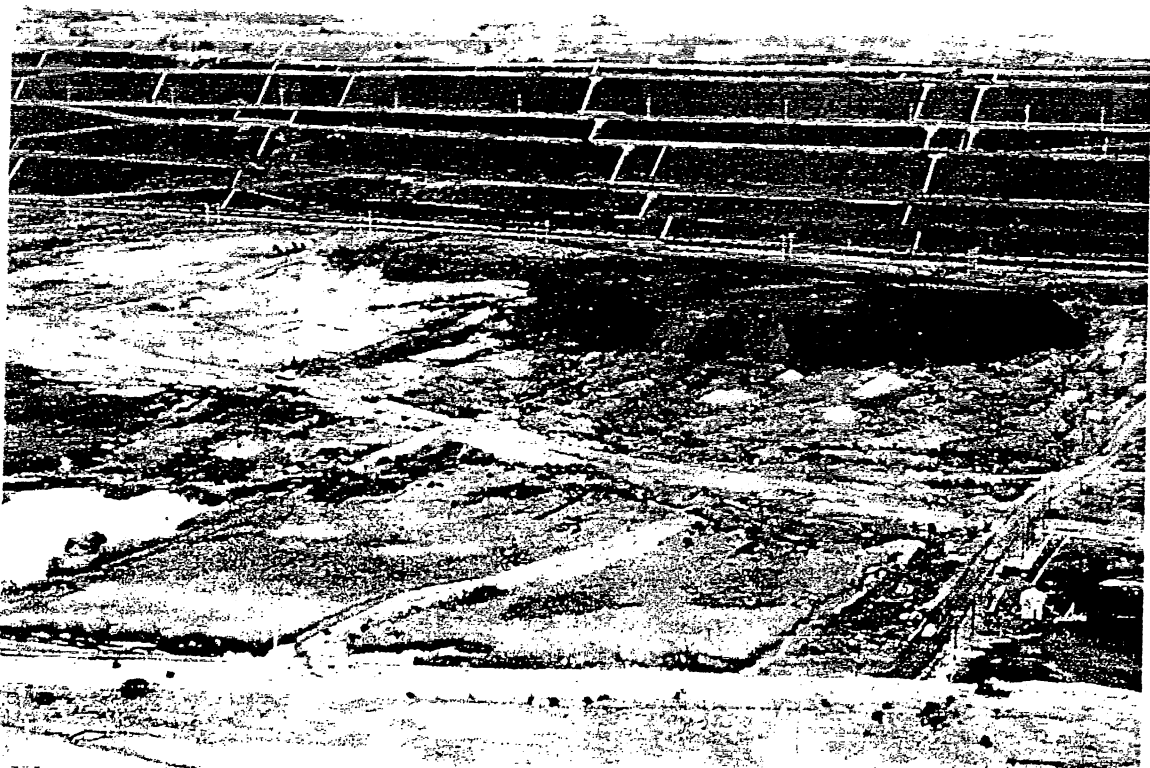
- (iv) there are specific activities which could represent a fire hazard, notably -
- traffic of vehicles without protected exhausts.
  - a coal production operation (refer figure 3), providing coal quantities equivalent to MPS requirements. Note that risk appraisal of this operation was considered as outside the terms of reference for this study.
  - a dirty coal dump near the southern pivot (refer figure 4).

FIGURE 4: Dirty coal dump in worked-out area (looking south).

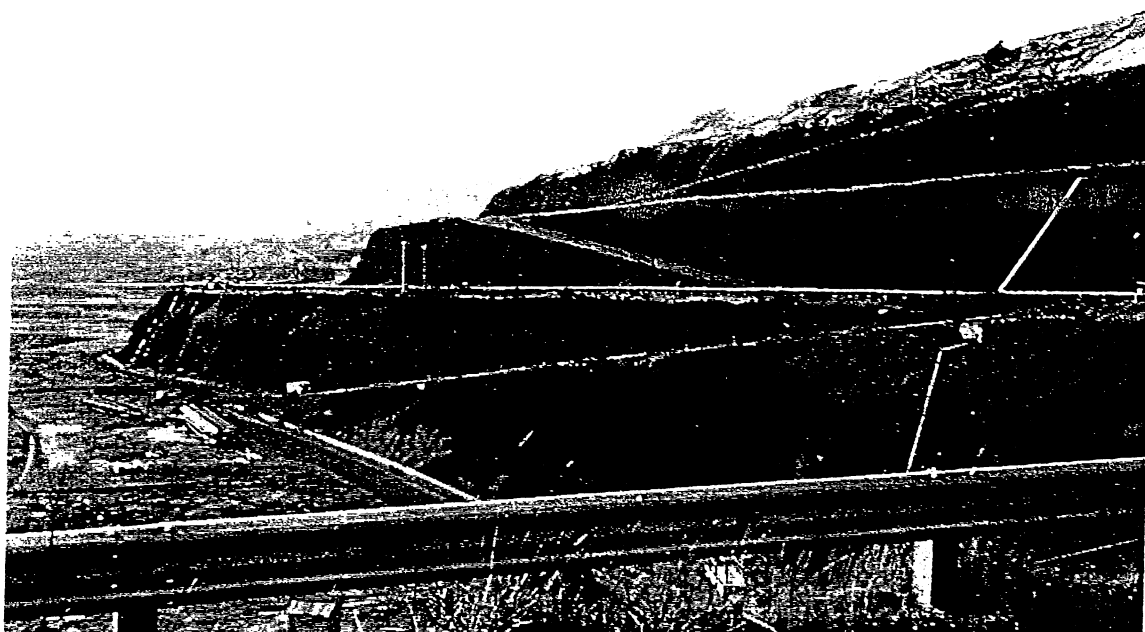
**FIGURE 7:** Looking generally north along the eastern batters, "20 series" conveyor in mid-picture. Note 6.6 kV power distribution feeder lines no's 15 and 16 coming down the batters on concrete poles.

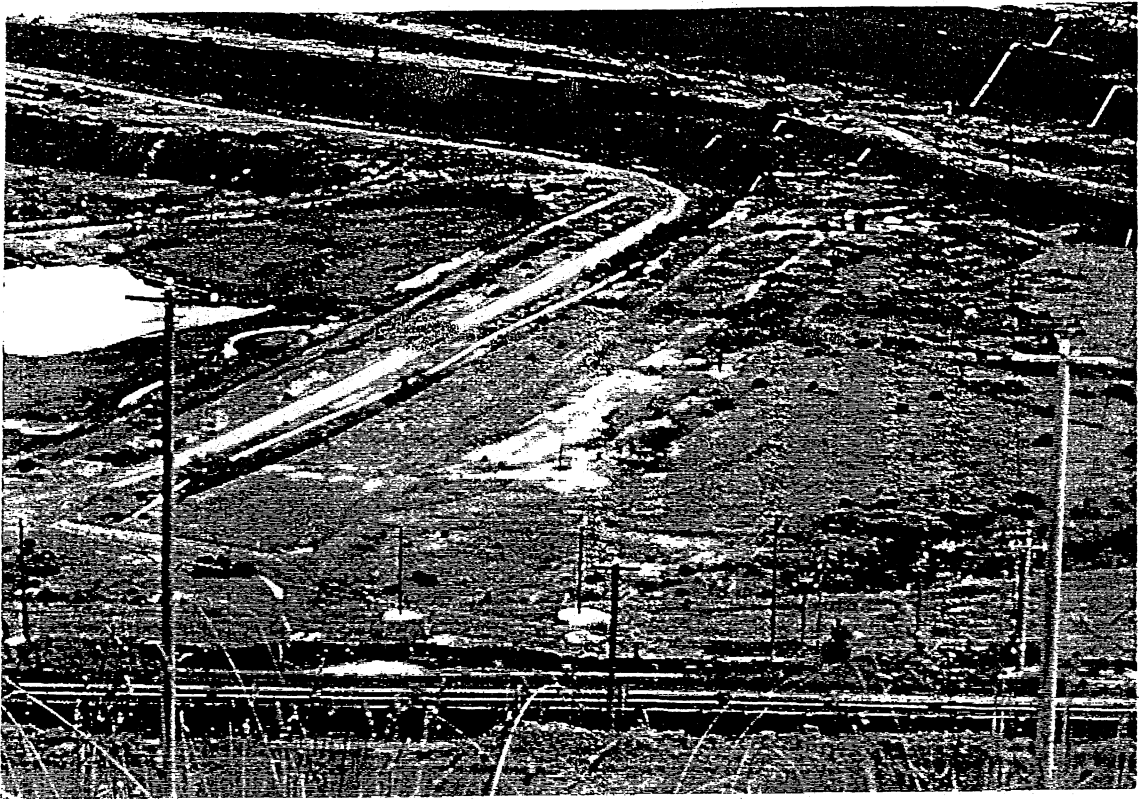
**FIGURE 9:** Looking north over "20 series" conveyor and along feeder lines 16 and 4 crossing the worked-out area, predominantly on timber poles.

- i. Keep all M.O.C. fire reports on a P.C. data base and regularly review this data for causes and trends. This data analysis will assist to systematically reduce fire risks.
- ii. Examine restrictions to roadways in the worked-out areas. For example, a permit system could be adopted to control access to specified roads and incorporate a check or control upon vehicle exhaust systems, at the same time.
- iii. Stop dumping of dirty coal adjacent to the 260 series conveyors. Look to relocate such dumping.
- iv. Relocate power feeders 15 and 16. We understand a relocation to near the 260 series conveyors is already proposed.
- v. Commence a pole replacement programme for the 4, 5 and 16 power feeders, replacing timber poles with concrete ones.

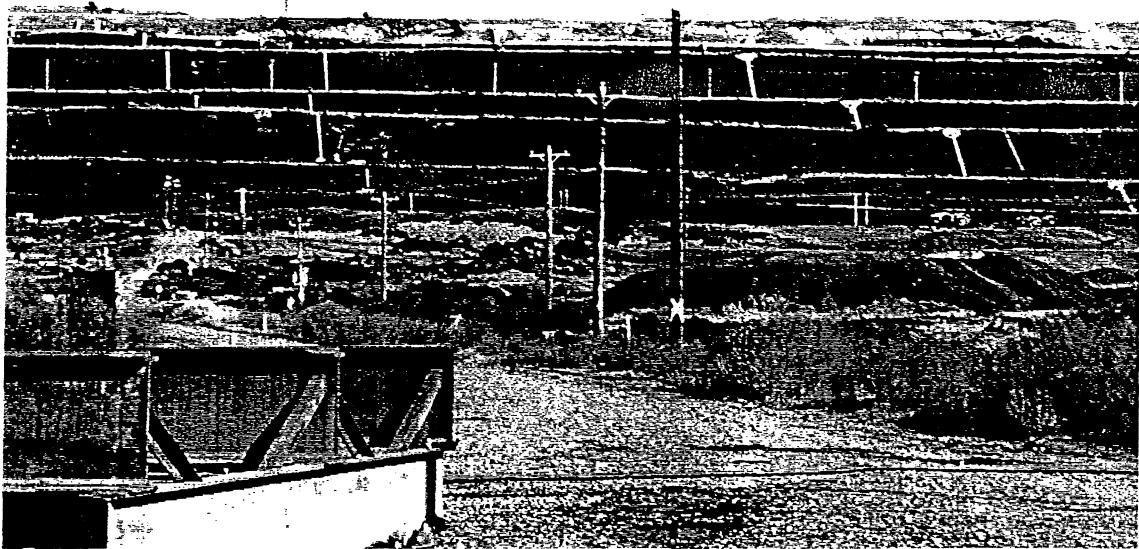
FIGURE 11: Feeders 15 and 16 crossing nearly through the middle of the worked-out area on timber poles, looking east.

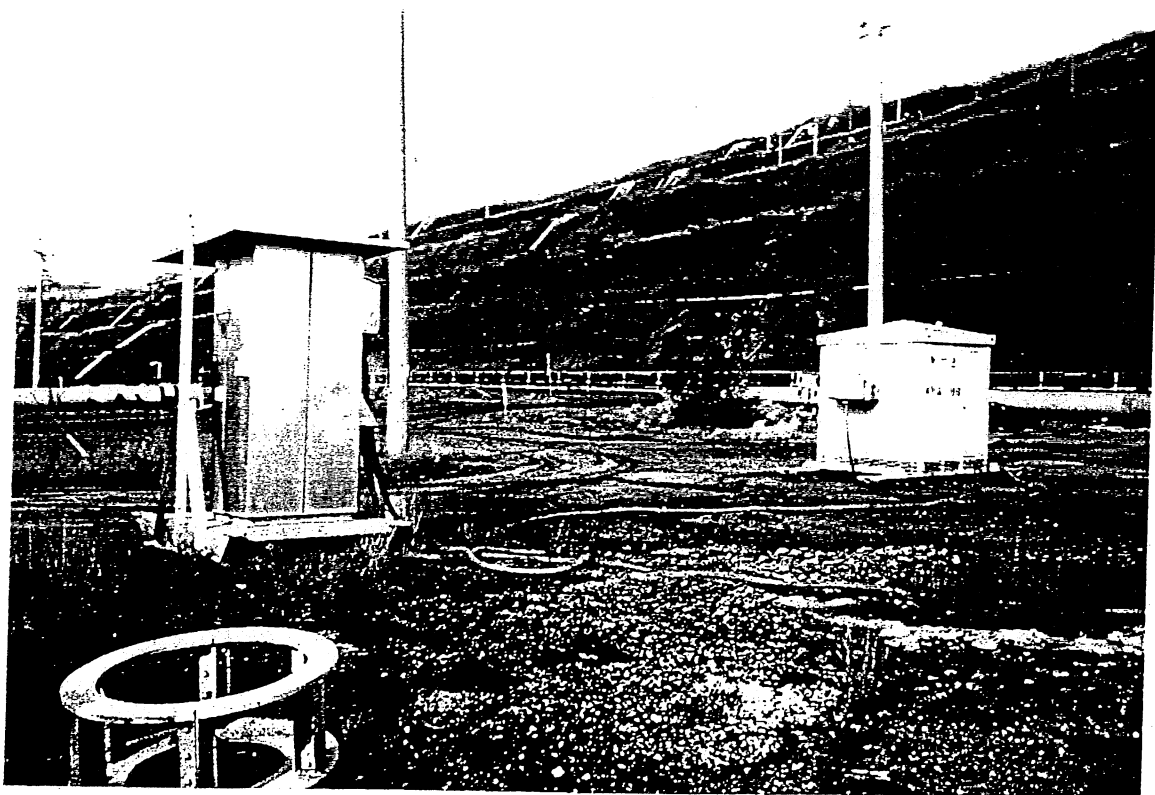
Loss of power to pumping stations or 20 series conveyor, through damage to feeders 4, 5, 15 and 16, is an evident exposure as are electrical cubicles, transformers and associated power supply cables linked to bores located in the worked-out areas.

FIGURE 12: Electrical cubicle for switchgear, etc. (at left) and 300 kVA transformer (at right) to power artesian bore pump, located near southern pivot in the worked-out area.

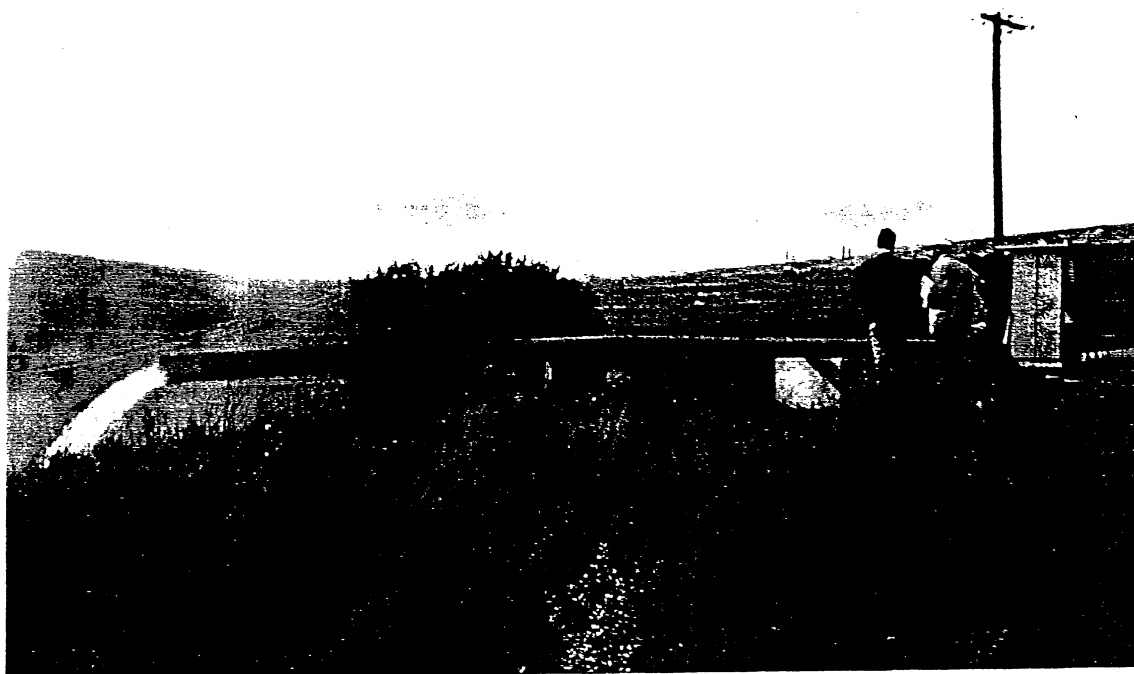
FIGURE 13: Artesian bore pump (per reference in Figure 12). Note electrical cubicle at right; foliage.

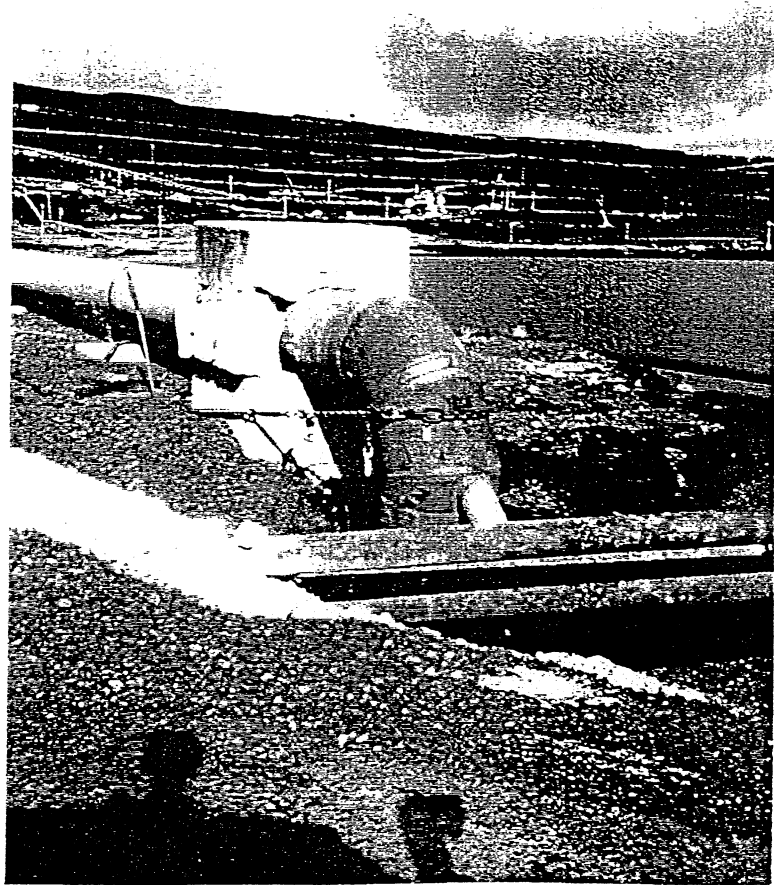
**FIGURE 19:**

Dirty water main at northern end of No.3 groyne adjacent dirty water pumping station. Note reinforcement of pipe elbow against water hammer and momentum.

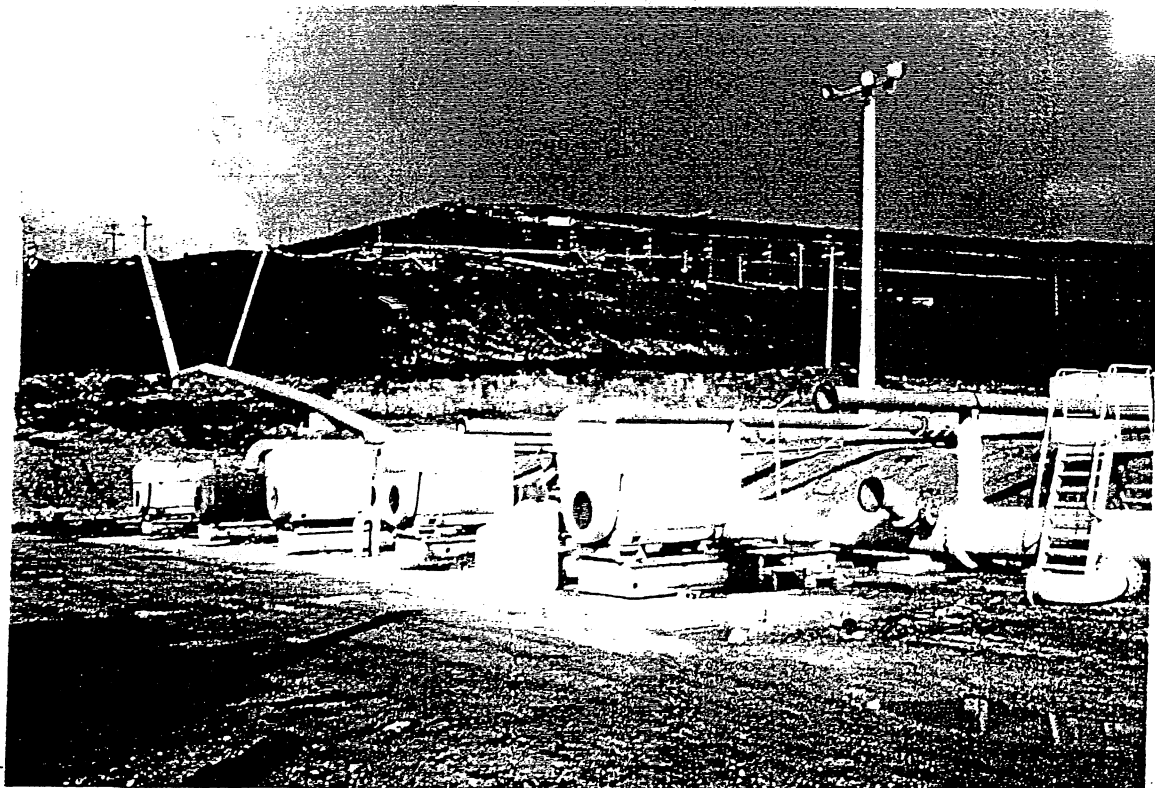
**FIGURE 20:** Clean water pumping station (looking towards southern pivot); three of five pumps out for repair.
