11 DREDGER CENTRE CHUTE FIRE INCIDENT

FINAL INCIDENT INVESTIGATION REPORT

**Incident Date 21/1/2012
AT 06:10 HOURS**

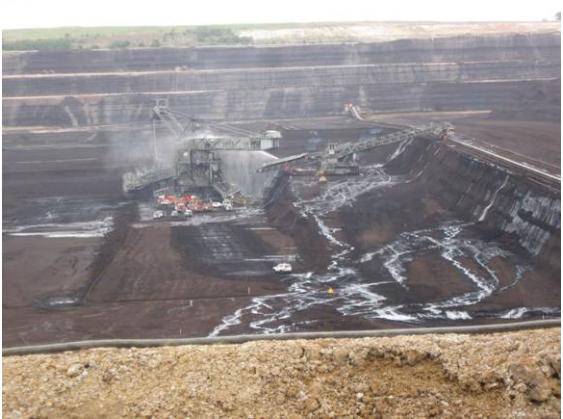
Photo #13

- D11 centre chute area acted as a chimney (once the discharge boom belt had burnt through). The machine configuration, with the discharge boom being elevated, may have made the chimney more effective in concentrating the fire and drawing air into the combustion area.
- A significant amount of flammable material, other than coal, is located in and above the chute area which fuelled the fire
- Weather conditions were calm and pleasant, no wind apparent which assisted in preventing the spread of fire to other areas of the mine.
- Visibility was good as the fire occurred just prior to sunrise at 06:23hrs.
- The fire origin was located approximately 12 metres above the coal surface. The closest access to the fire from the ground outside the machine was 25 metres from the fire source on the machine (refer photograph 13). This severely limited the effectiveness of some fire equipment.

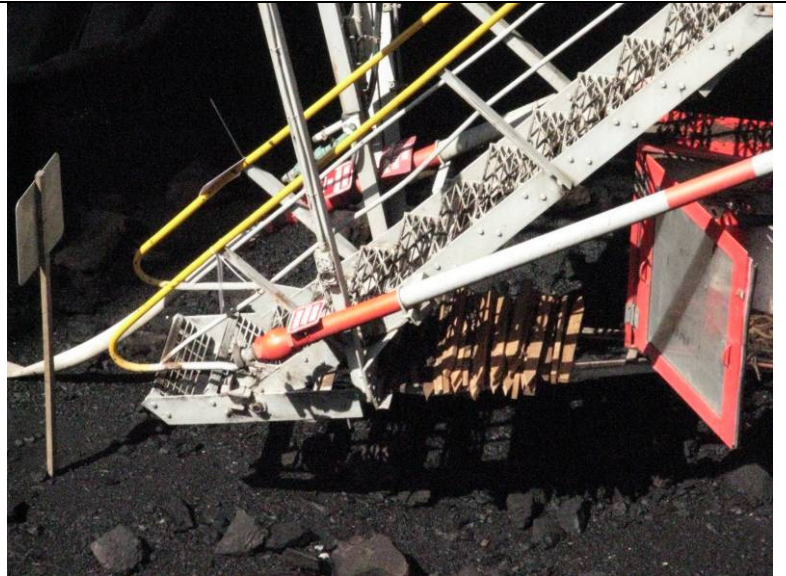
Photo#68 Showing rotary hose connection and the birds mouth connection on the other side
