## Check List For Fire Fighting Equipment Annual Audit & Inspection

International Power  
Hazelwood

### International Power – Hazelwood Mine

### Preliminary Annual Audit

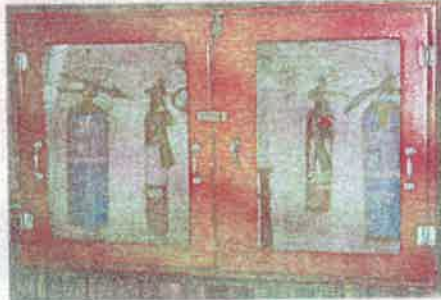
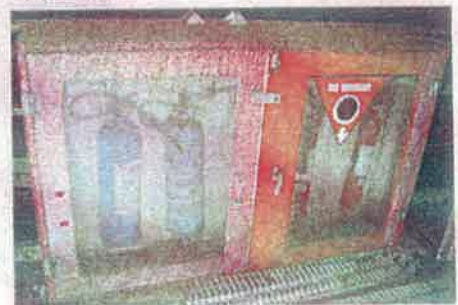
#### Walkway Fire Extinguisher Storage Boxes

| Component<br>& Id No. | Observations / Comments | | | | | | Inspection<br>Date | W/O |
|---|---|---|---|---|---|---|---|---|
| | Foam | 0 | <input checked="" type="checkbox"/> | <input type="checkbox"/> | <input type="checkbox"/> | BROKEN DOOR..... | | |
