International Power Hazelwood

October 2006 Mine Fire Investigation Incident Investigation Report

January 2007

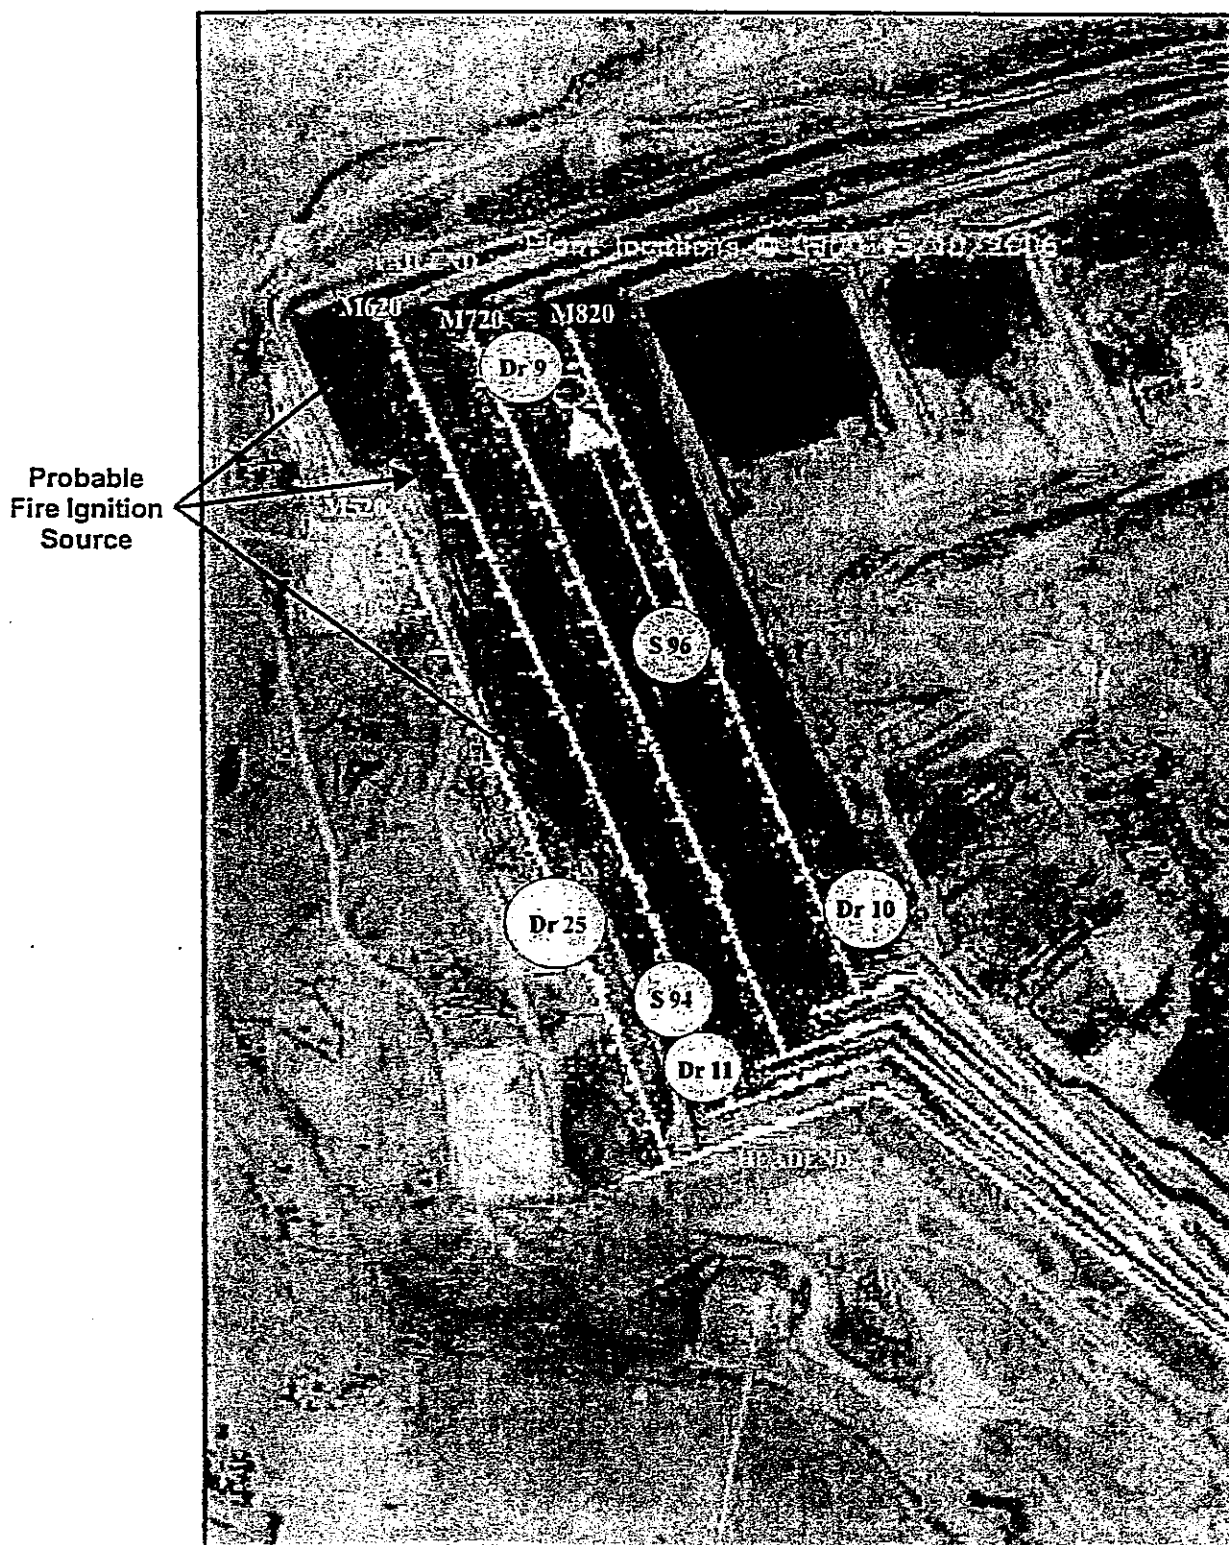
Figure 7 - Likely Initial Fire Ignition Sources

- ▶ Hot idler on M620 conveyor. A collapsed bearing was subsequently discovered at the 853 metre mark (frame number 157) of M620 conveyor. The likely ignition was caused by the collapsed bearing falling onto the return side of the belt and travelling towards the tailend where it was ejected onto the coal level at the tailbox. The hot metal smouldered in the coal and was fanned by the strong winds several hours later and eventually caused a fire to start and spread along the level assisted by the strong northerly winds. In addition it is probable that the belt on M620 conveyor eventually caught fire at the 853 metre mark where the hot idler fanned by strong winds ignited it and burnt towards the head end. Idler inspection records show that the idler on frame 157 of M620 conveyor had not been detected and hence not reported for replacement.

The physical evidence collected by the CFA fire investigation leads to the conclusion that the hot idler is the most probable cause of the fire. However it should be noted that a non-IPRH vehicle crossing the coal formation during a Fire Alert could easily have started a fire and due to the rapid spread of the fire by the wind along the formation, there is also the possibility that the fire started from multiple ignition points. Refer to Appendix G for the CFA Fire Investigation Report.

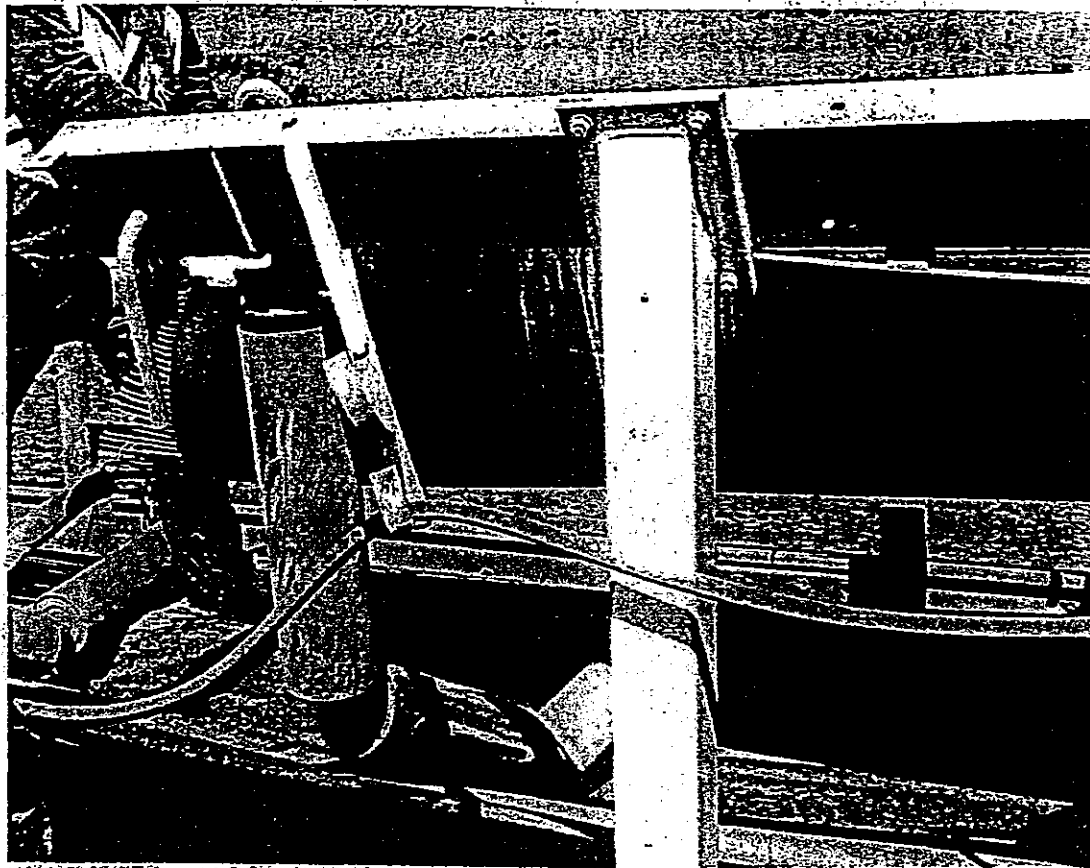
The point of origin was most probably at conveyor unit 157, 852 meters from the head of M620. The remains of the idler assembly that failed were most likely transported on the conveyor to the tailend. The conveyor belt was destroyed to the south of the idler and not north of the belt, it is probable the fire that burnt the belt was a secondary ignition from the same source, see the photo below and note the damage to both the feed and return belts on the left side of the image.

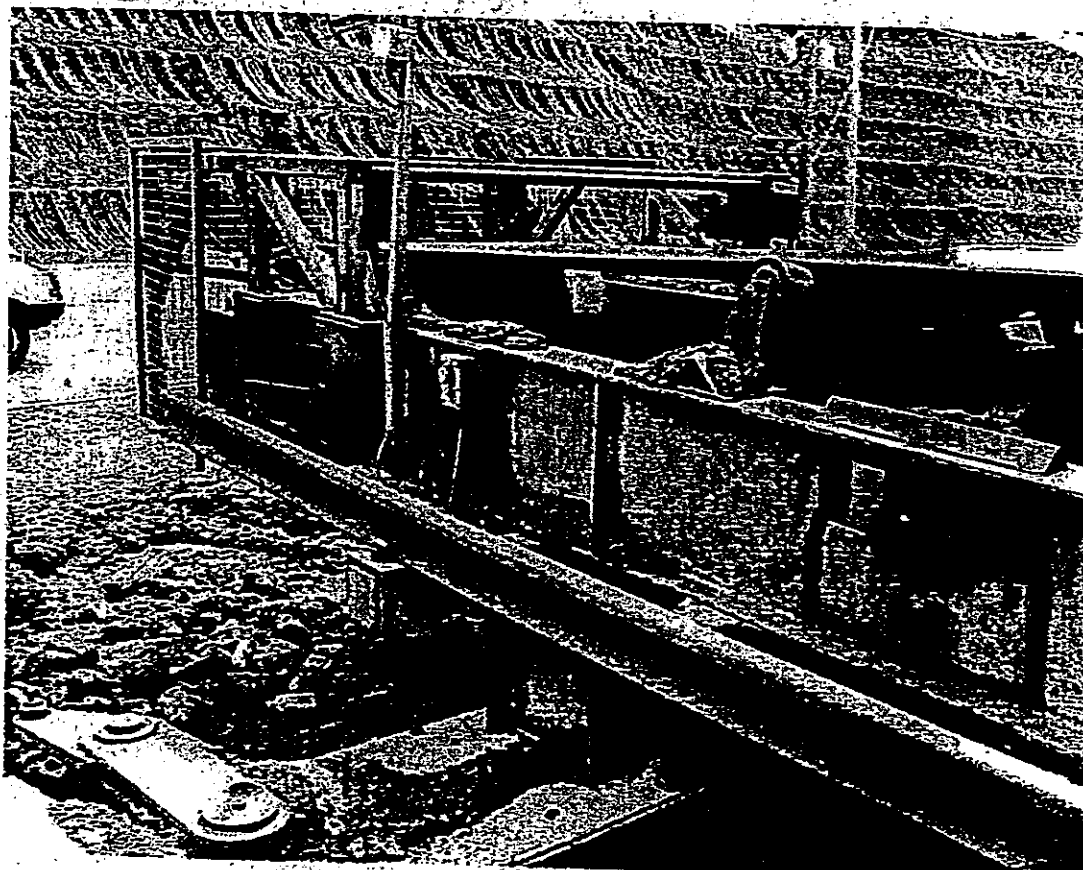
The following three pictures below and on the next page are of the area that the fire was first seen in this is around the tailend of conveyor M640. Note the build up of coal dust on the tailbox and conveyor. This build up is what is left after the fire and the coal buildup was hosed down to extinguish it.

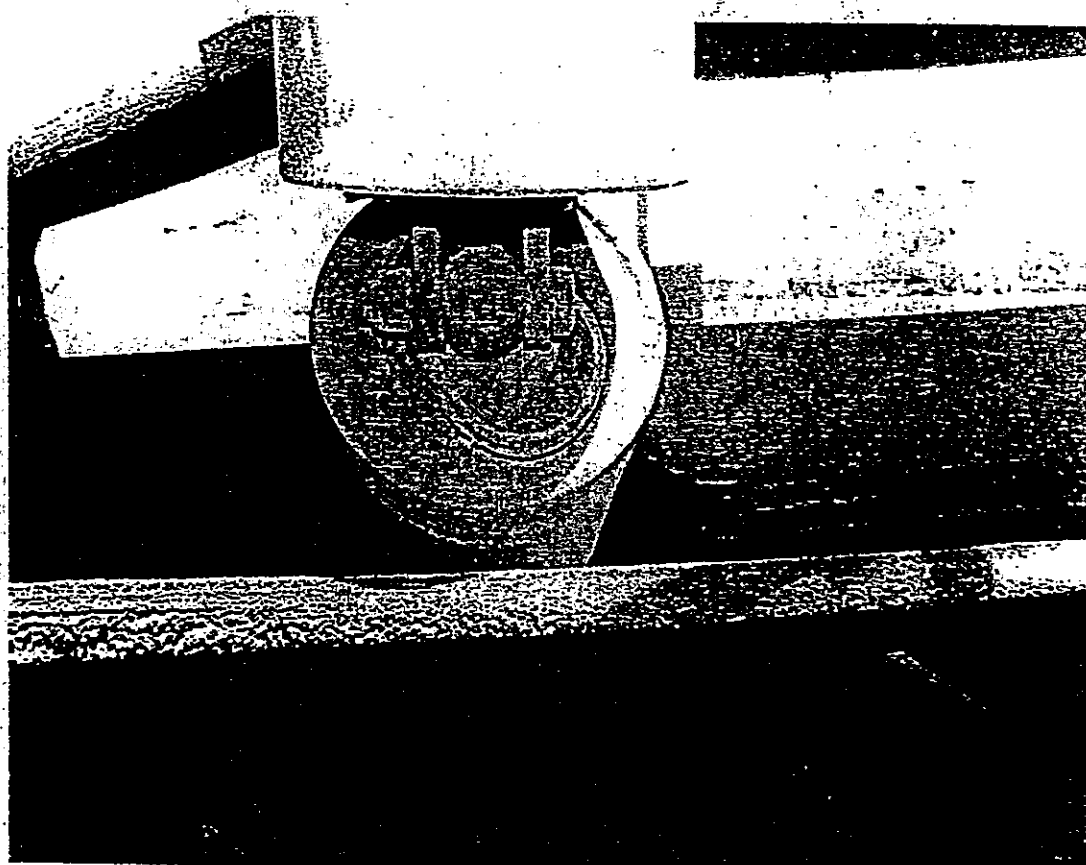
The following photos show the destroyed idler bearing and the conveyor looking towards the tailend.

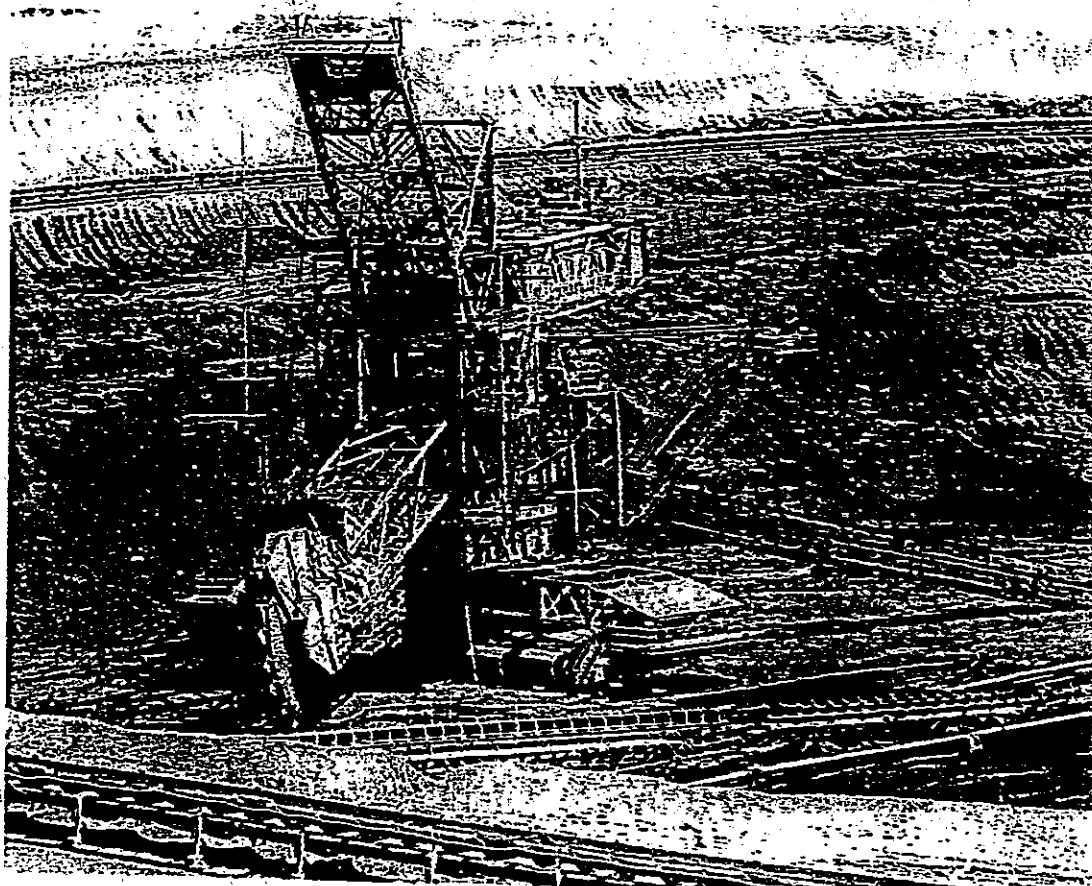
Type: Digital.
Direction: North-West
Taken By:
Description: Dredge 11, post fire.
