Report to Country Fire Authority

The Morwell open-cut mine fire

12-19 October, 2006

Compiled by Brian V Potter QFSM, FIFireE

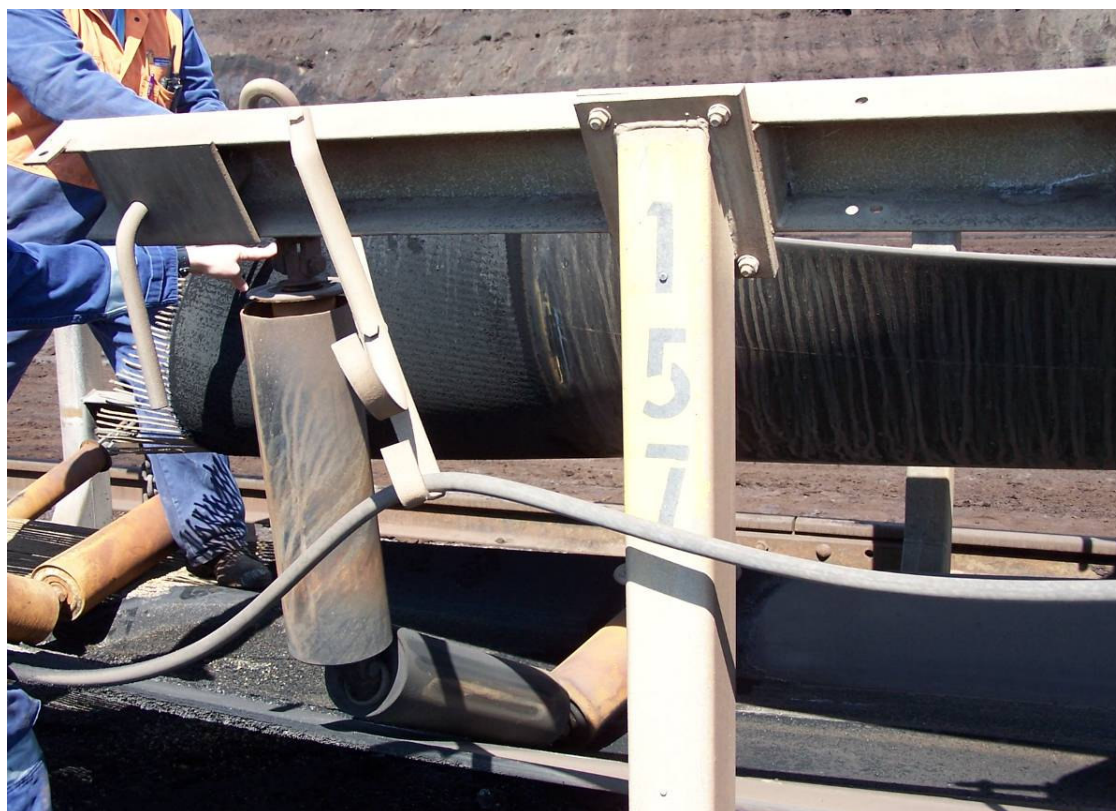
The Fire Investigation Team found that the most likely point of origin of the fire was at conveyor unit 157, 852 metres from the head of Level 620. (The head is the point at which the drive motors are situated, in this case the southern most point of the conveyor or the point where coal is transferred to an other conveyor running perpendicular to it.) The remains of the idler assembly which failed were most likely transported along the conveyor. The point of origin of the actual coal fire was most probably where the heated remains of the idler assembly landed in the build-up of coal at the tail-end (that point most distant from the drive motors) of M620, close to the tail box.

Idler Assembly 157 – CFA Fire Investigation Team

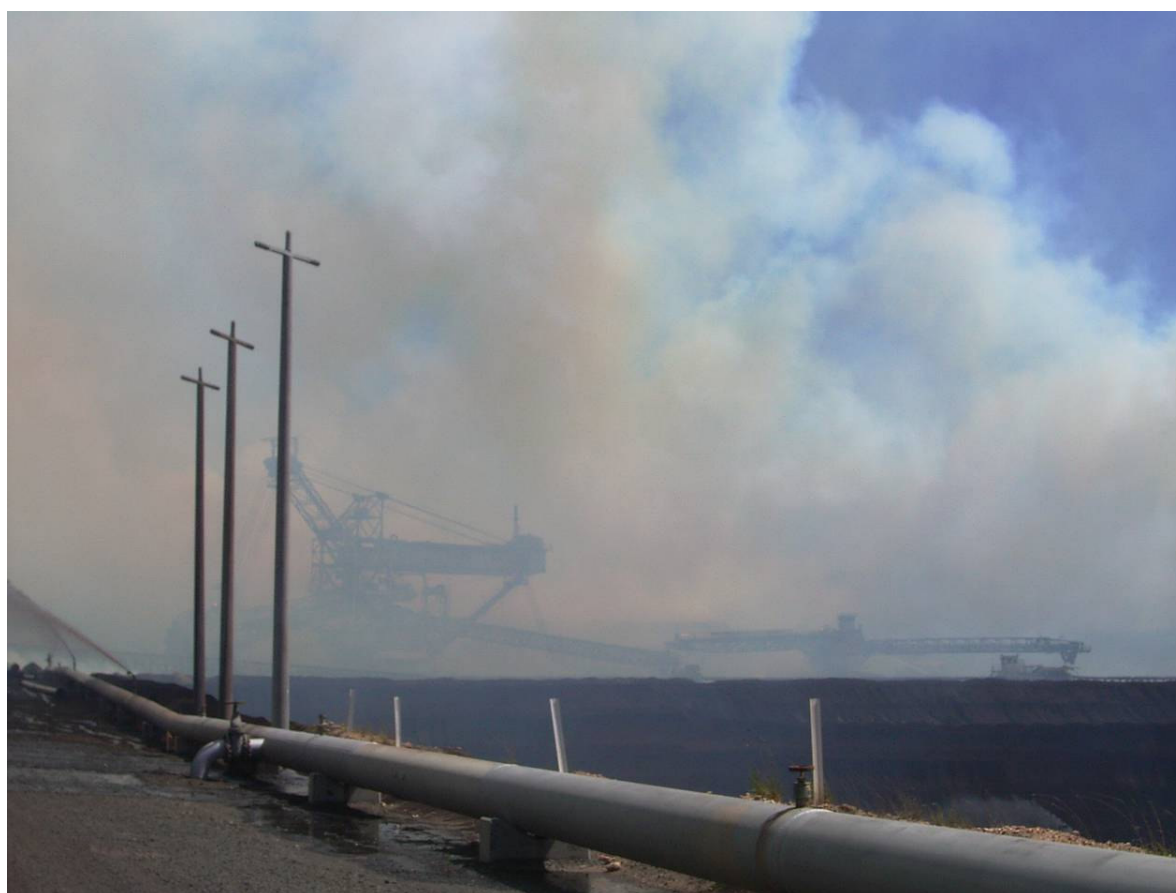
Dredger DR11, 12 October, 2006 – CFA Fire Investigation Team

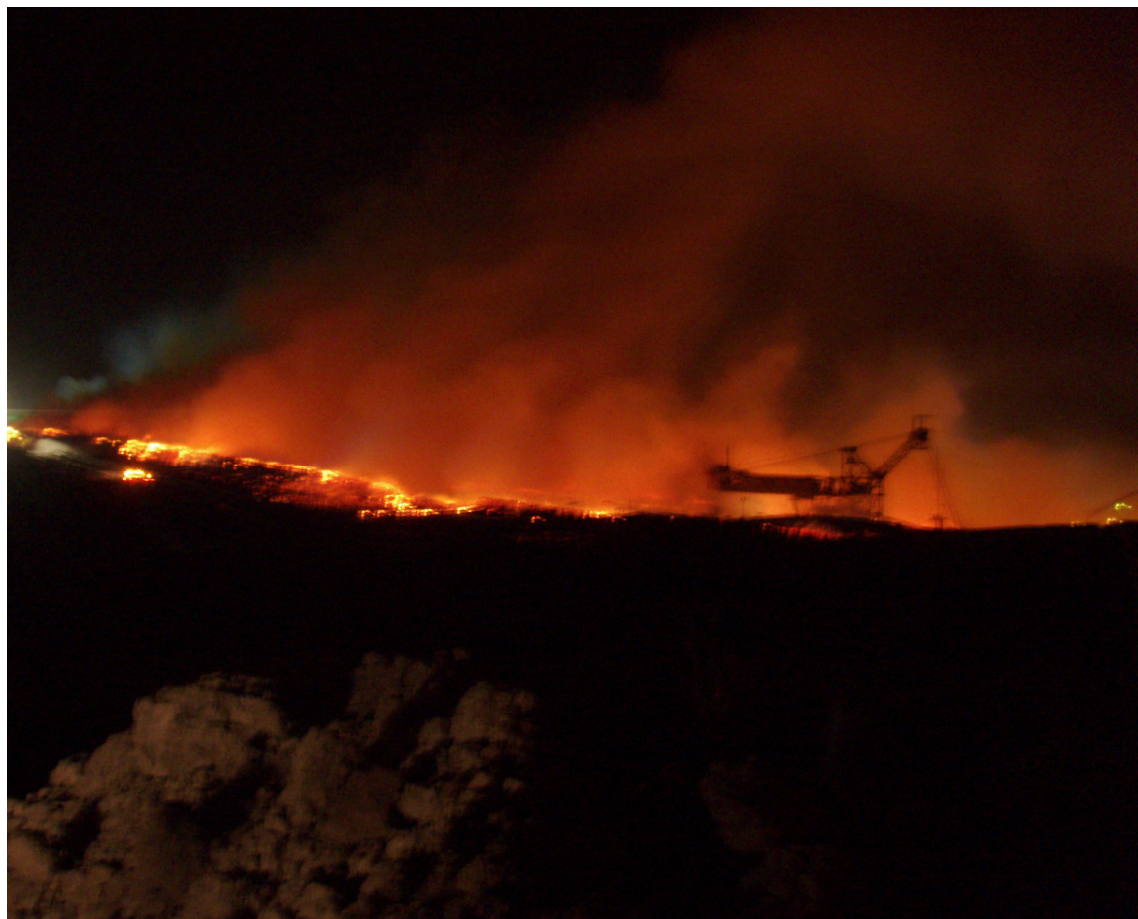
View towards Dredger DR11, Night of 12 October
Photographer unknown

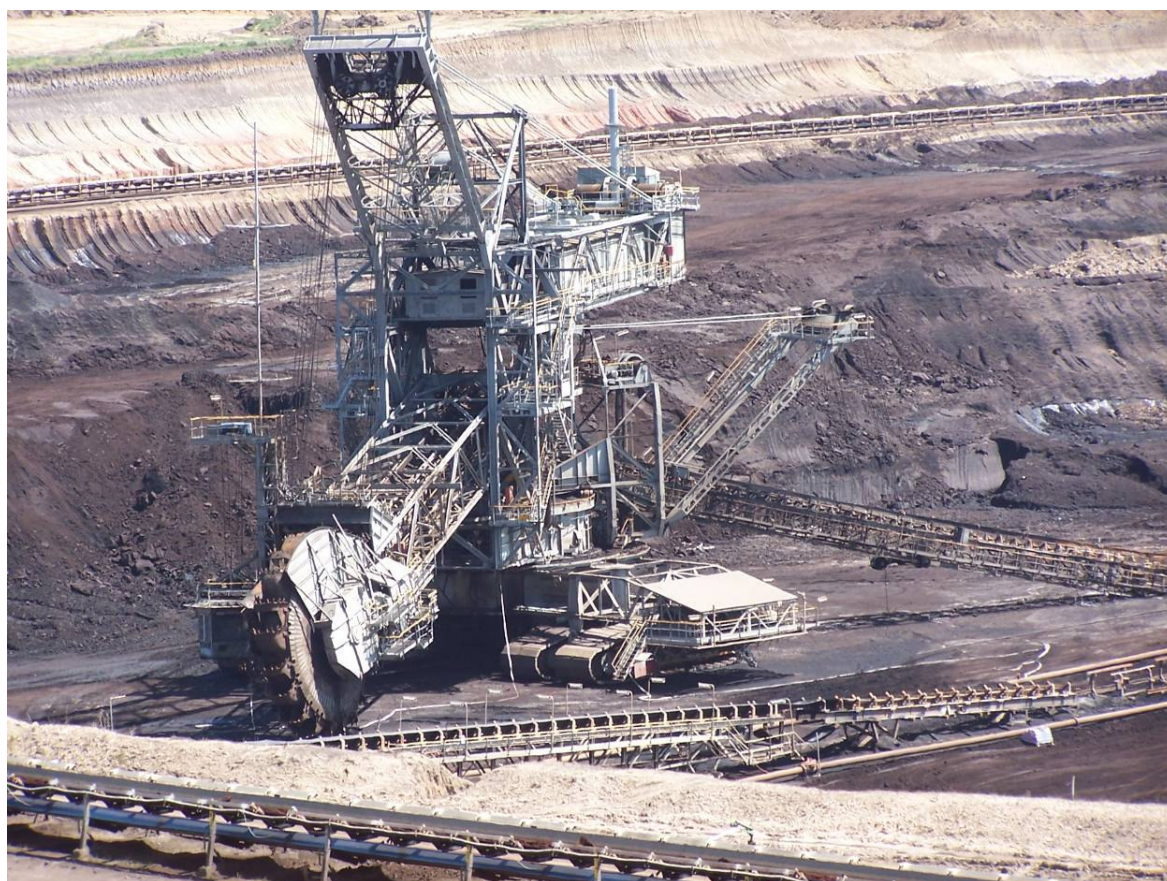
Dredger DR11 after fire damage – CFA Fire Investigation Team

The eventual damage bill was significantly less than that estimated on the first day. The total amount was not as high largely due to the damage to Dredger 11 being less than expected. The predominant costs were associated with the necessity to provide alternative methods of overburden disposal due to the loss of the dredger for almost 12 months. Overall losses were:
