**Country Fire Authority
Fire Investigation Report
Fire & Incident Reporting System (FIRS) Number: 1074299**

**FINAL REPORT
MORWELL OPEN CUT MINE FIRE,
MORWELL, VICTORIA, 3840.**

12/10/2006

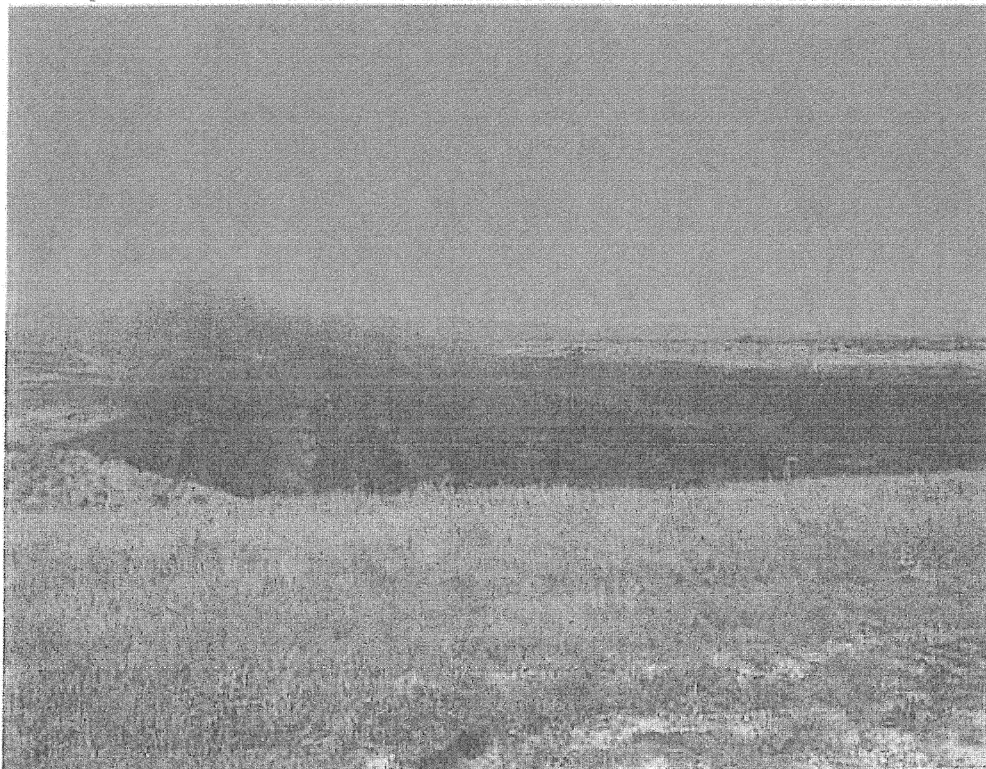
The above photo was taken by [REDACTED] a Mine Surveyor. It was taken from the northern side of the mine looking south, note the amount of raised dust and water sprays operating. The photo was taken at 1123 hours on the 12th of October 2006. See the Photographic Timeline for more details.

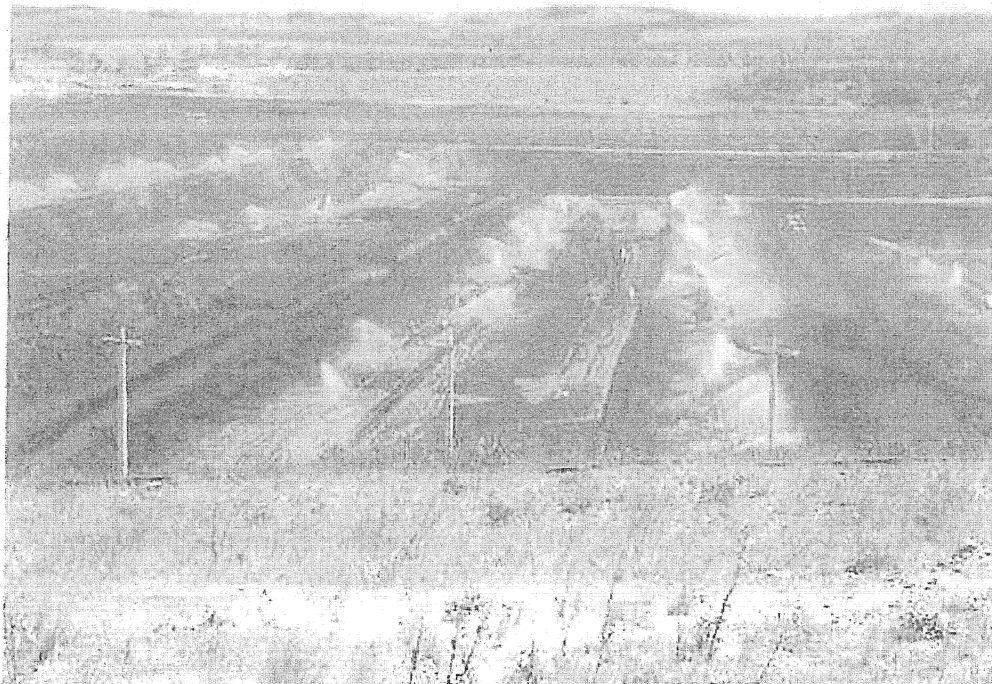
Approx 10:30
12/10/2006

The maintenance work that was programmed required the delivery of crawler pads to DR11 from the store, a transport contractor [REDACTED] is used to conduct these deliveries. [REDACTED] truck arrived at the main gate of the mine at 0910 hours and traveled along the clay roads on the southern batters to reach DR11. With the assistance of one maintenance worker, [REDACTED] laid out the crawler pads in front of the dredge to allow them to be replaced. He was then required to pick up some used crawler pads located on the northern batter access road to level M620. He proceeded to drive his International semi-trailer across the coal formation of M620 to reach the tailend and onto the northern clay road. He recalled the sprays were operating at the time of his crossing and he had followed a worn track across the coal. The track was midway between the topside fire service pipe and the coal batter. At one point he was required to divert from the tracks to miss a boggy area of wet coal, he recalled that he might have had to drive through wet area. He reached the crawler pads where he turned around so he could load the pads from the passenger side of the truck. This is visible in the photo below, taken at between 1030 and 1045 hours.

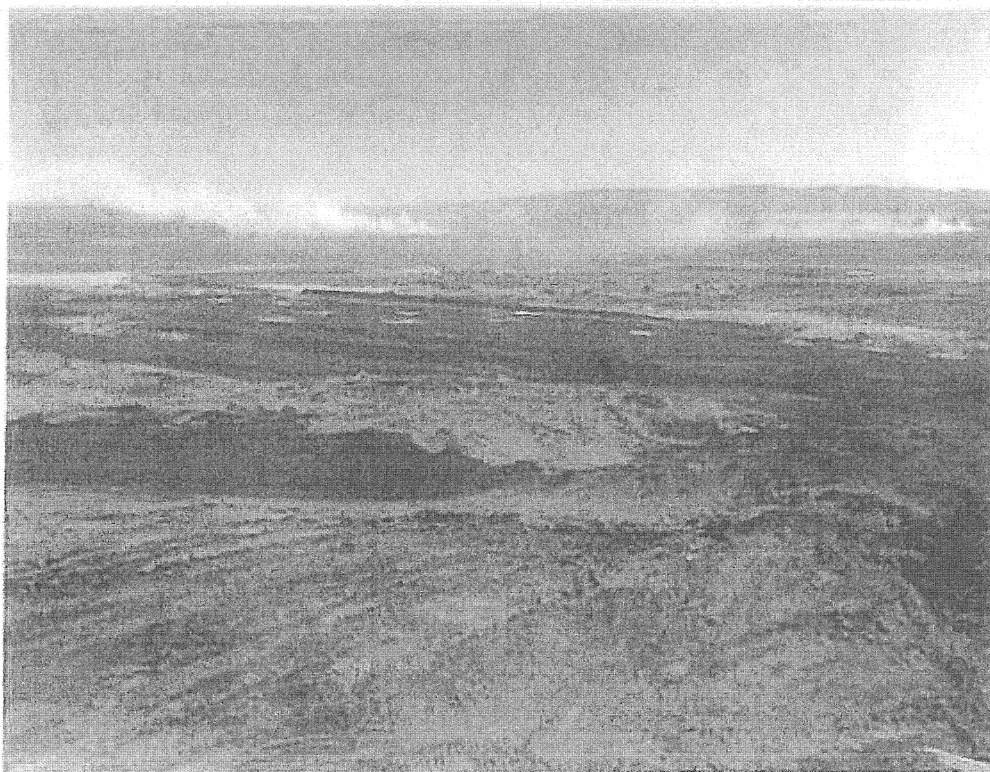
Shortly before 1148 hours a call was made over the open radio channel requesting that all available leading hands and roadrunners report to M620 to assist with fire suppression. The operator of the overburden stacker heard the call and slewed his machine around to see smoke issuing from one end of the batter to the other. He took photos of this on his mobile phone. See Below.

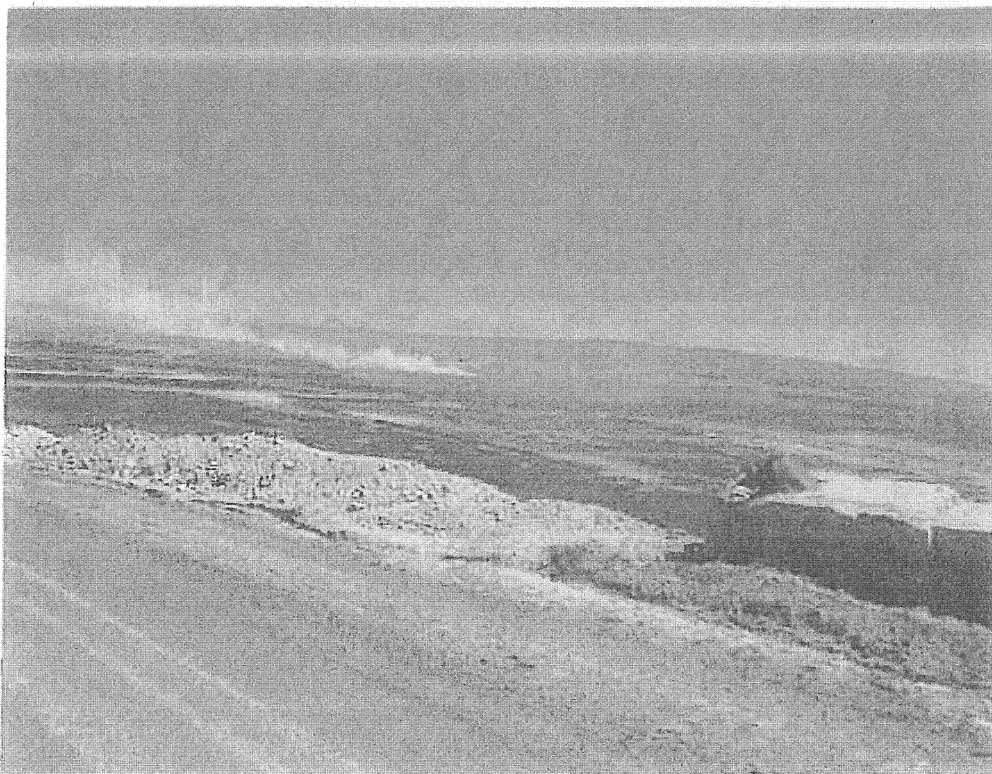
At the same time the mine surveyor [REDACTED] was driving down the southern batters towards the main transfer station and then onto DR11. He took several photos that show the fire from the tail end to the head end of the M620 batter, and of the fire burning around DR11 and Slew 94. The first of his photos was taken at 1152 hours. See below.

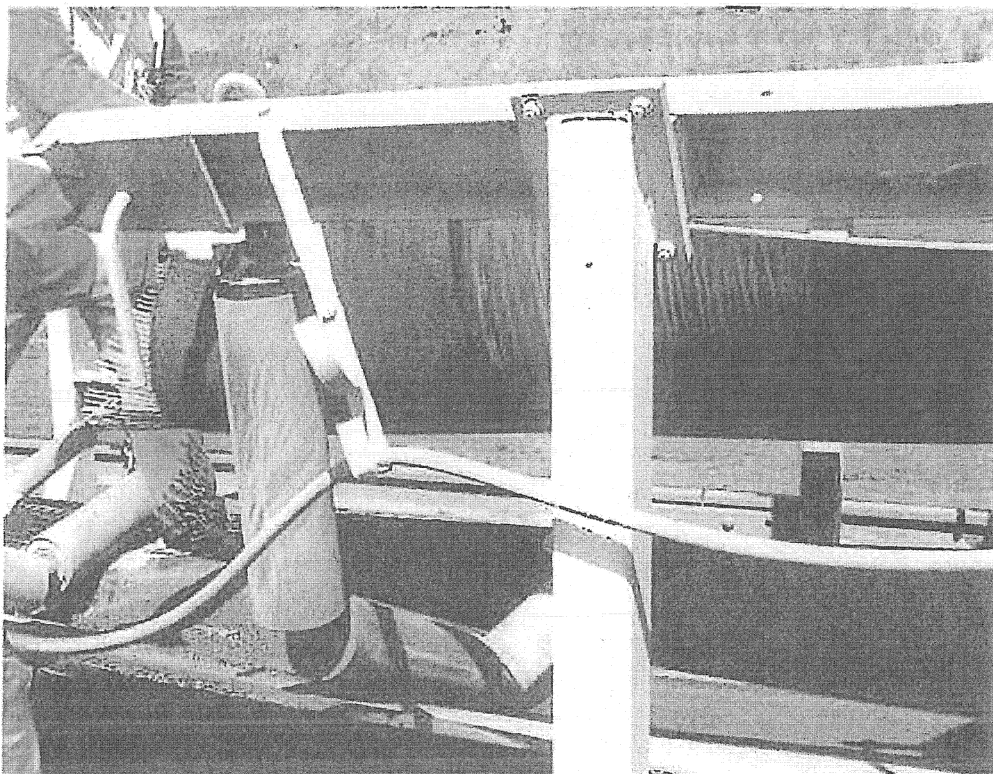
The point of origin was most probably at conveyor unit 157, 852 meters from the head of M620. The remains of the idler assembly that failed were most likely transported on the conveyor to the tailend. The conveyor belt was destroyed to the south of the idler and not north of the belt, it is probable the fire that burnt the belt was a secondary ignition from the same source, see the photo below and note the damage to both the feed and return belts on the left side of the image.

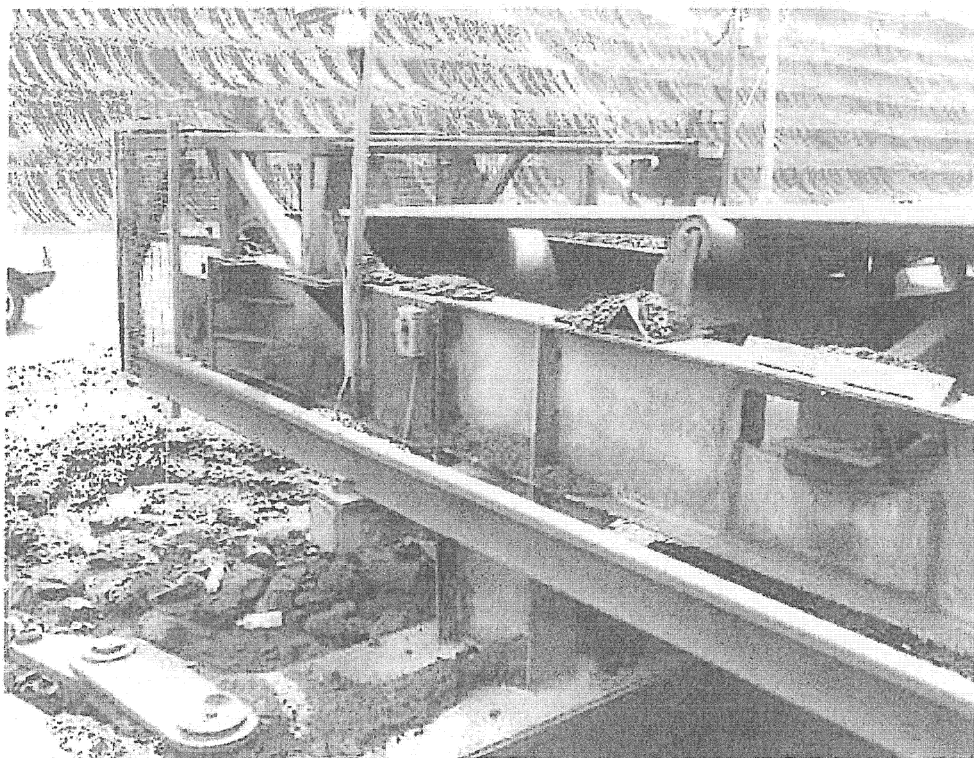
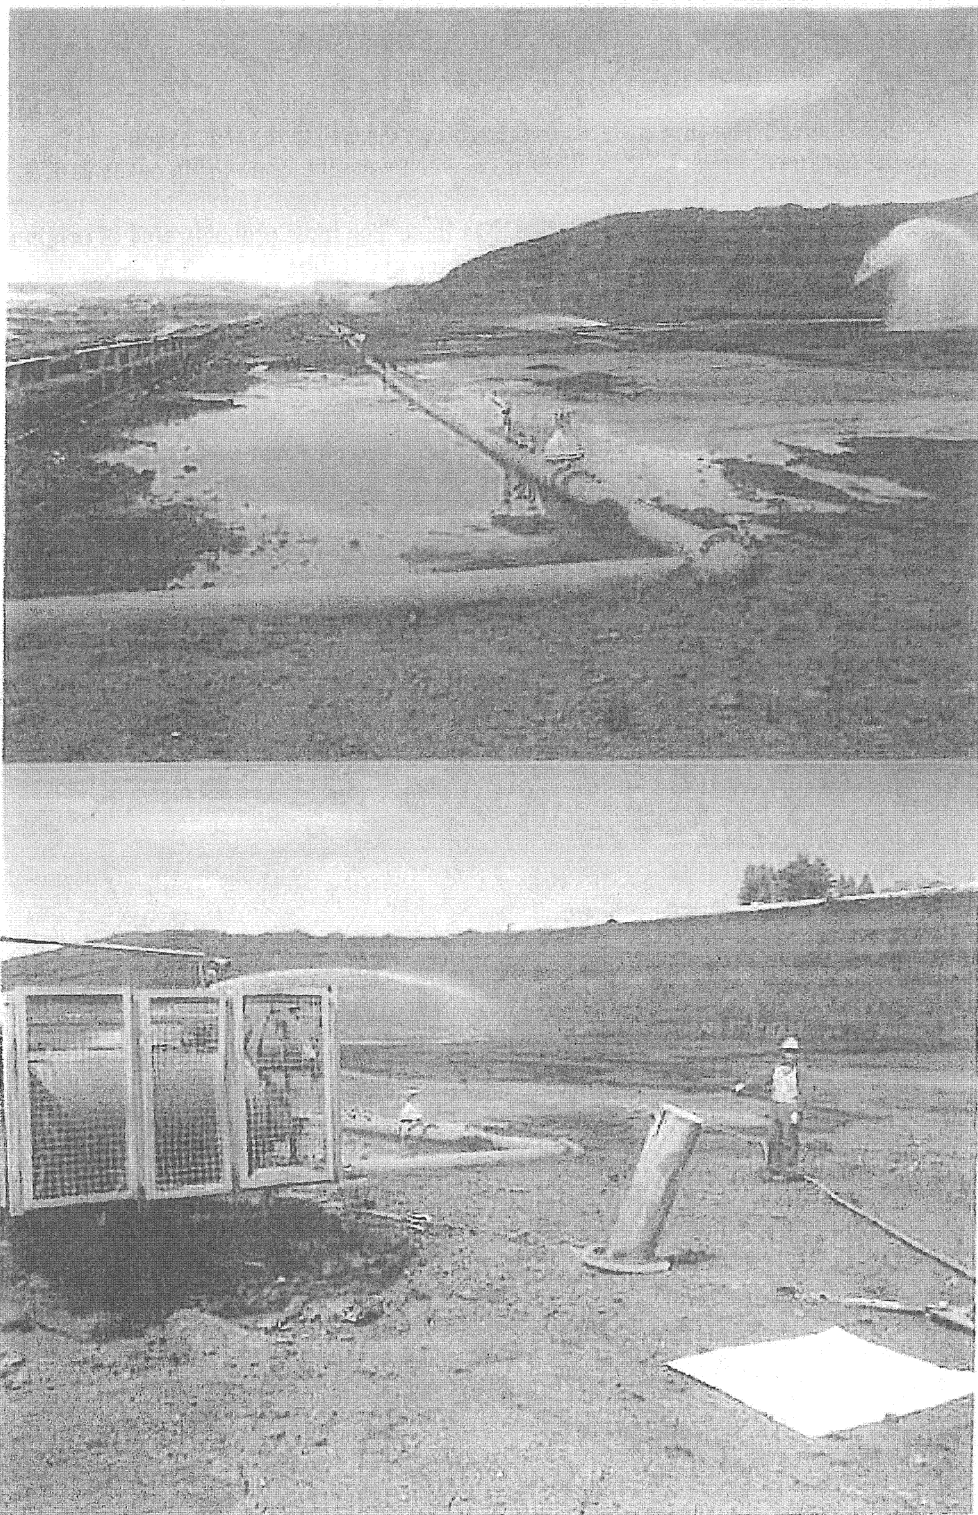
The following three pictures below and on the next page are of the area that the fire was first seen in this is around the tailend of conveyor M640. Note the build up of coal dust on the tailbox and conveyor. This build up is what is left after the fire and the coal buildup was hosed down to extinguish it.

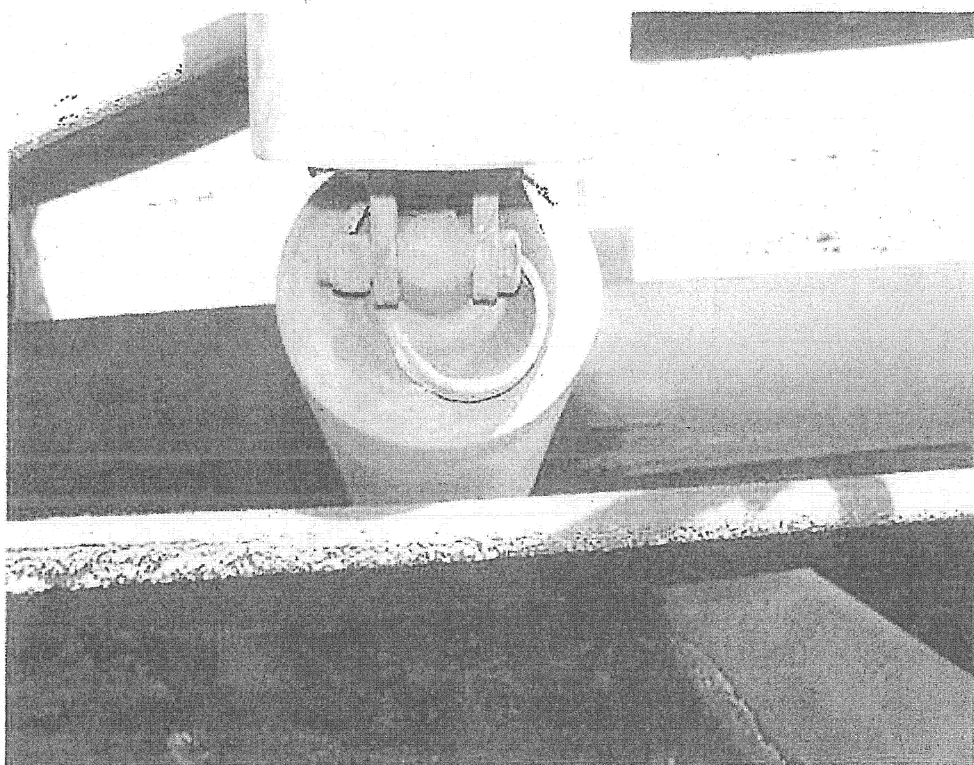
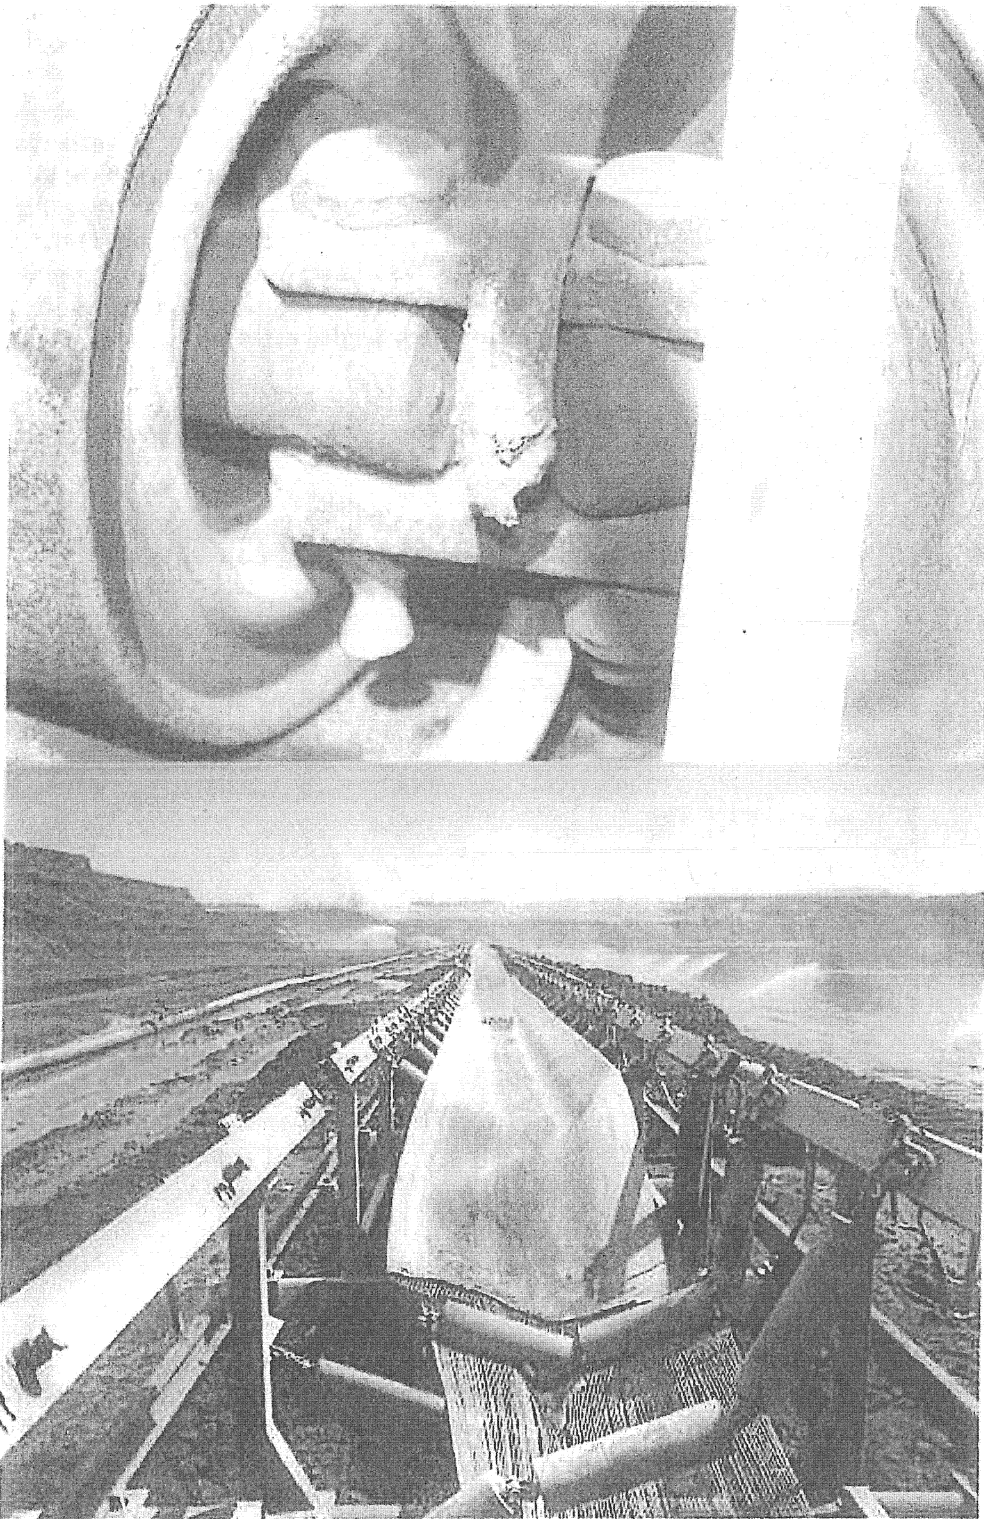
The point of origin was most probably at conveyor unit 157, 852 meters from the head of M620. The remains of the idler assembly that failed were most likely transported on the conveyor to the tailend. The conveyor belt was destroyed to the south of the idler and not north of the belt, it is probable the fire that burnt the belt was a secondary ignition from the same source. The fire at the tailend, in the vicinity of the tailbox was noticed at the same time the wind speeds had increased. This was several hours after the conveyor was shutdown for maintenance. The point of origin of the actual coal fire was most probably where the heated remains of the idler assembly landed in the built up coal at the tailend of M620, close to the tail box.

The following photos show the destroyed idler bearing and the conveyor looking towards the tailend.

First Idler Bearing Set, on conveyor unit 157. The lower bearing collapsed in the bottomside, feed idler, the roller had ground away the nut and bolt below it. There was evidence the conveyor had run for a period of time after the failure as the idler had destructed and the only remains of the bearing was a molten bearing cover.

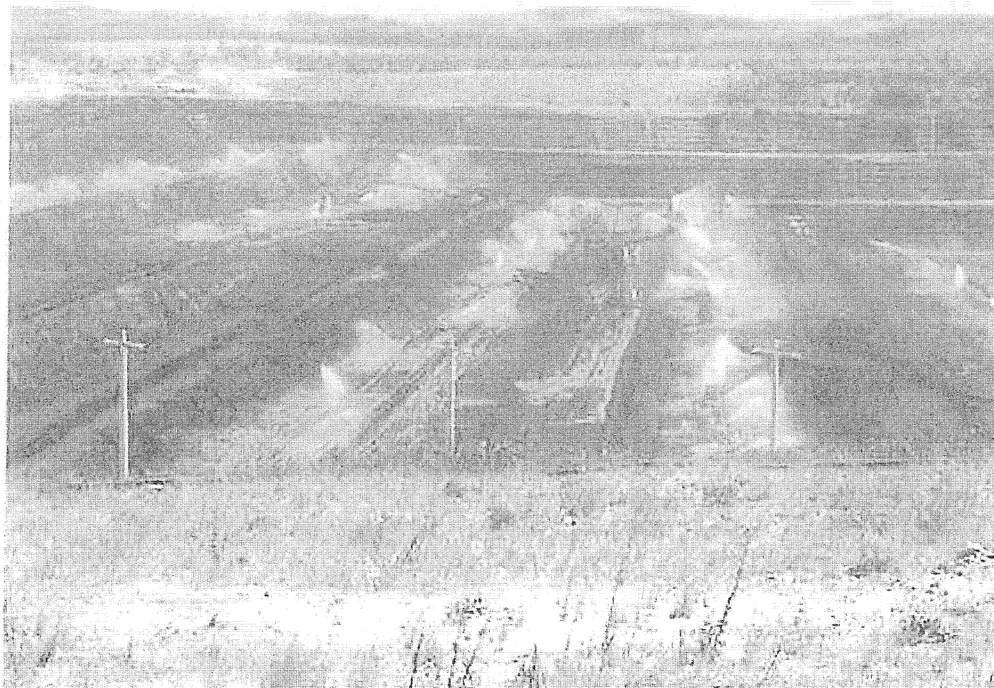
Approx 10:30
12/10/2006

The above image was taken by an unknown person, the image was presented to the CFA investigators to show the mine's fire sprays were operating prior to the fire. The caption on the image states it was taken at approximately 1030 hours on the 12/10/2006, however the time stamp is for 1150 hours on the 12/10/2006. The truck located in the middle of this photo belongs to [REDACTED] a local transport contractor. His gate pass recorded that he entered the mine at 0910 hours and left at 1115 hours. Discussions held with [REDACTED] revealed that it took him 30 minutes to exit the mine to the gatehouse. He stated that he took approximately 1 hour to load at the location in the picture. The possible timeframe for the capture of this image is between 1015 and 1045 hours, however closer inspection of the photo shows [REDACTED] truck is loaded. This would make the likely time probably **1030 to 1045 Hours.**

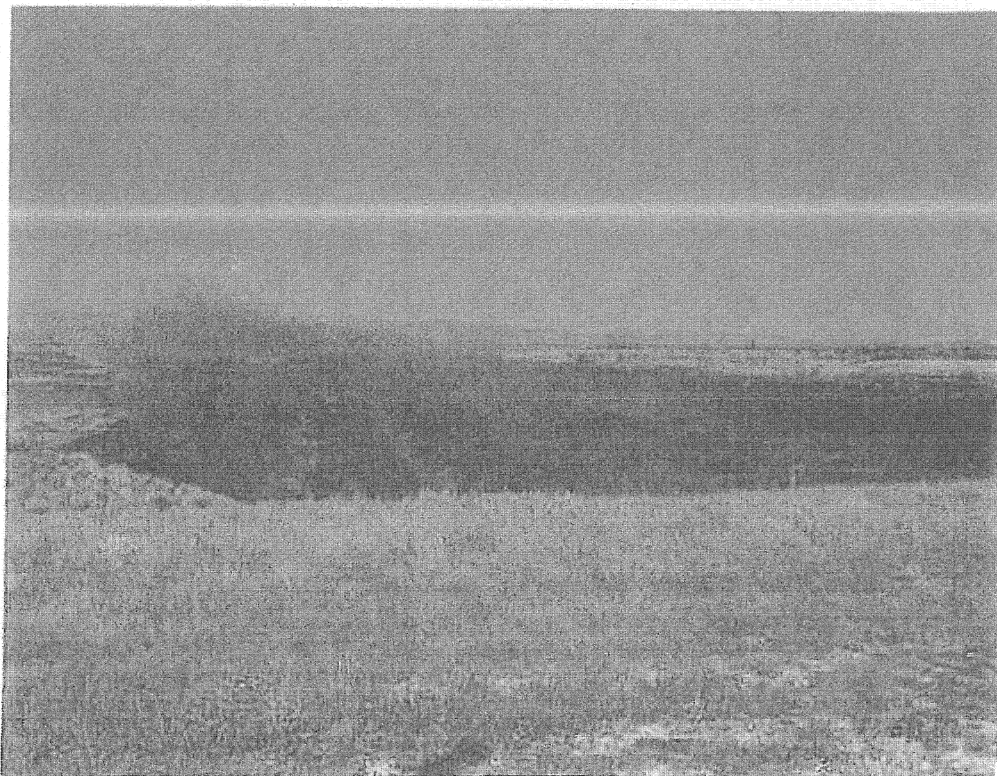
The above photo was taken by [REDACTED] a Mine Surveyor. It was taken from the northern side of the mine looking south. The time stamp on the camera was 1213 Hrs on the 12/10/2006. Inspection of [REDACTED] camera revealed the time stamp is approximately 50 minutes fast, the actual time of this image is 1123 hours. Batter and formation M620 is visible in the right of the picture, the sprays to the right of the image are operating on M620. The heads of all of the conveyors are not visible due to raised dust. From the left of the picture, Dredgers 10 and 9 are visible. The Dredge on the far right is DR25, DR 11 is sited on the far end of M620, and it is not visible due to the amount of raised coal dust. The tail end of M620 is on the far right of this image and not in view, this shows the topside sprays operating and shows the limited coverage of the sprays due to the wind. As this image does not show the tail box, it is not possible to determine if there is an active fire at the time of the photo.

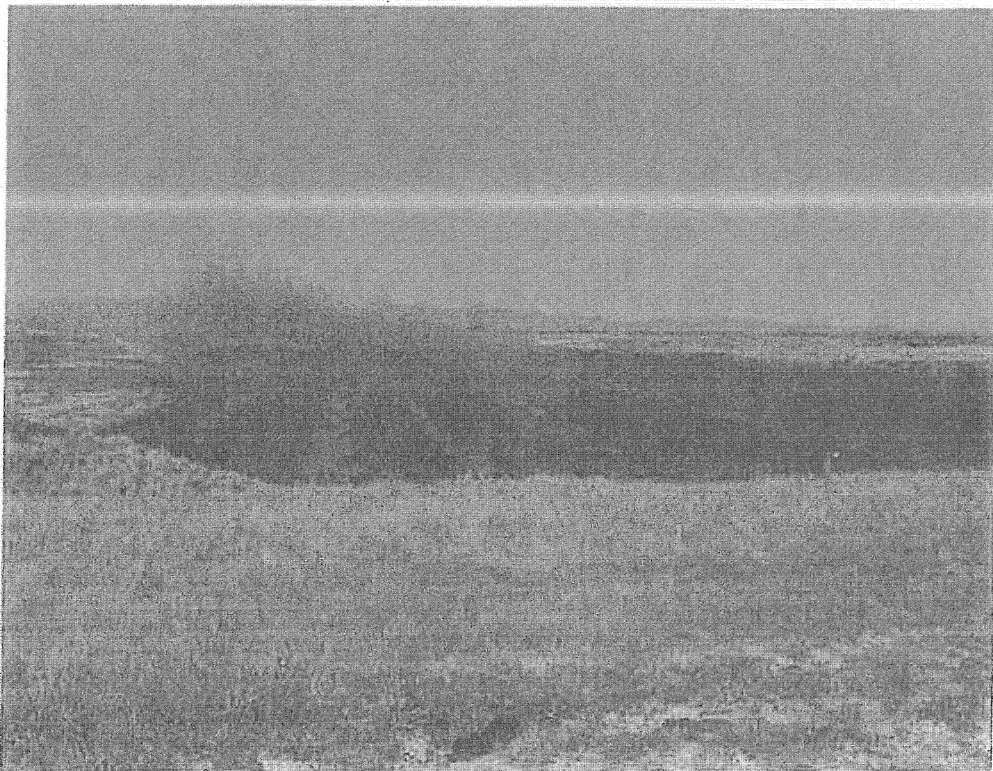
The above image is the second in a series of two taken by [REDACTED] from the northern end of the mine; it was taken shortly after the previous image.

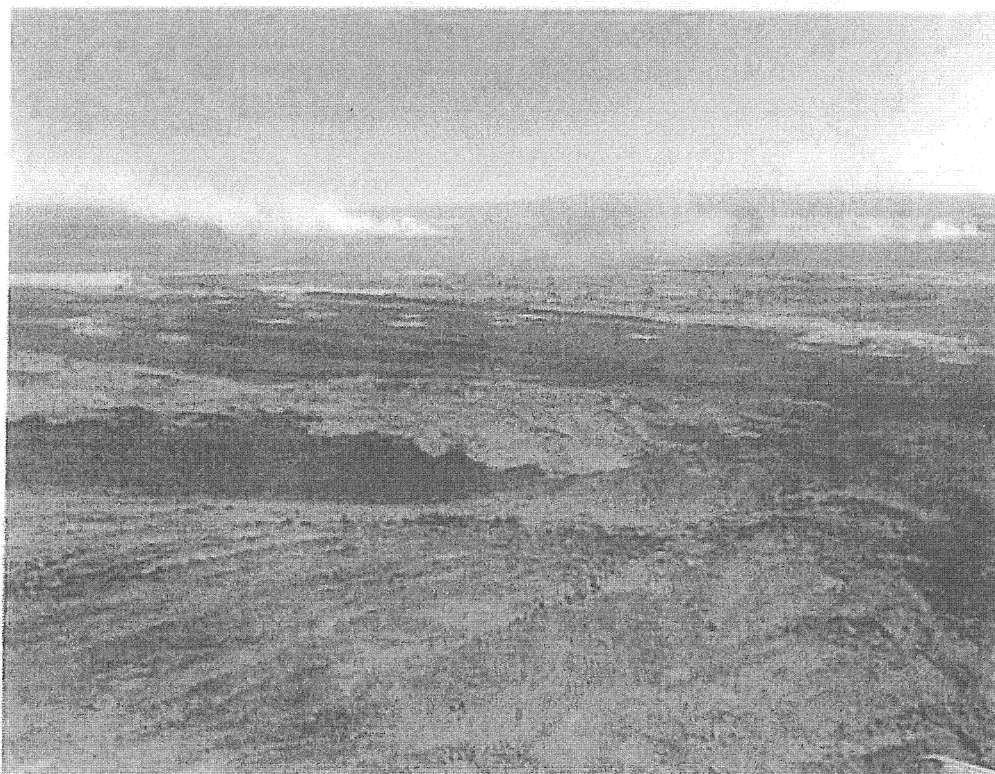
This image was captured by [REDACTED] in his mobile phone when he overheard a radio call for roadrunners and leading hands to attend a fire over the open channel. [REDACTED] was operating the TS2 Overburden Stacker on the south side of the mine, on hearing the call he slewed his machine around and took a series of photos. The first photo was recorded at **1149 hours**. This image is from the east looking at the fire on the M620 formation and batter. The tail end is to the right and the dredge is just visible through the smoke on the left side of the mine.

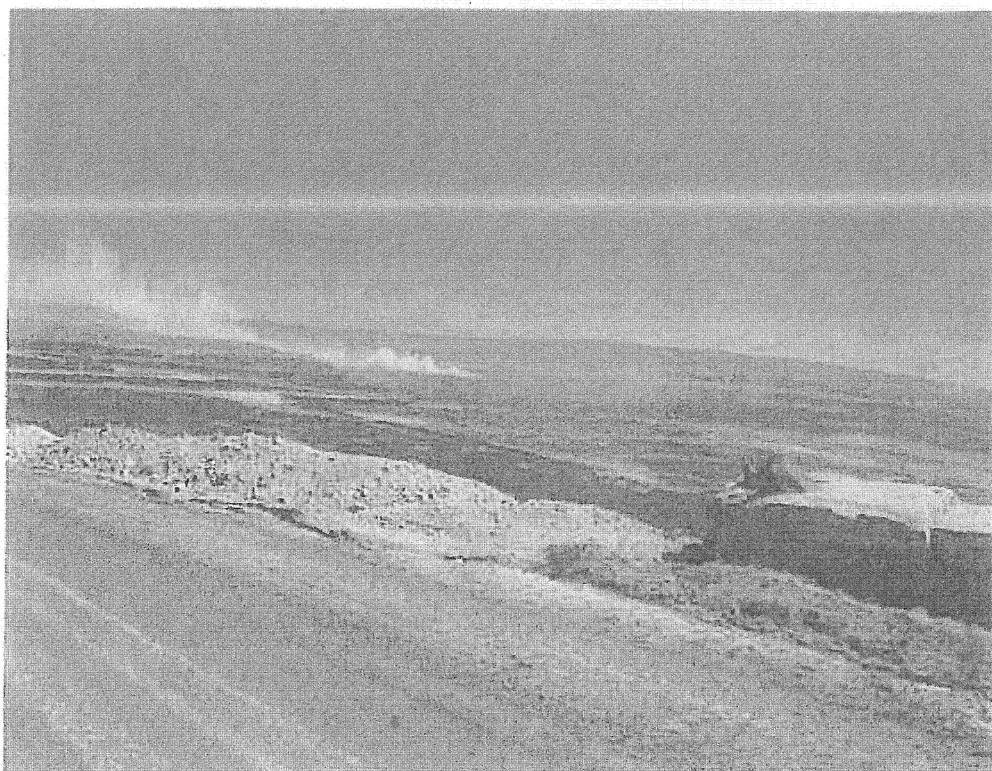
This photo was taken by [REDACTED] at 1152 hours as he traveled towards the head end of the mine. This photo was retaken by [REDACTED] to see if the 11DR and S94 would have been visible from this point. As you can see in the next photo they would have both been in the picture, but appear to have been obscured by smoke. They would have also had fire around them.

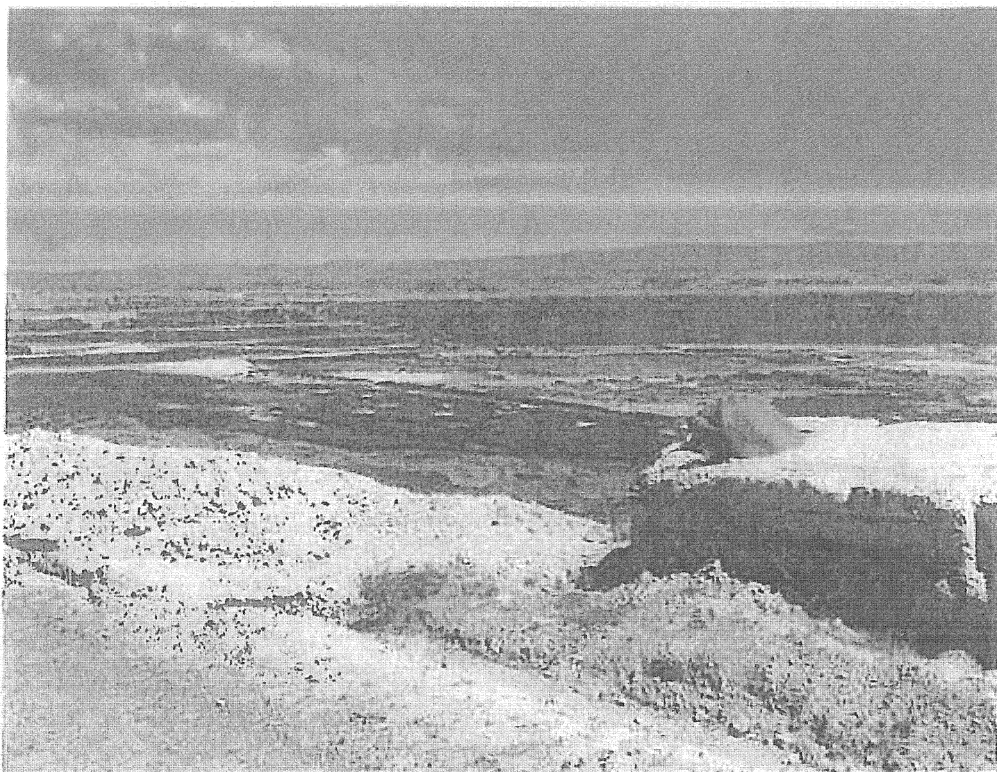
This photo shows the view of the 11DR and where S94 would have been. Taken by [REDACTED]

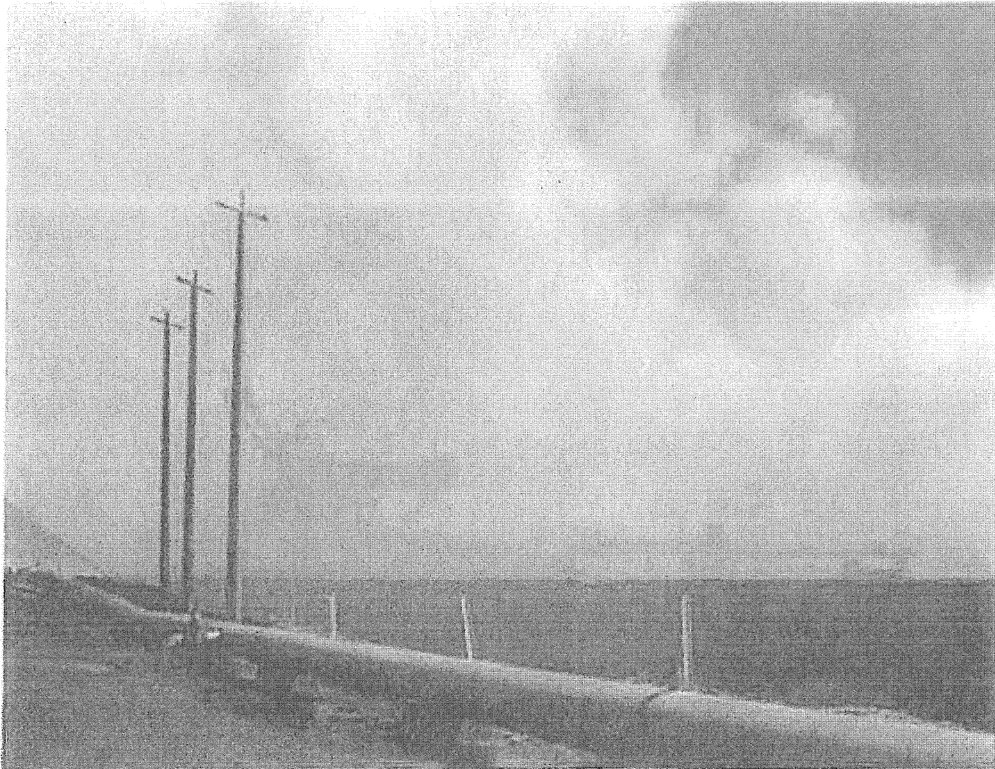
Photo taken by [REDACTED] while approaching the fire from the headend at 1229 hours. DR 11 and S94 both in view.

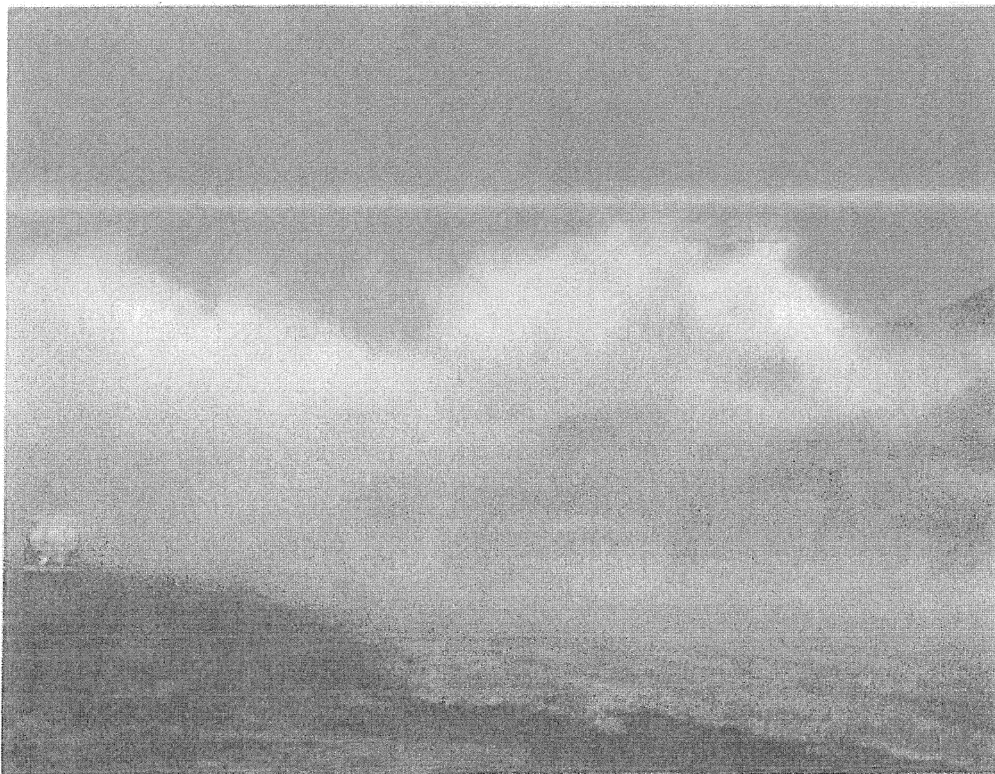
Photo taken by [REDACTED] at 1235 hours from the tailend of M620. Note the batter is also now involved in fire.

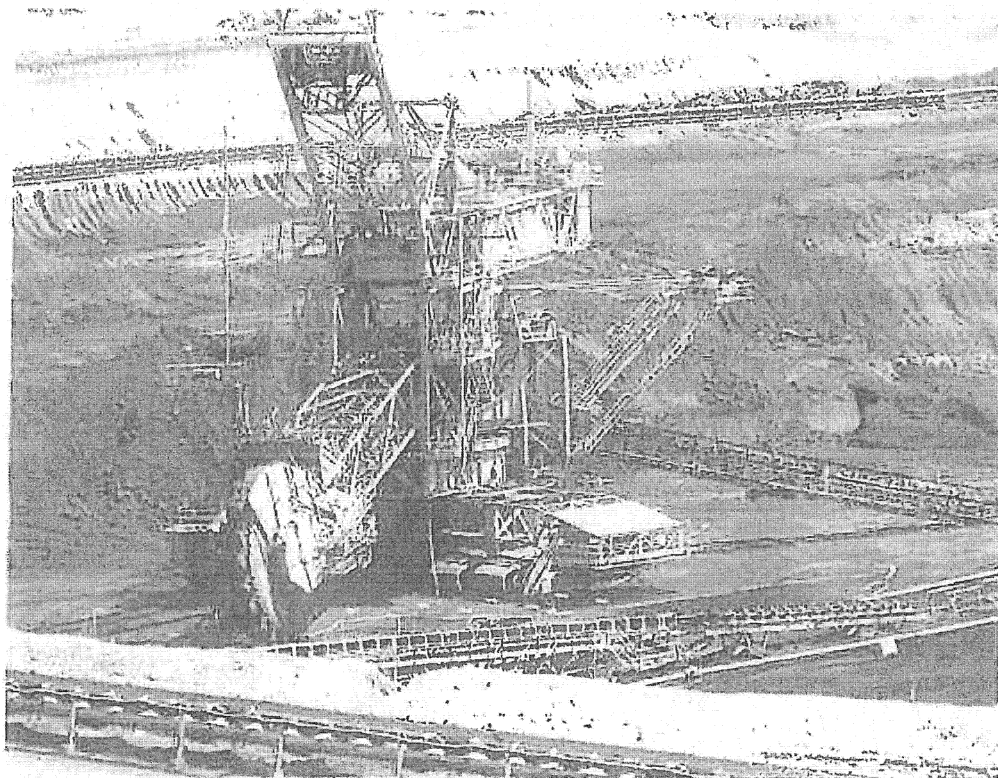
Type: Digital.
Direction: North-West
Taken By: Fire Officer [REDACTED]
Description: Dredge 11, post fire.

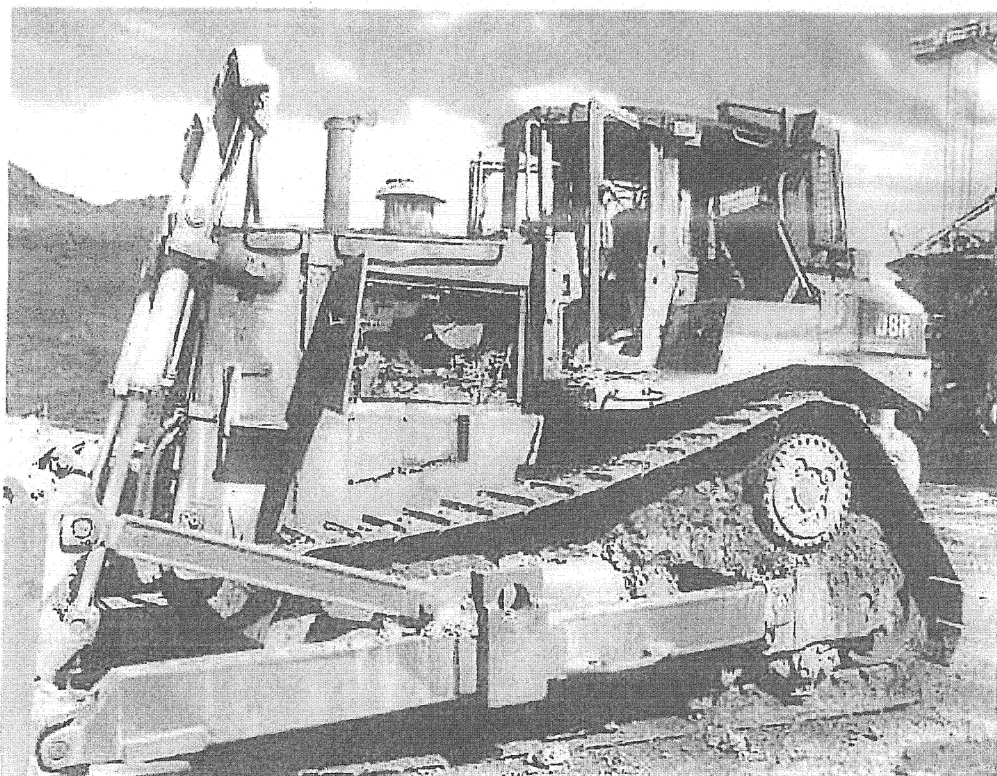
Type: Digital
Direction: West
Taken By: Fire Officer [REDACTED]
Description: Destroyed Bulldozer at head of M620.

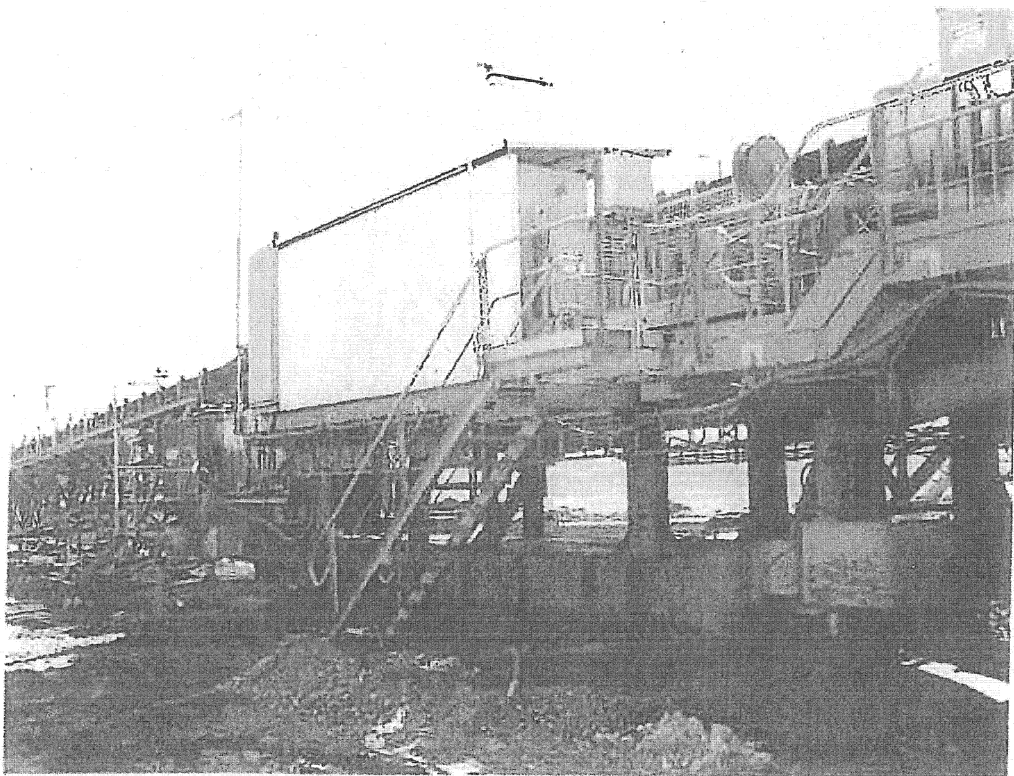
Type: Digital
Direction: North East
Taken By: Fire Officer K
Description: Destroyed head unit from the M620 conveyor.

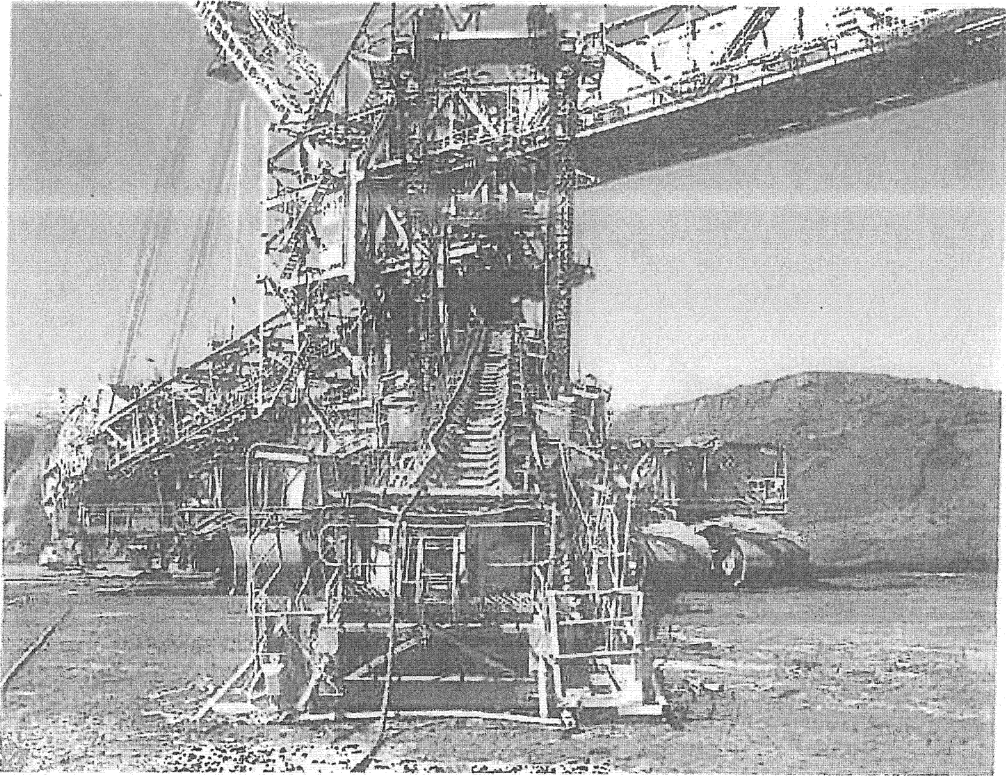
Description: North end of the damaged DR 11. This photo shows the conveyor that exits the rear of the unit.

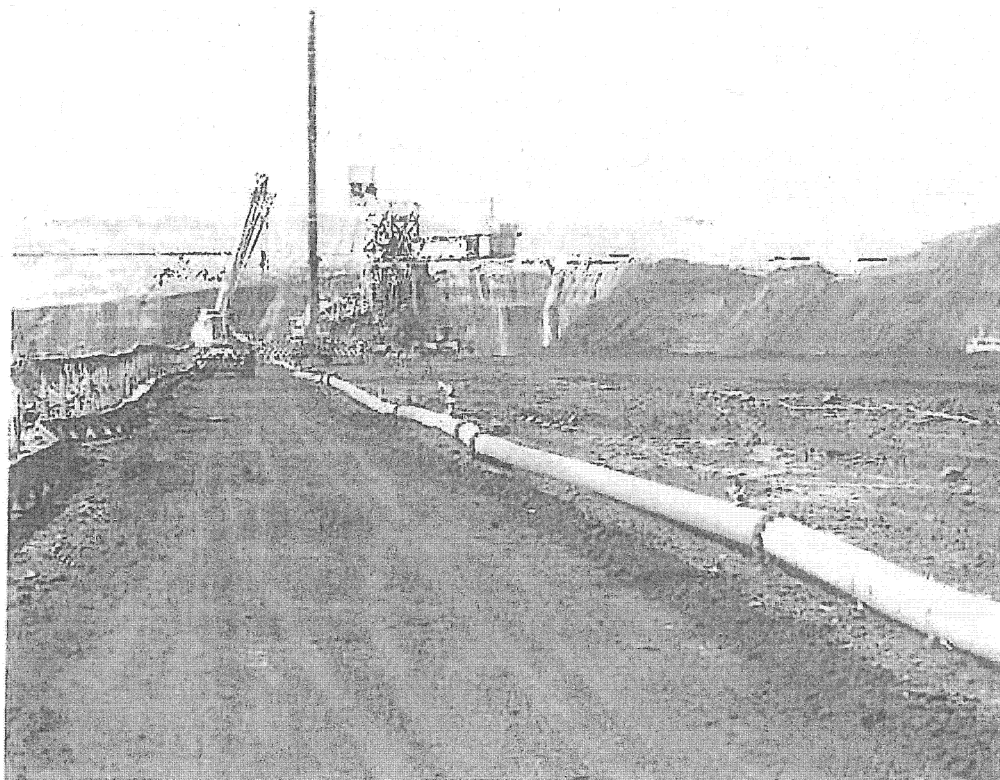
Description: View of the M620 profile and batter, repair work was underway prior to our arrival on site.

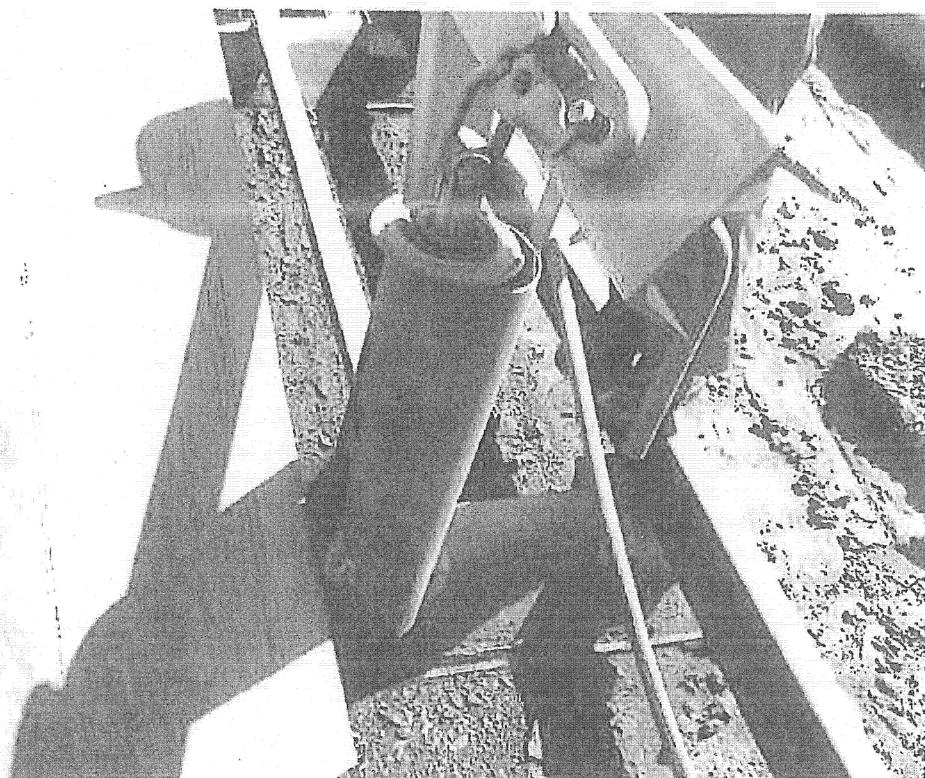
Description: Damaged idler on conveyor unit # 157, 852 meters from the head of conveyor M620.

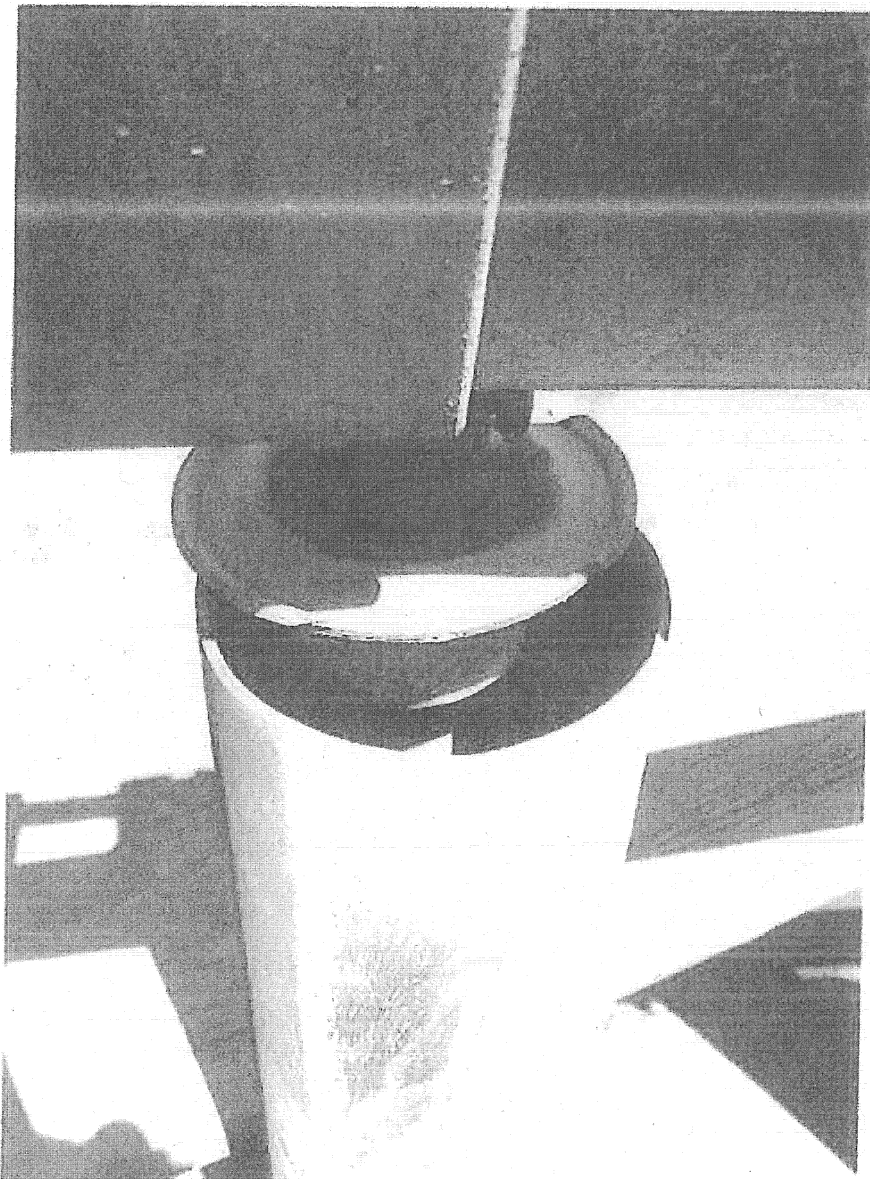
Type: Digital
Direction: South West
Taken By: Fire Officer M
Description: Damaged idler on conveyor unit # 157, 852 meters from the head of conveyor M620.

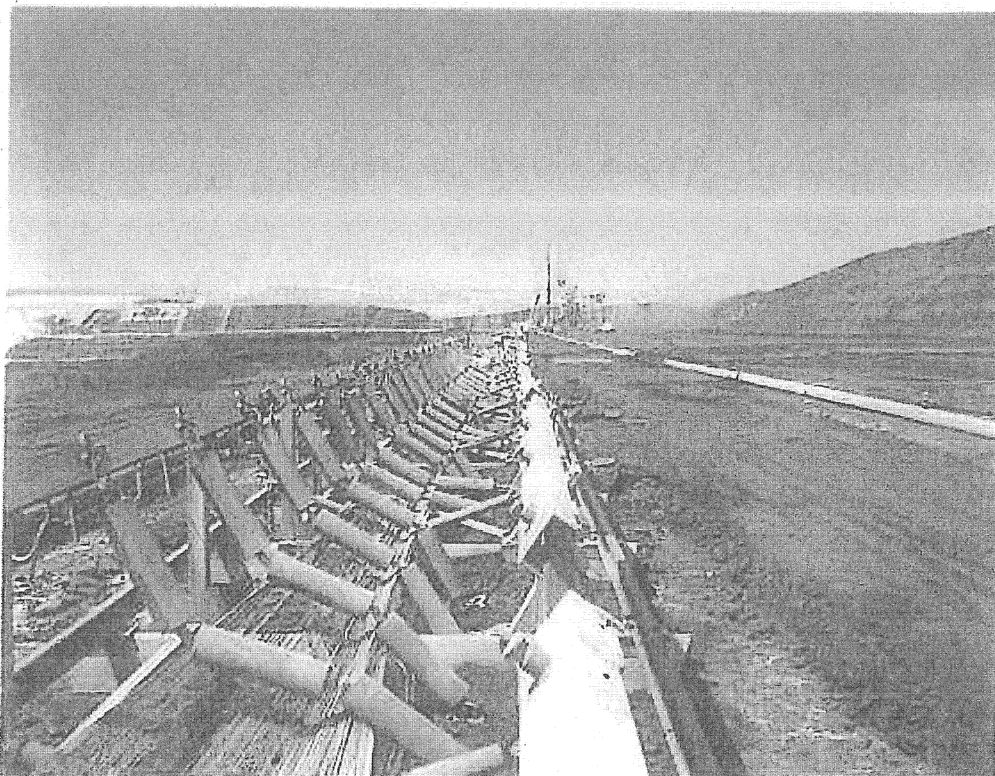
Description: View of the M620 conveyor, profile and batter, repair work was underway prior to our arrival on site. The feed belt had been removed and topside idlers already released. This picture was taken from the conveyor unit 157 with the damaged idler bearing.
