**Country Fire Authority
Fire Investigation Report
Fire & Incident Reporting System (FIRS) Number: 1074299**

**FINAL REPORT
MORWELL OPEN CUT MINE FIRE,
MORWELL, VICTORIA, 3840.**

12/10/2006

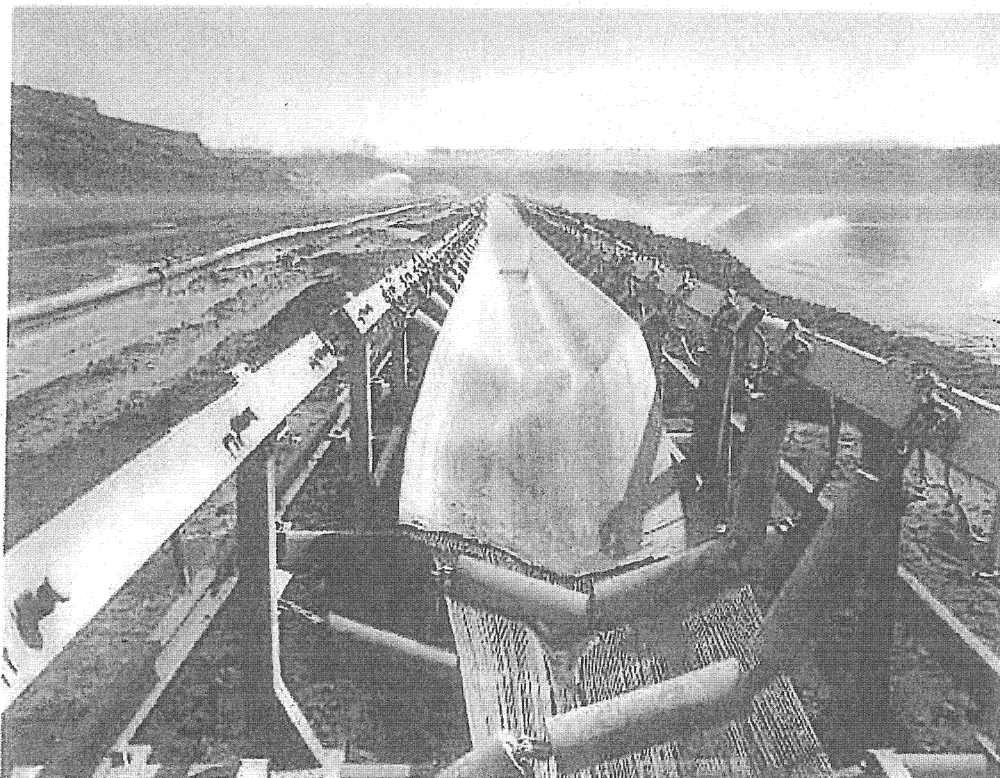
- Type: Digital
- Direction: North
- Taken By: Fire Officer [REDACTED]
- Description: View of the M620 conveyor, looking towards the tailend of the system. Note where the damaged belts finish, the third idler on the right hand side of the image is the damaged one.

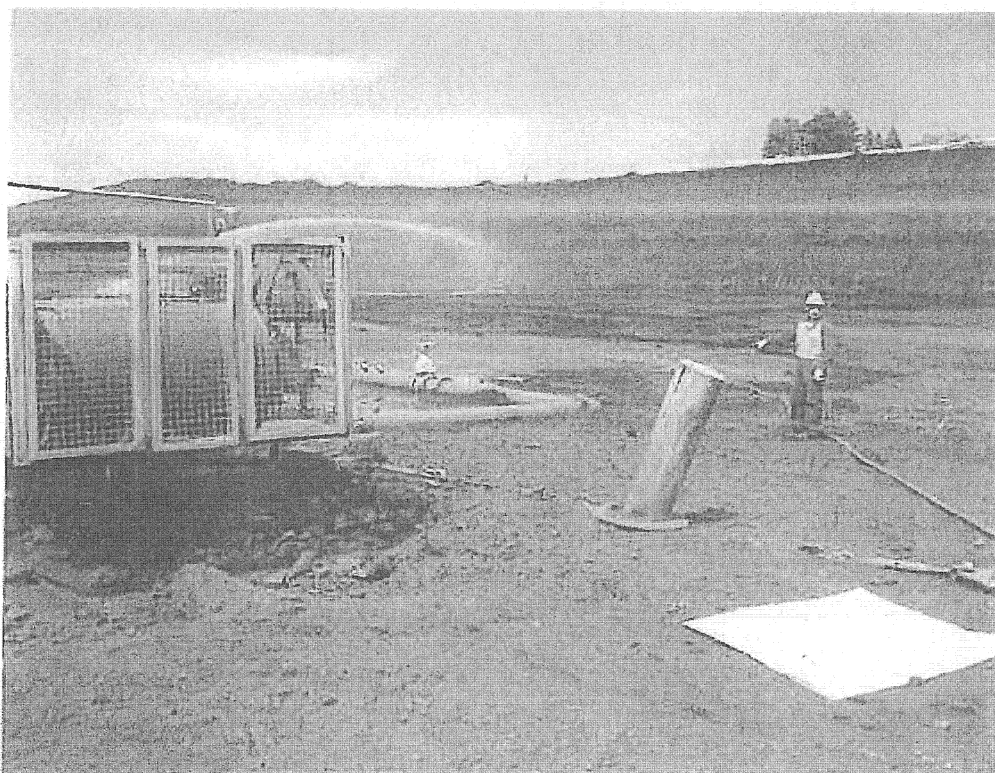
Description: The initial fire was also on the topside of the M620 conveyor when crews arrived. It was burning between the conveyor and the topside fire service pipe work, as pointed out by [REDACTED]

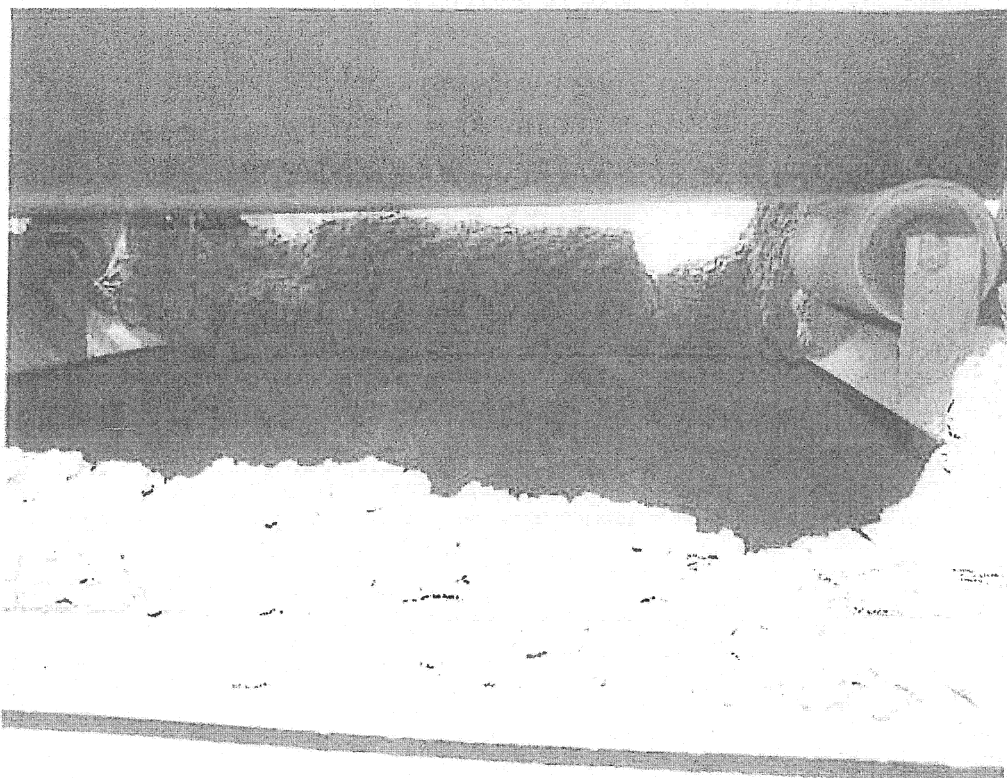
Type: Digital
Direction: North-East
Taken By: Fire Officer [REDACTED]
Description: Tailbox of conveyor M620, note the coal build up on the unit.

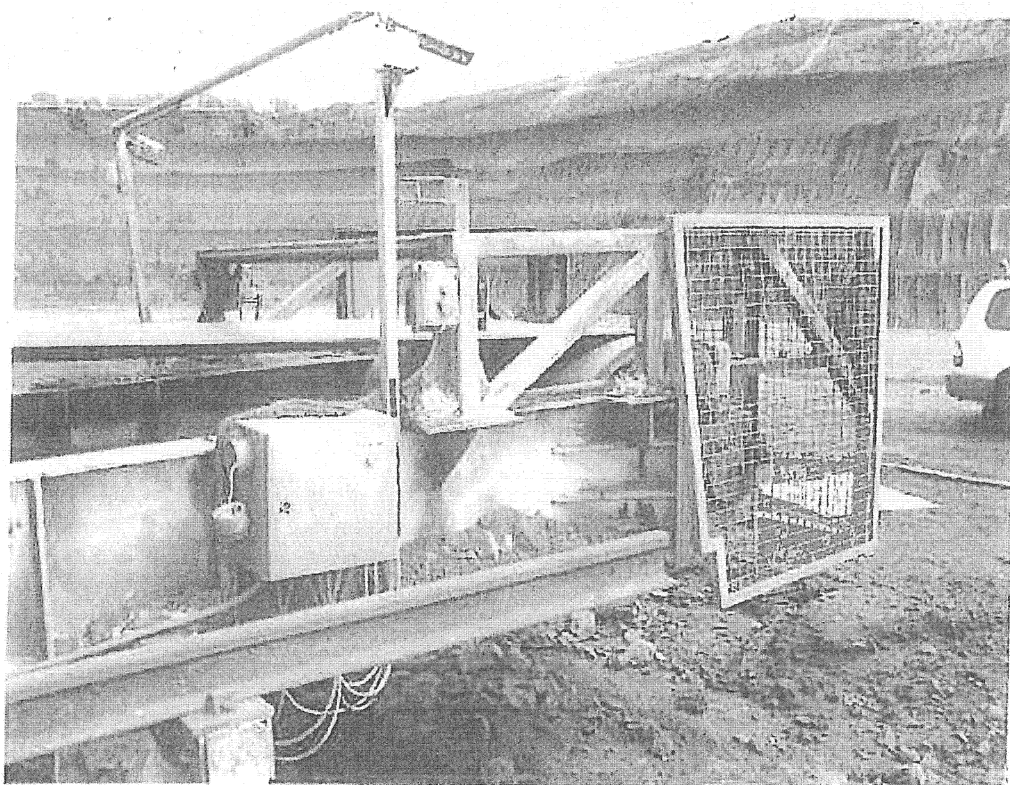
Type: Digital
Direction: North-West
Taken By: Fire Officer [REDACTED]
Description: Tailbox of conveyor M620, note the coal build up on the unit.

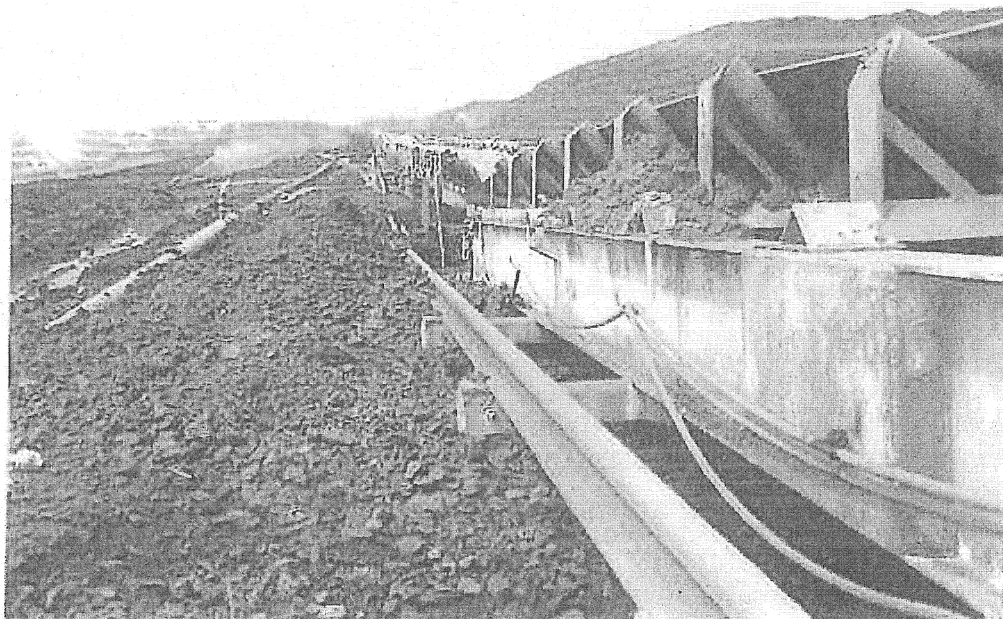
Description: Tailbox of M620 looking towards the head.(south) There was loose coal on fire on this side of the conveyor when crews arrived. Once again note the build up of coal debris on the plant.

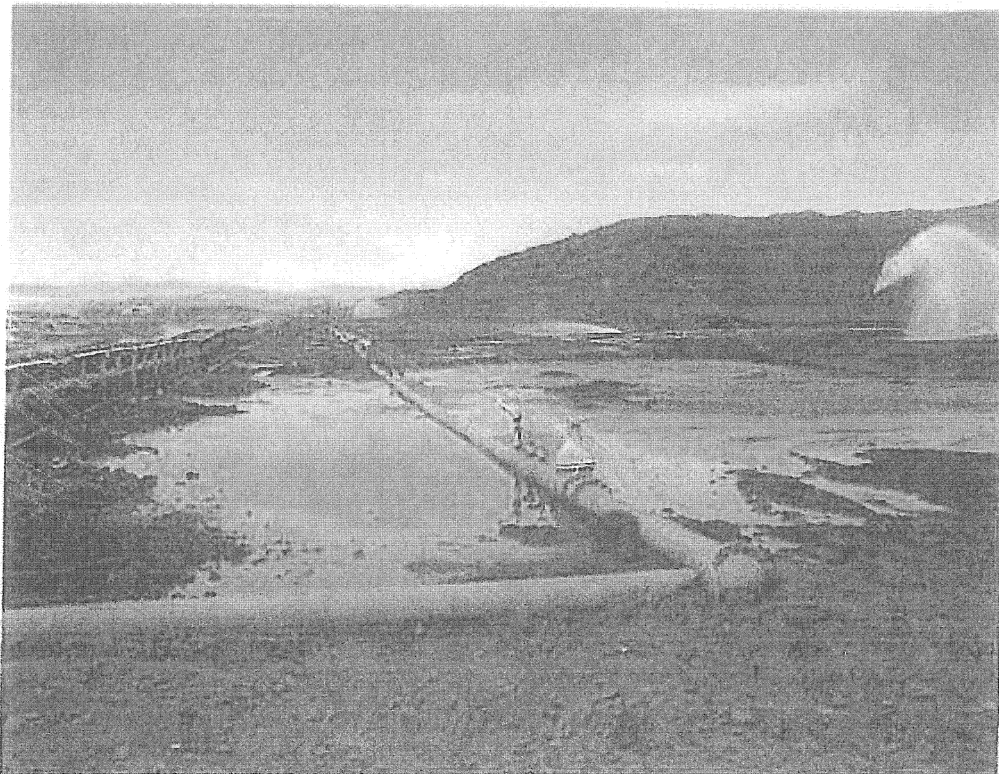
Description: The initial fire was also on the topside of the M620 conveyor when crews arrived. It was burning between the conveyor and the topside fire service pipe work.
