International Power Hazelwood

**October 2006 Mine Fire
Investigation
Incident Investigation Report**

January 2007

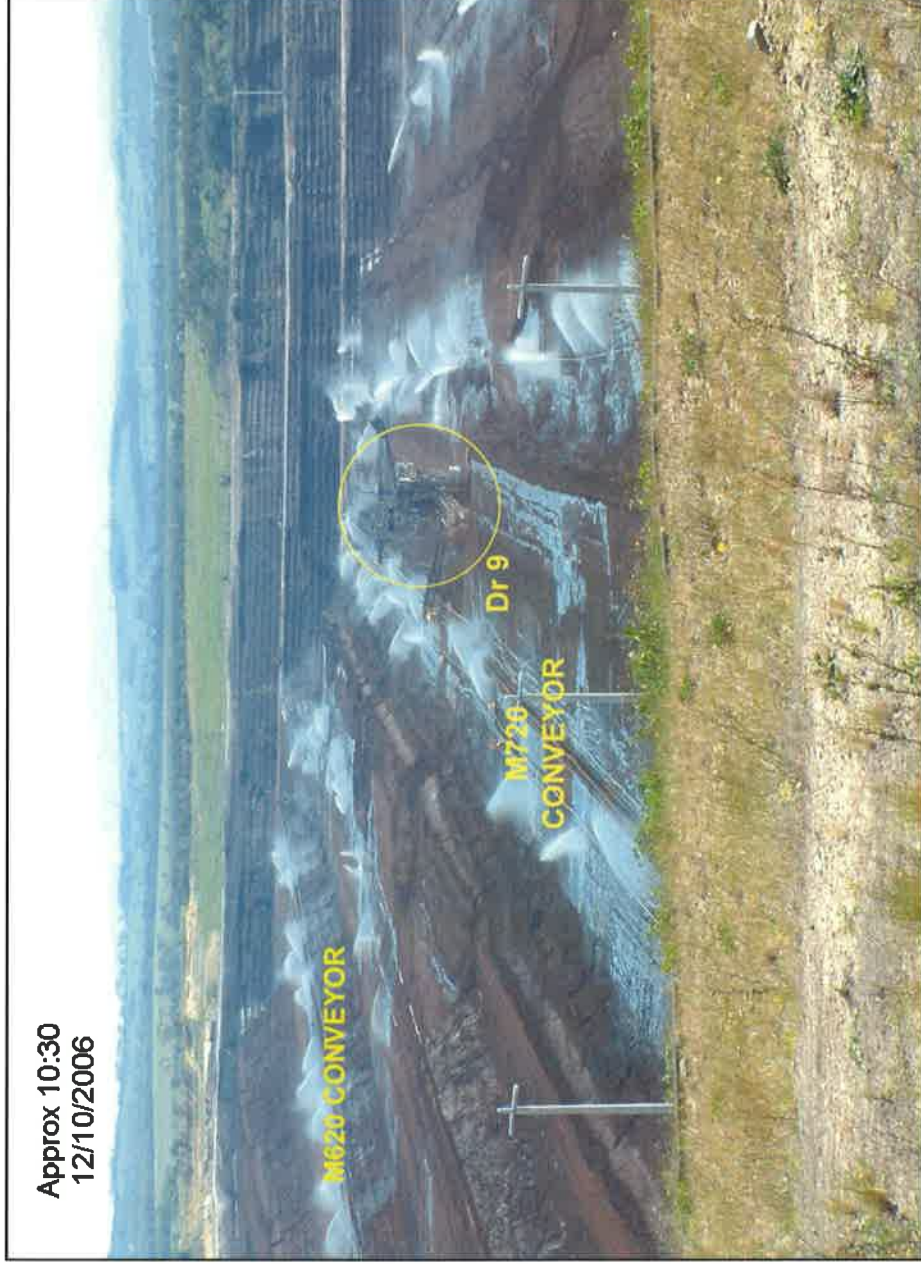
Figure 4 – Extent of Water Sprays at Time of Fire Alert (12/10/06 – 10.30am)

Contributing Factors	Underlying Causes
<p>Water spraying insufficient to wet coal faces since water pipes are located too far from coal faces, particularly as wind pushed spray water in other direction.</p> <p>It is not practical to wet all coal faces.</p>	<p>Annual internal audit of all fire services facilities, systems and procedures as specified in current 'Mine Fire Service Policy and Code of Practice' had not been completed.</p> <p>Work procedures and practices within the 'Mine Fire Service Policy and Code of Practice' and the 'Fire Instructions' are not systematically reviewed.</p>
<p>A collapsed bearing smouldering in the coal on the M620 conveyer is undetected.</p>	<p>The detection of smouldering bearings from faulty idlers relies on visual inspection from mine personnel.</p> <p>The use of thermal imaging cameras in the detection of faulty idlers should be investigated for their application and used where appropriate.</p>

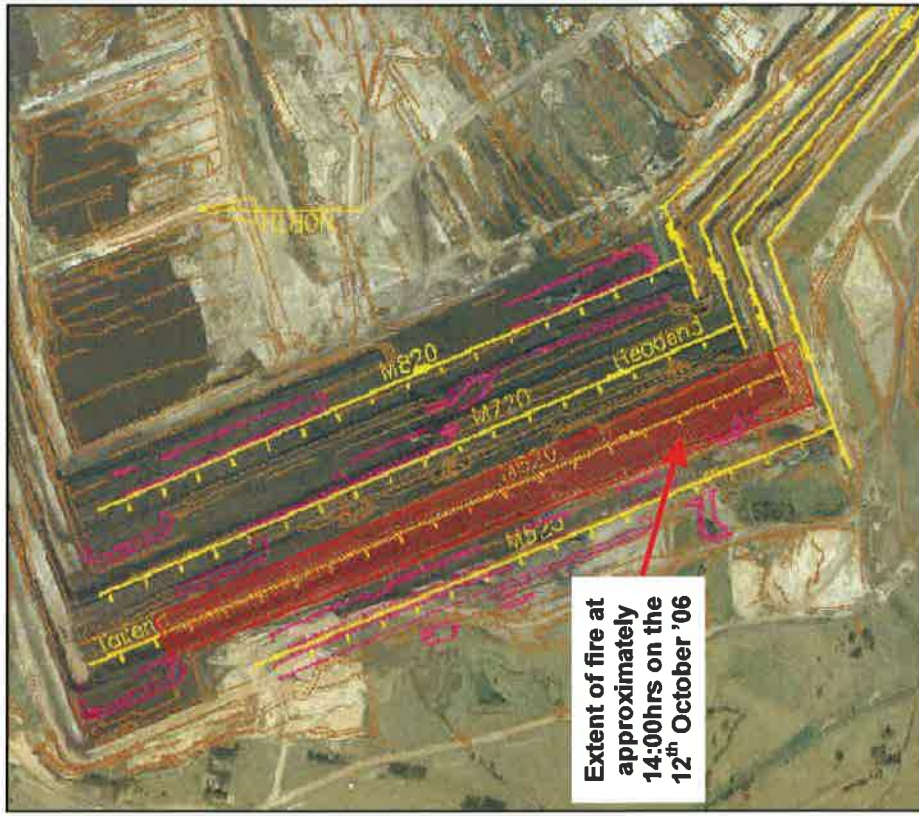
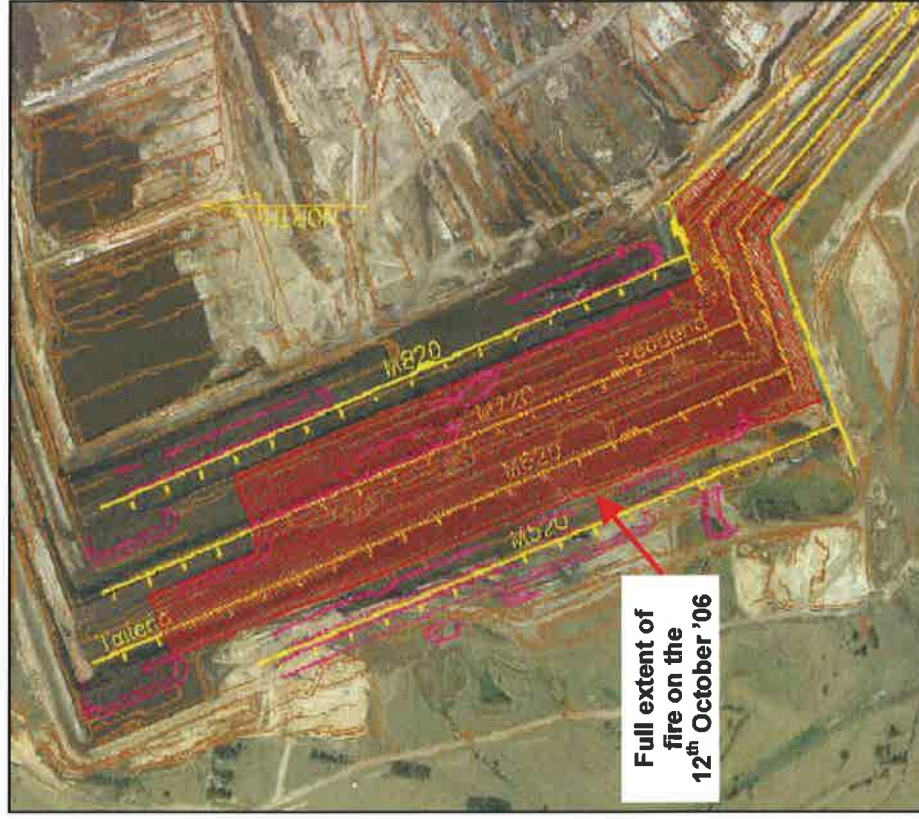
Figure 6 - Extent of Fire (12/10/06)

The significant factor in this fire was the escalation of a small fire into an uncontrollable fire within a short time due to extreme weather conditions and the delay in IPRH providing sufficient resources to combat the initial fire.

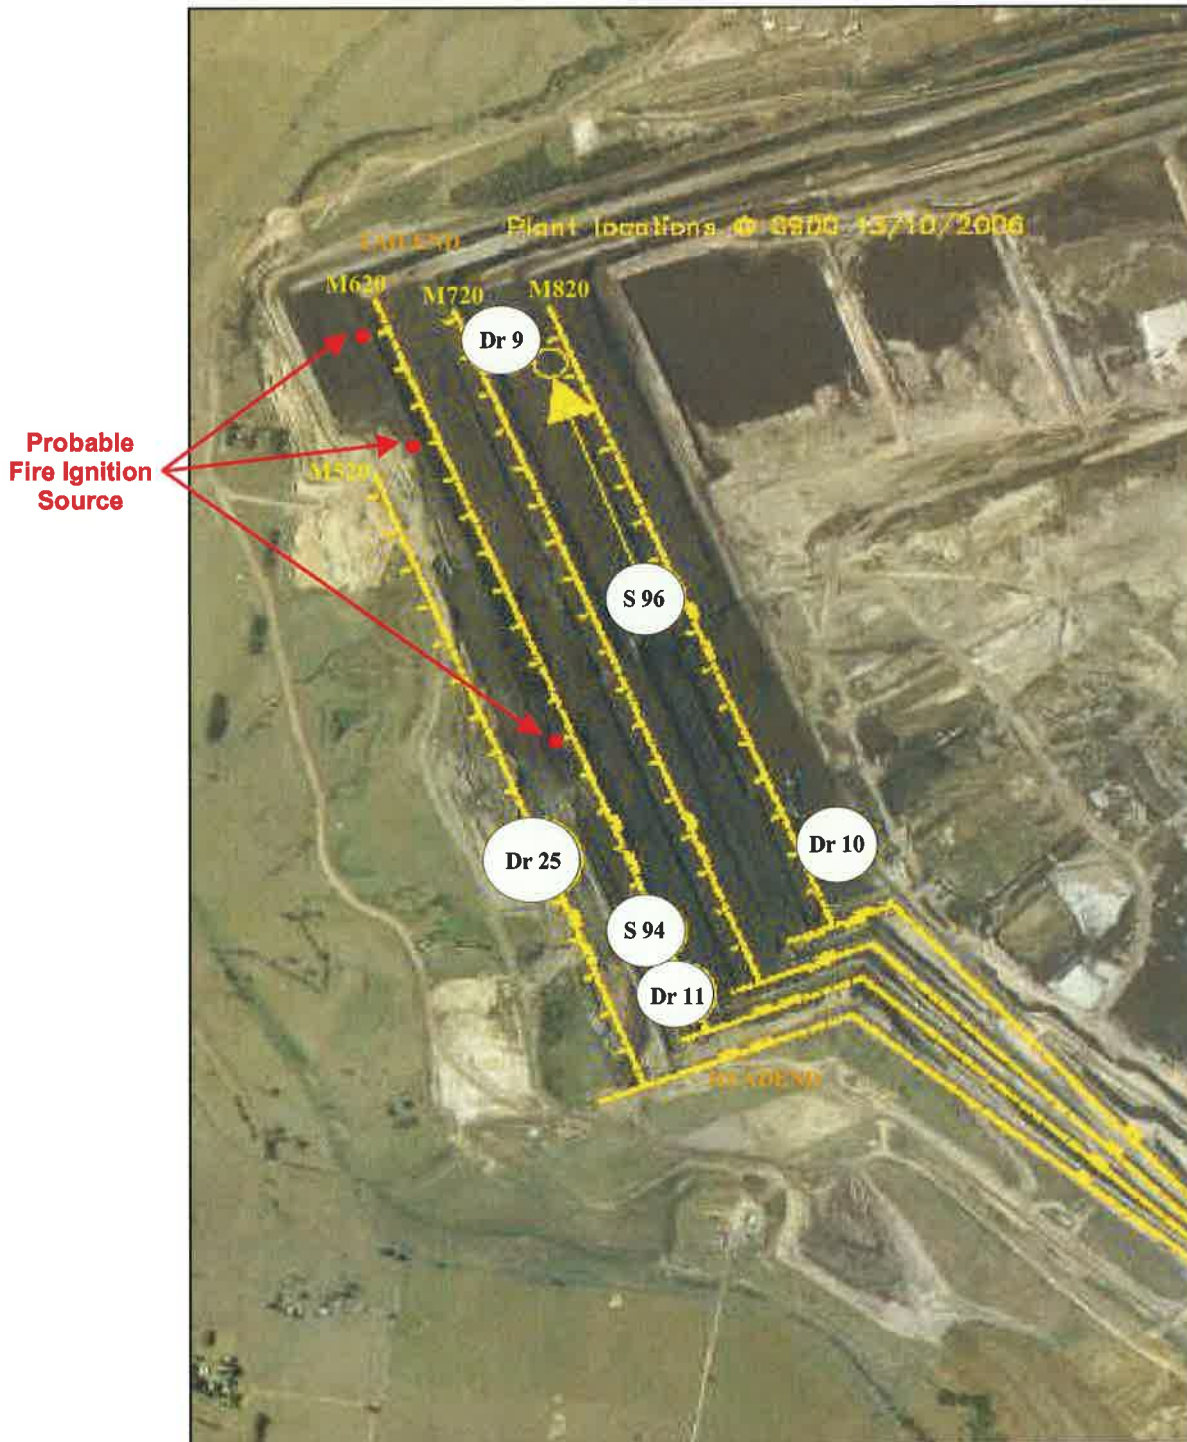
Figure 7 - Likely Initial Fire Ignition Sources

- ▶ Hot idler on M620 conveyor. A collapsed bearing was subsequently discovered at the 853 metre mark (frame number 157) of M620 conveyor. The likely ignition was caused by the collapsed bearing falling onto the return side of the belt and travelling towards the tailend where it was ejected onto the coal level at the tailbox. The hot metal smouldered in the coal and was fanned by the strong winds several hours later and eventually caused a fire to start and spread along the level assisted by the strong northerly winds. In addition it is probable that the belt on M620 conveyor eventually caught fire at the 853 metre mark where the hot idler fanned by strong winds ignited it and burnt towards the head end. Idler inspection records show that the idler on frame 157 of M620 conveyor had not been detected and hence not reported for replacement.

The physical evidence collected by the CFA fire investigation leads to the conclusion that the hot idler is the most probable cause of the fire. However it should be noted that a non-IPRH vehicle crossing the coal formation during a Fire Alert could easily have started a fire and due to the rapid spread of the fire by the wind along the formation, there is also the possibility that the fire started from multiple ignition points. Refer to Appendix G for the CFA Fire Investigation Report.

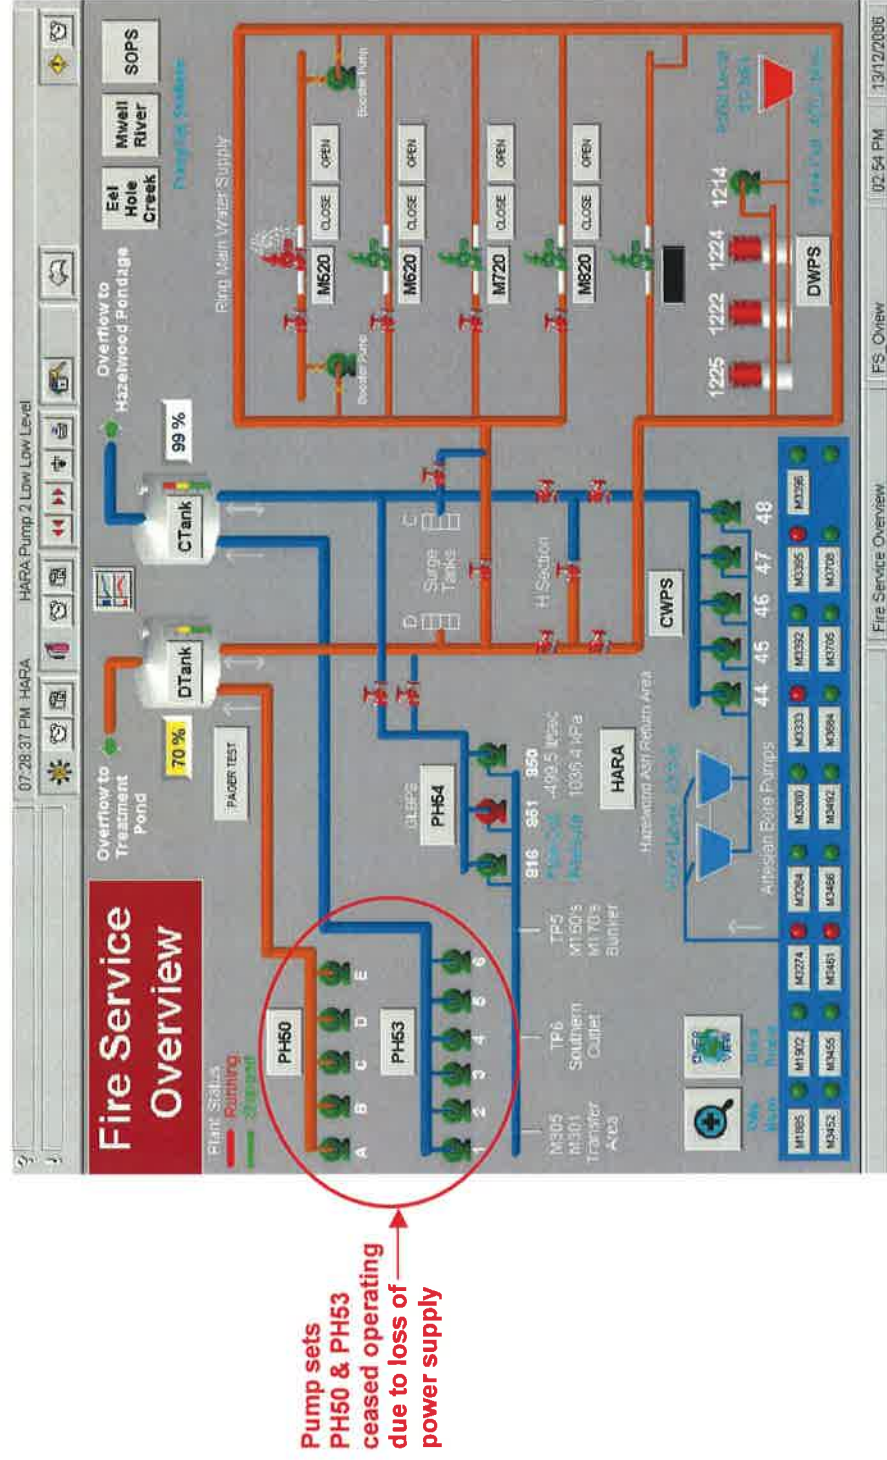
Figure 8 Schematic of the Mine Fire Service Network

At approximately 3.30pm, a loss of power supply to the external pump stations PH50 and PH53 caused the pumps to cease working. Meanwhile, the fire system software used to monitor the water level in the fire services tanks stopped updating. The water level dropped causing water pressure loss for fire fighting and subsequently a severe reduction of water supply.

Contributing Factors	Underlying Causes
<p>Fire fighting was interrupted due to loss of power supply to the external fire pump stations at PH50 and PH53 that led to severe reduction of water supply.</p>	<p>Roles, responsibilities and procedures outlined within the Emergency Response Plan are not systematically referred to during an emergency and should be more user friendly.</p>
<p>The fire pumps were not monitored when the fire system software stopped updating the status of the system and led to the loss of water pressure.</p>	<p>Interface and communications between Operations, Fire Services and Maintenance needs to be reviewed in terms of fire systems, particularly in relation to the power supply for the fire pumps.</p> <p>Annual internal audit of all fire services facilities, systems and procedures as specified in current 'Mine Fire Service Policy and Code of Practice' had not been completed.</p> <p>A back up system for crucial services within the Mine Fire Service Network is not available.</p>
