Hazelwood Mine Fire Inquiry

Morwell Open Cut Fire Report

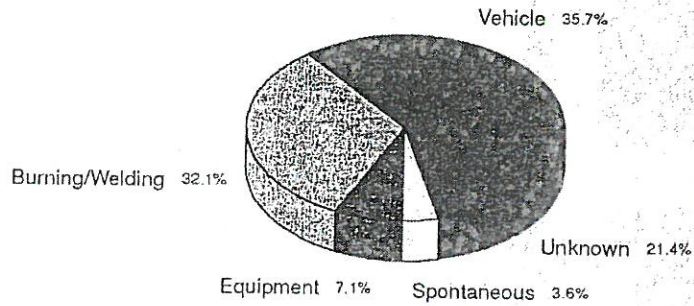
Figure 21

Cause of Fires in the Worked Out Area

- (i) there have been 28 fires reported in the worked-out areas in this period. This suggests occurrence of around 20 fires per year.
- (ii) primary causes are motor vehicles and burning/welding. "Unknown" causes could include bushfire spotting, lightning, electrical causes like conductor clashing on power feeders, falling power poles, etc. These have occurred in the worked-out areas.

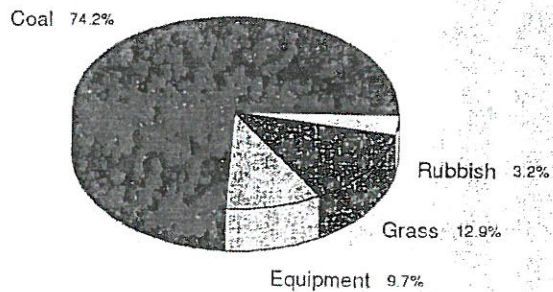
Figure 22

Burning Source for Fires in the Worked Out Area

- (iii) loose coal was primarily the material burnt.
- (iv) piped water was the major means of fire suppression.
- (v) in terms of manhours and equipment hours reported for extinguishment, the fires in the worked-out areas are of similar severity on average to those occurring in the working areas of the mine.

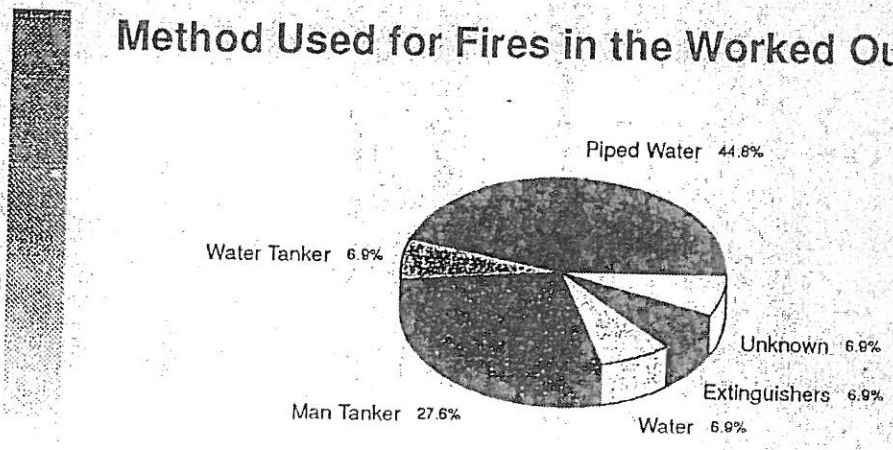
Figure 23

Method Used for Fires in the Worked Out Area

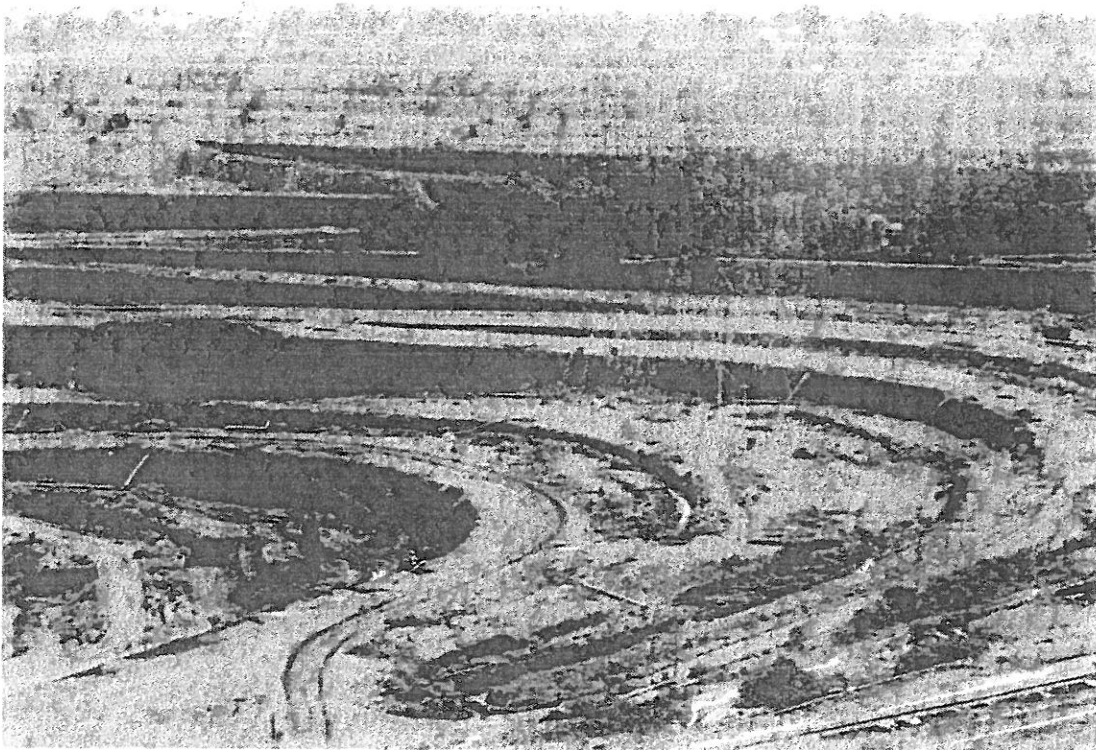
FIGURE 3: Coal winning operation using mobile plant and haul trucks located in north-east corner of the worked-out area.

- (iv) there are specific activities which could represent a fire hazard, notably -
 - traffic of vehicles without protected exhausts.
 - a coal production operation (refer figure 3), providing coal quantities equivalent to MPS requirements. Note that risk appraisal of this operation was considered as outside the terms of reference for this study.
 - a dirty coal dump near the southern pivot (refer figure 4).

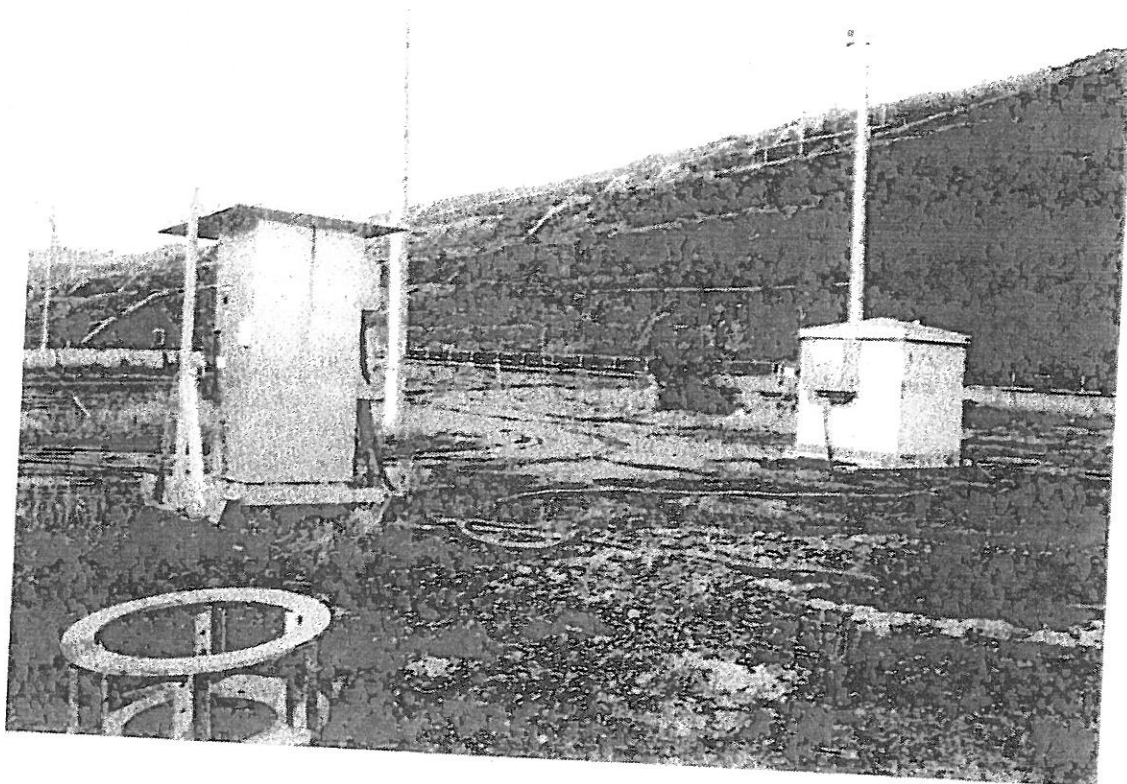
FIGURE 12: Electrical cubicle for switchgear, etc. (at left) and 300 kVA transformer (at right) to power artesian bore pump, located near southern pivot in the worked-out area.

Loss of power to pumping stations or 20 series conveyor, through damage to feeders 4, 5, 15 and 16, is an evident exposure as are electrical cubicles, transformers and associated power supply cables linked to bores located in the worked-out areas.
