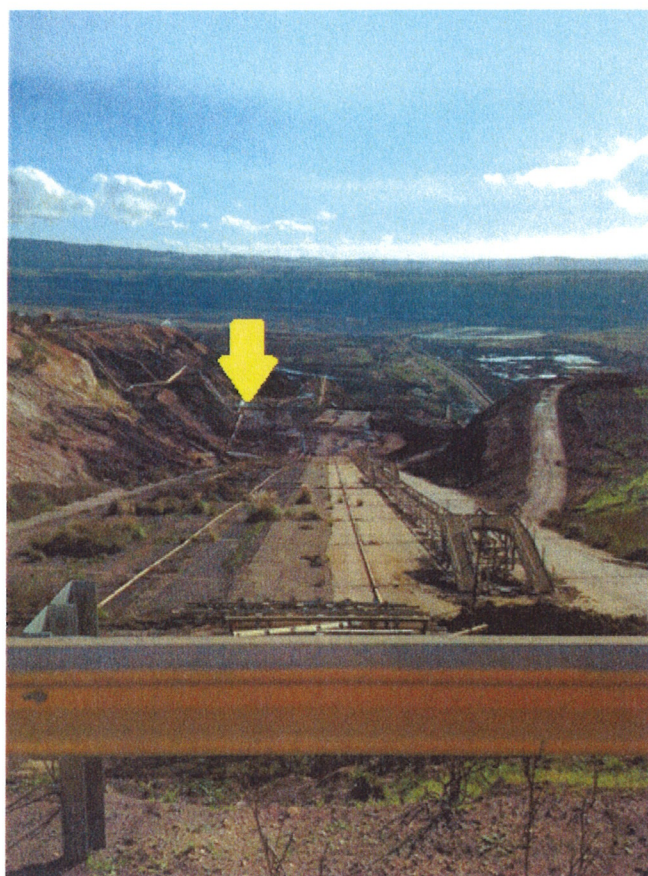
47. I took vehicle HP03, which is a 4WD, to open up the gates. As I was driving around the southern batters of the Mine in an anti-clockwise direction, at about 2:00pm, I observed a small fire at the southern outlet of the Mine, in the vicinity of an old conveyor transfer point, known as transfer point 7 ("TP7"). The approximate location at which I observed the fire is marked on the Location Plan at **Annexure 8** as fire location "A". The approximate location at which I observed the fire is marked in the photograph below.

48. I immediately alerted the Mine Control Centre to this fire on radio channel [redacted]. All earthworks, 2 x 12 and 1 x 7 crews operate on [redacted] during times of high fire alert. I discovered later in day that the Mine personnel had changed back to [redacted] because of radio interference from the nearby HVP tree plantation. I started also using my mobile phone from that point onwards because I wasn't always obtaining responses over the radio.
49. At 2:00pm, as I was making my way around the eastern batters of the Mine (still heading in a anti-clockwise direction), I observed smoke from about 3 locations to the west of the Mine in the vicinity of Driffield and the Strzelecki Highway. At that time, the smoke was small, but

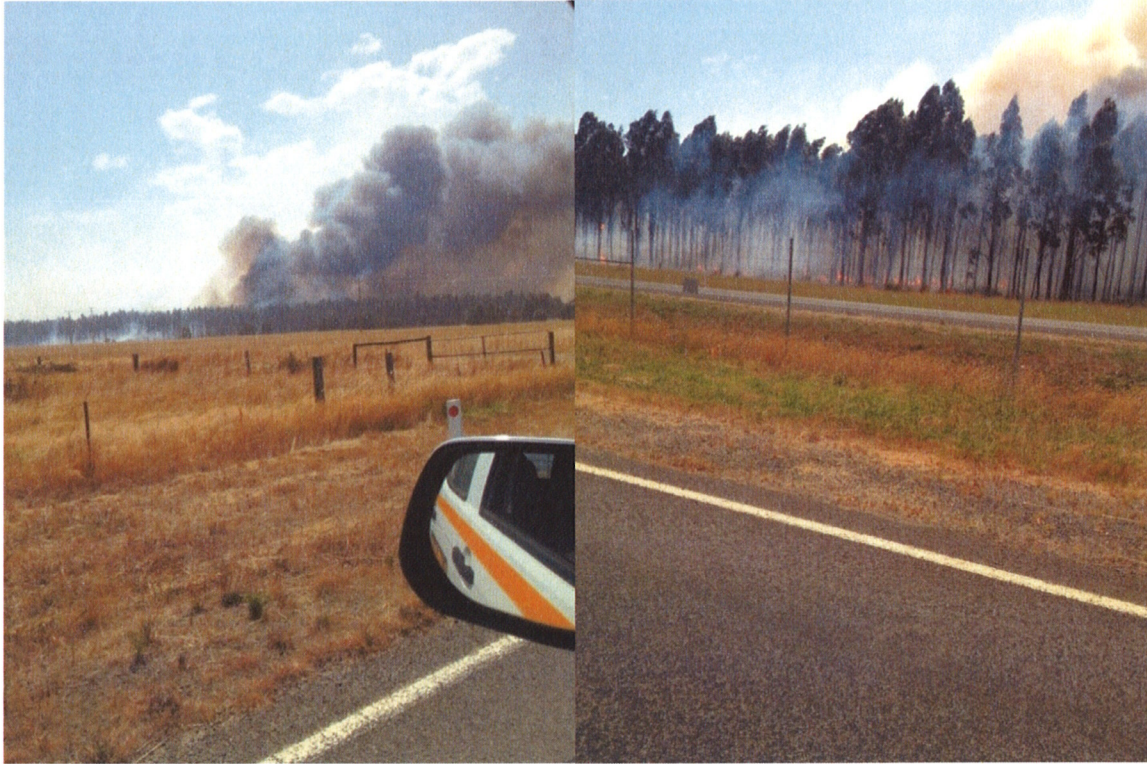
The approximate locations from which the photos were taken are marked as “1” and “2” (left to right respectively) on the Location Plan at **Annexure 8**.

55. Between about 2:10pm and 2:17pm, I opened the Drilling Depot Road gates and took two photos of the Hernes Oak fire activity to the north of the Mine. These photographs are below:

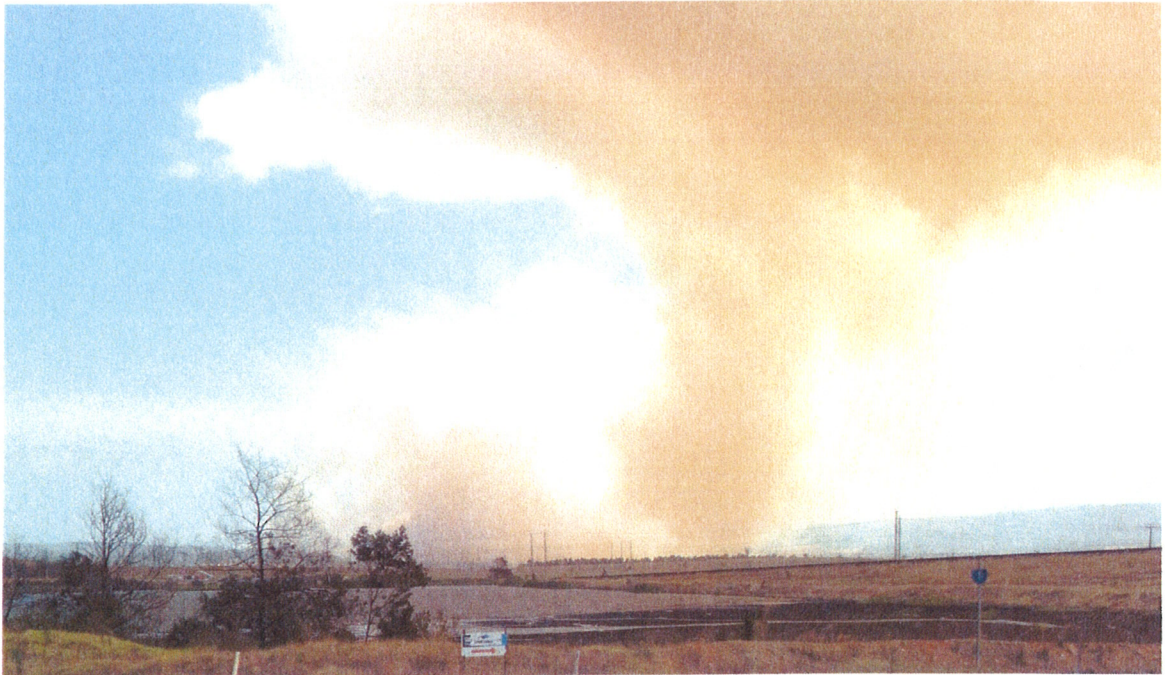
The approximate location from which the photo was taken is marked as “3” on the Location Plan at **Annexure 8**.

58. On my way to the southern batters lookout, at 2:32pm I took the following photo near the wash down pond at TP5 of the Driffield fire:

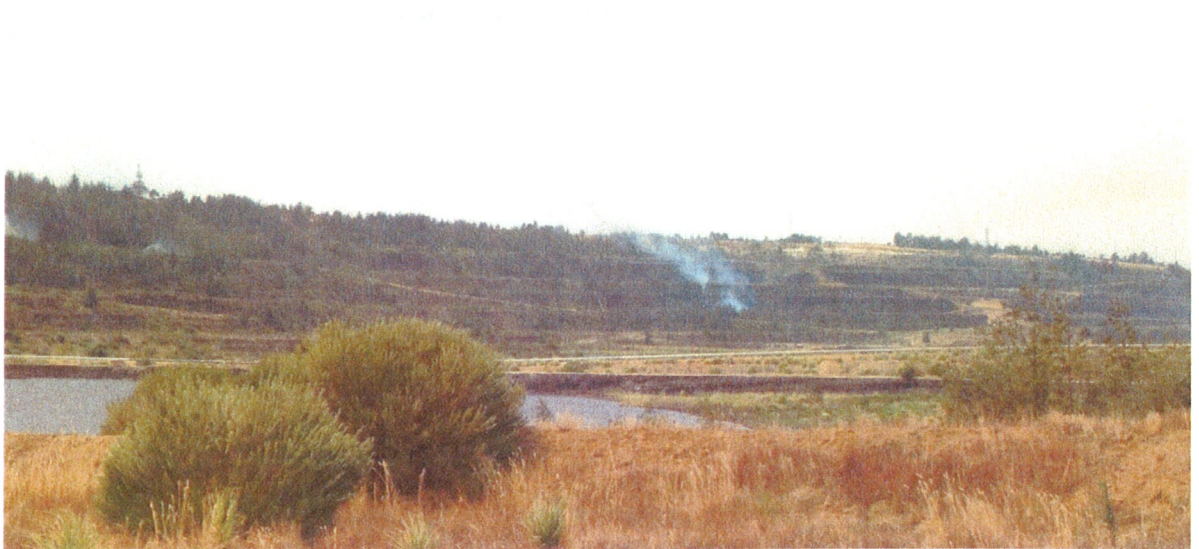
The approximate location from which the photo was taken is marked as “4” on the Location Plan at **Annexure 8**. The photo also depicts:

64. Whilst travelling to the northern batters to turn off non-essential sprays, I took a photo at 2:55pm from Groyne 8 of the fire activity on the northern batters. By this time, there was fire activity on level 5, level 3 and possibly level 1. To me, this indicated that the initial fire had jumped up 1 or more levels. The photograph is below:

- the clay capped fire hole on the northern batters (to the east of the fire, partially obscured by a tree); and
- two operating sprays on 3 level (to the west of the fire).

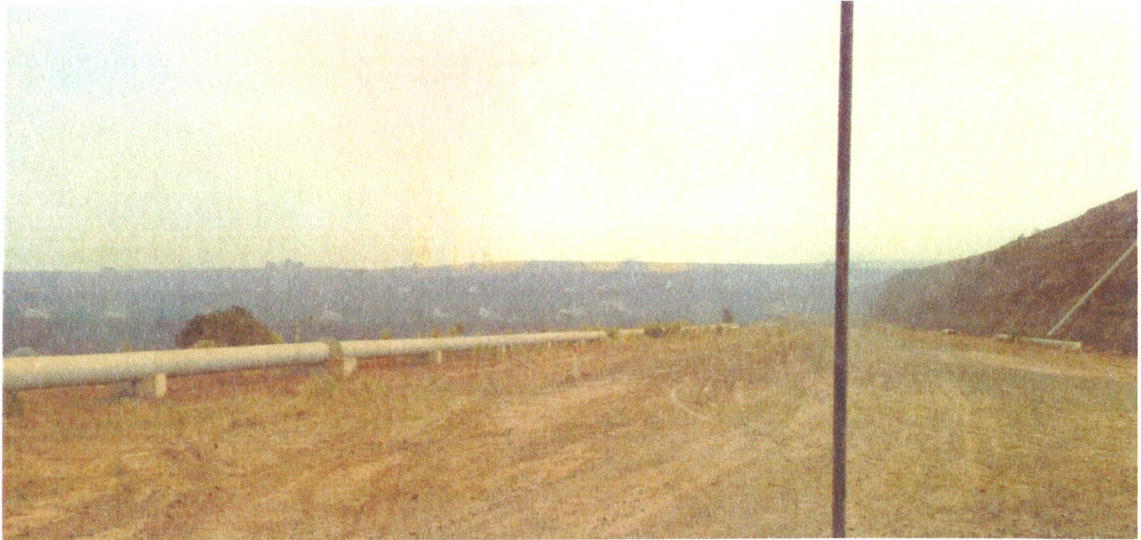
The approximate location from which the photo was taken is marked as “5” on the Location Plan at **Annexure 8**.

65. I also took the following photo of the operating face of the Mine at 2:56pm, depicting the sprays operating in that area at that time, as a fire protection measure:

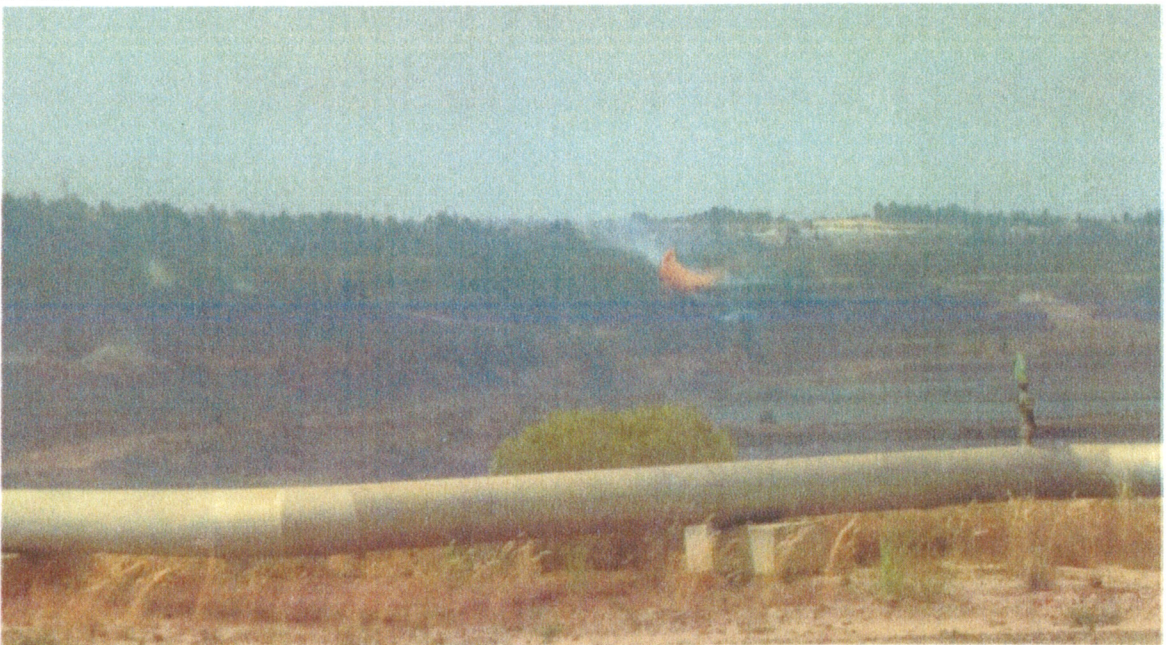
The approximate location from which this photo was taken is labelled “6” on the Location Plan at **Annexure 8**. The orange spray in the photograph is fire retardant being dropped by the aircraft.

66. I turned off non-essential water sprays on 3 and 5 levels at the western part of the northern batters of the Mine to allow additional water for the essential areas. These sprays that I turned off were approximately 1 km away from the location of the northern batters fire.
67. During this activity, I observed aircraft bombing the northern batters fire with water and retardant. Given the prevailing conditions (strong wind and heat), I thought that this bombing was unlikely to control the spread of the fire. A photo that I took at 2:57pm is below:

- to the west, several operating sprays; and
 - to the east, the clay-covered fire hole on the northern batters.
68. Between about 3:00pm and 3:20pm, I was working on turning off non-essential sprays in the north western part of the Mine.
69. At 3:22pm, I took a video from the north-west part of the Mine, above pond 8 where I had just been turning off sprays. The approximate location from which I took this video is labelled "7" on the Location Plan at Annexure 8. The video is labelled "**Video 1**" on the CD enclosed with this statement. The video depicts sprays operating in the operating part of the Mine, the fire on the northern batters, and the fire in the overburden dump on the floor of the Mine. In the video, as I pan the camera around the Mine, I state as follows:
