ANGLESEA MINE COAL COVERAGE PROJECT REVIEW

TECHNICAL REVIEW

ALCOA

FINAL REPORT

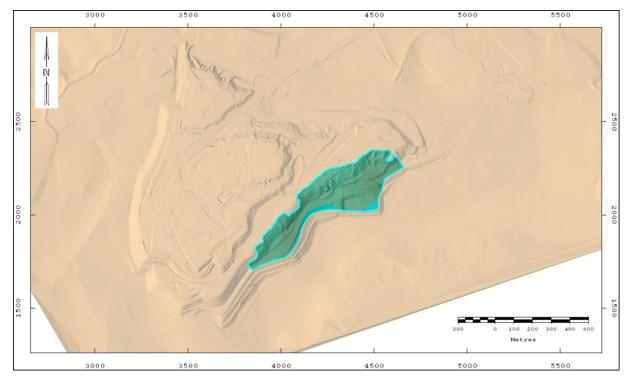
Figure 2-1 Waste Material from Existing Dump

The work is to be based on a best professional judgement as the scope of work did not include a full technical assessment of the soils. This report provides a high level overview of the placement of cover material, as well as recommendations on methods and processes to achieve an acceptable level of cover. Fleet analysis has not been included into the study as this was deemed to be beyond the current scope. Figure 2-1 below shows that the waste material available to be used for capping in that particular area of the existing waste dump is approximately 1.67 million bcm.

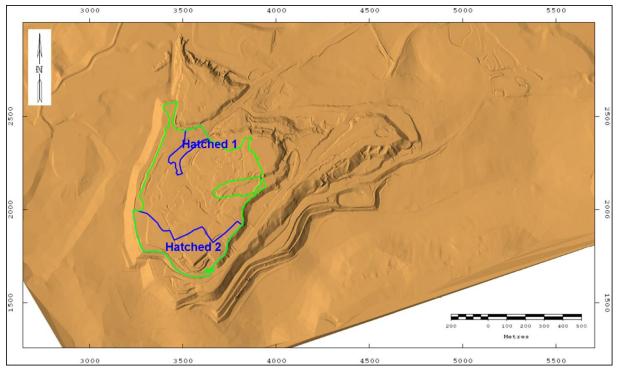
Figure 3-3 : Hatched Areas showing unmined or partially mined coal seam.

Approximately 41 hectares of horizontal surface is exposed in the base of the pit however most of this area has had the bulk of the coal seam removed. Figure 3-3 illustrates two hatched areas that represent unmined or partially mined coal seams; the remainder of the pit has been mined out with only remnant coal remaining as a result of not mining into the underlying clays which would present as dilution at the power station. These two areas have different risk profiles:

- The hatched areas (Blue polygons) represent 30.5% of the horizontal exposure and consists of competent coal seams, if a spontaneous combustion event was to occur in these areas then the coal would fuel the event, therefore Mining One suggest that attention be paid to the use of high clay content materials when capping these areas. A cover of no less than 1.0m should be used over these areas.
- The remainder of the pit has been mined out and the remnant coal sits on a base of inert clay, this represents a lower risk and therefore material selection is not as critical. Mining One suggest a covering of at least 1.0m be placed over these areas as to reduce the potential of ash attack or spontaneous combustion. However, the clay content in this material is not as critical and a clay content approximating 10% or greater would be considered adequate.

Mining One have suggested that a coverage of 1.0m be maintained across site as described above as it is viewed that while this presents a minimum, yet adequate coverage it also allows easier access to the seams if a spontaneous combustion event occurs, this equates to approximately 417,000 lcm of material for capping of the horizontally exposed coal.

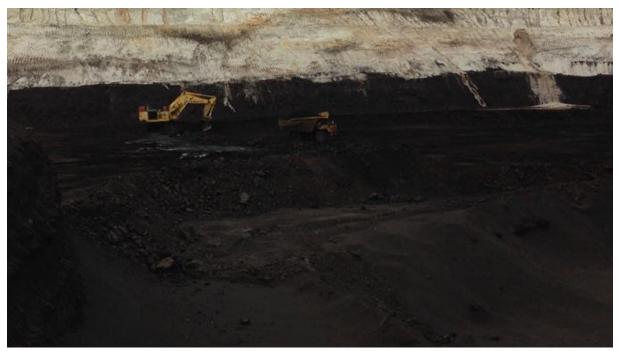
Figure 3-5 : Coal Mining South Western Corner

At the time of the side visit, adequate coal had been exposed in the south western region of the pit to supply the power station through until August 2015 when the power station will be shut down. Accessibility to the coal will be required through until late-August and then this area will be capped. A combination of load and haul of waste onto the pit floor and dozer push from overburden located above the coal seam will be used to cover the coal (Figure 3-5). Based on observation during the site visit, the material in the pit face appears to be a combination of sand and clays which is considered suitable for cover material.

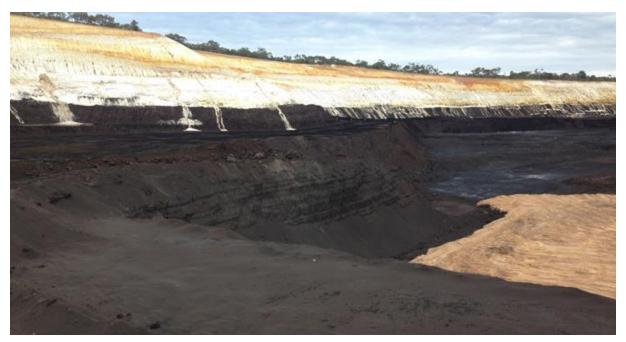
Figure 3-6 : South Western Coal Edge

The limit of the coal located in the South Western region of the pit as discussed in section 3.2.1 has an exposed coal edge approximating 10 metres vertical exposure. Figure 3-6 illustrates the coal edge which will require management during the interim closure period as it is relatively fresh with significant amounts of fines present at the face. It is suggested that the fines be removed as to reduce the potential of a post closure spontaneous combustion event. As this coal has been recently exposed it is suggested that the vertical exposure also be sealed against the elements with not less than 1.0m of material containing more than 10% clays.

If this face is not covered, a program involving daily inspection of the face must be implemented as part of the interim closure strategy to ensure the fresh material is not subject to a spontaneous combustion event. This is particularly true during the summer months where the ambient temperature can contribute to the initiation of the spontaneous combustion event.

Mining One recommends that all vertical coal faces that have been exposed for less than 2 years should be covered as part of the interim closure strategy. The vertical coal face in Figure 3-6 should be covered by pushing the waste contained in the pit wall over the coal using dozer push as this face represents fresh material.

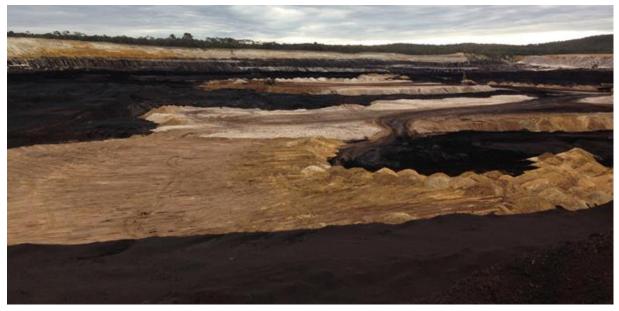
Figure 3-7 : Northern Aspect of Pit Floor

material which had very little clay content and is identified as coarse white sand. This material should not be used to cap the coal seams as identified in Figure 3-3. Mining One recommends that Sand and Clayey Sand classed material (ref Figure 3-8) be deposited around the sump as this area has already been mined and has minimal coal present, in addition a rise in the dam level in line with the traditional water table will submerge the coal and eliminate the potential of any heating event:

It should be noted that moisture can often be seen as a contributor to a spontaneous combustion event and moist fine material presents the least favourable condition in which to leave the coal exposed to the atmosphere. However, there is a critical moisture level that when exceeded mitigates the risk of spontaneous combustion events as the water then acts to dissipate the heat. In addition, moisture within the capping material acts as a sealant against the oxygen rich atmosphere and is therefore a desirable characteristic of the capping material.

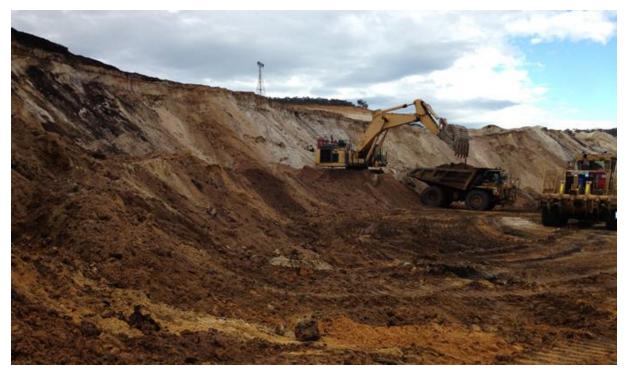
Figure 3-8 : Source of Capping Material

An inspection of the waste material being sourced for capping was undertaken with the main observations being that all material being sourced for capping has minimal rock in it and is therefore considered ideal for capping as it predominantly consists of clays and sands. As the material is being sourced from an old waste dump the material was well blended and had a good distribution of clays through it. With the exception of the white coarse sand most of the material appeared to contain adequate clay to provide a competent cap. It should be noted that inspection of this material indicated clay levels approximating 20%, this is considered ideal for encapsulation of the coal.

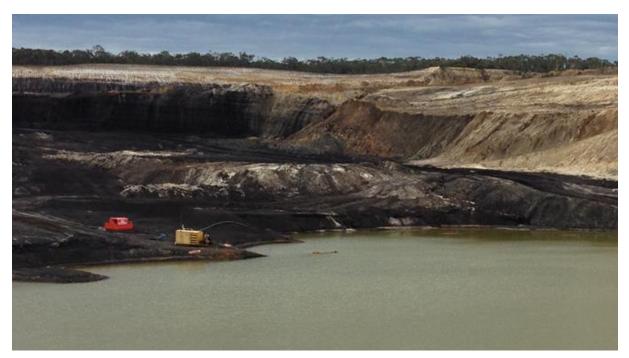
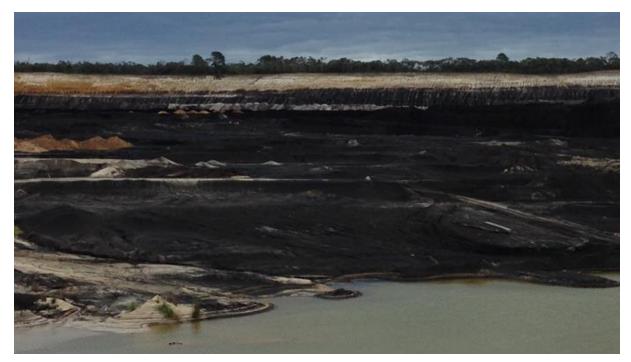
Figure 3-9 and Figure 3-10 show the encapsulated area of the pit which extends west and north of the sump. As can be observed in the images, the coal seams have been excavated to the under laying clay and is indicated where white can be see surfacing through the coal.

During the site visit, it was observed that a clay material was present under the coal seam which would provide an ideal capping material but will not be excavated as part of the interim closure strategy. While this material provides an excellent capping material, it will not be excavated as part of the mine closure for a number of reasons:

As can be observed in the two figures the vertical exposure of coal around the western pit limit presents a coverage issue and with limited time available it is unlikely that complete covering of this will be achieved. Mining One believes that the long term exposure of this coal presents minimal combustion risk and proposes that the vertical faces be left exposed in the period between the interim closure work and final rehabilitation. However, if this strategy is pursued then the following items need to be part of the management strategy:

suppressant such as RST's "Flame Out" product should be considered. Details of this product are contained in Appendix B.

> A TARP (Target Action Response Plan) must be developed to provide appropriate procedures for the escalation of a nearby bushfire event.

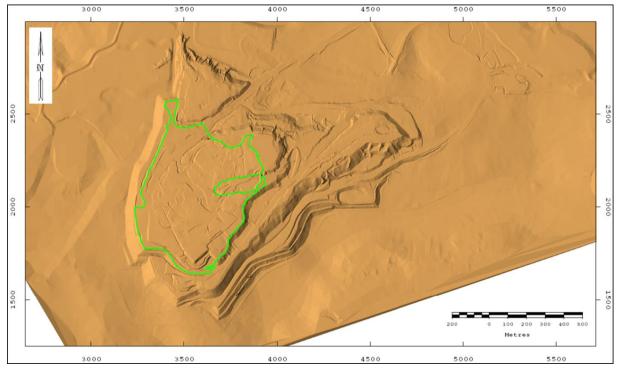
Figure 5-1 : Horizontally Exposed Coal Encapsulation Area

Figure 5-1 provides an illustration of the coal asset area requiring cover for the Anglesea mine. This area will require approximately 413,000 lcm of material to provide encapsulate the area. The cover material will be sourced from the existing overburden dumps as well as pushed from the existing pit walls by a dozer battering down in situ material from the pit wall.

Mining One endorses the strategy of capping these coal assets with 1.0m of inert cover material drawn from the overburden dumps. The cover material should have a clay content of greater than 10% based on field measurements using Table 3-1 as a guideline. This will provide adequate protection from ash attack and more importantly seal the coal against oxidation leading to spontaneous combustion. Special attention should be paid to the insitu coal seams that require absolute control on the clay content to ensure adequate coverage of the coal is achieved.
