Technical Review Board

TRB Recommendations RE: PSM Hazelwood Northern Batter Movement Report

TRB RECOMMENDATIONS RE: PSM HAZELWOOD NORTHERN BATTER MOVEMENT REPORT

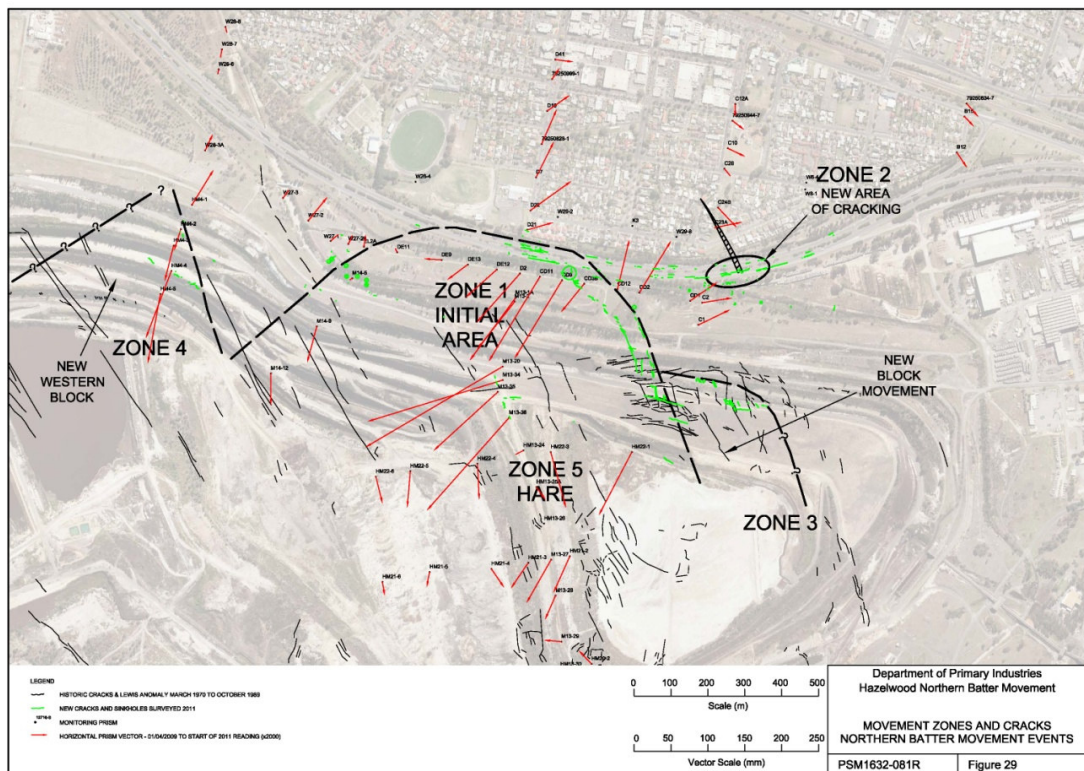
The TRB accepts that Figure 29 of the PSM Report, reproduced as Figure 1 in this report, generally depicts the current state of movement and cracking in the vicinity of the Northern Batters. The TRB is concerned by the extent of movement and cracking. It is in agreement with the PSM Report that:

Figure 1: Reproduction of Figure 29 of PSM Report Showing Cracks and Movements in the Northern Batter

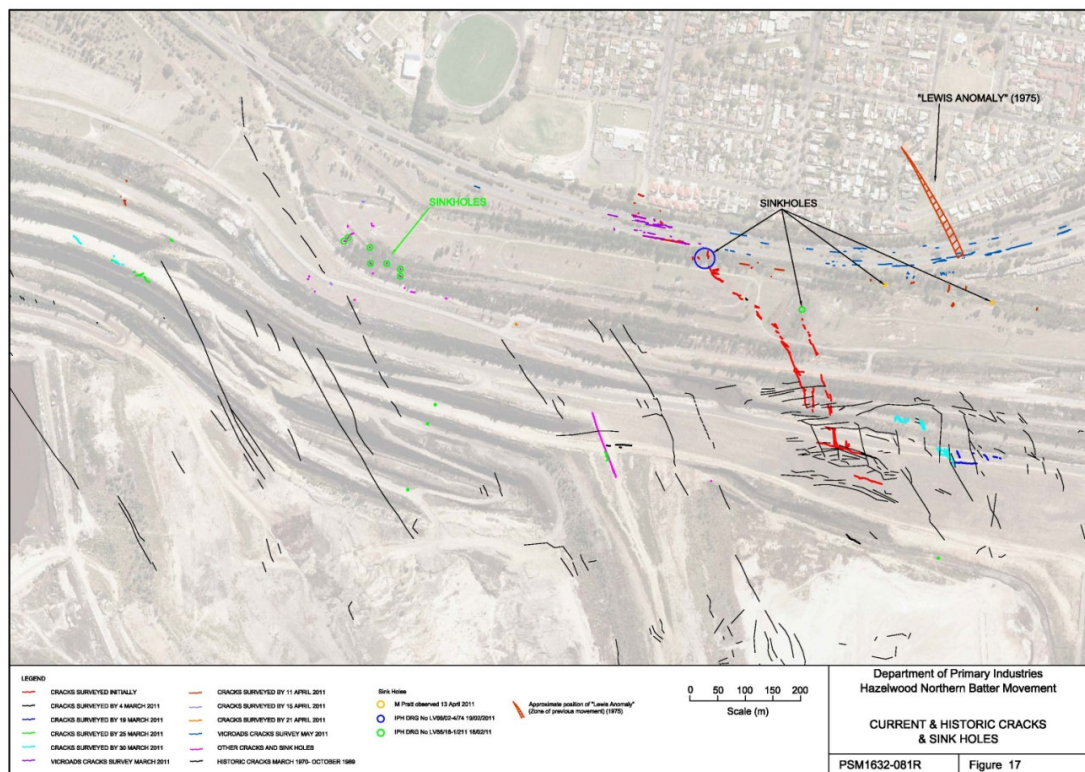
The drain is described in the PSM Report as having received “... *no remediation for the last two decades*” as well as being “*in a poor state with extensive shrub and tree growth*”. It is also stated “*one sinkhole started forming in 2007 and some repair works were reported*” and “*other sinkholes were reported in 2009*”. Further to the above, according to plans showing the location of historic cracks and sinkholes, Figure 2 (reproduced from Figure 17 of the PSM Report), there is a likelihood that more cracks and sinkholes had developed in the MMD by this time but were not observed because of the vegetation cover.

Figure 2: Reproduction of Figure 17 of PSM Report Showing Current and Historic Cracks and Sinkholes

As the Northern Batter seems likely to continue experiencing relatively large movements, which must impose a significant risk to the long-term integrity of any drainage channel located close to the crest of this batter, the only effective long term solution to batter failure, other than to significantly redesign the slope, is to divert all external runoff so that it does not enter the mine area and, thus, obviate the need for the drain. Therefore, it is strongly recommended that this total diversion is effected as soon as possible.

As this long term solution may take some time to implement, it is recommended that a temporary short term solution be developed and constructed as quickly as possible. It is understood that consideration is currently being directed towards the reconstruction of the existing MMD as a clay-lined open channel. While the details of the design for the drain's reconstruction have not been provided to the TRB, it is recommended that careful consideration be given to risks to the integrity of any lining. This is especially the case when not only is there continued movement but there may also be areas under the channel footprint that could be potentially unstable, have not been detected, and could threaten the reformed MMD in time to come.

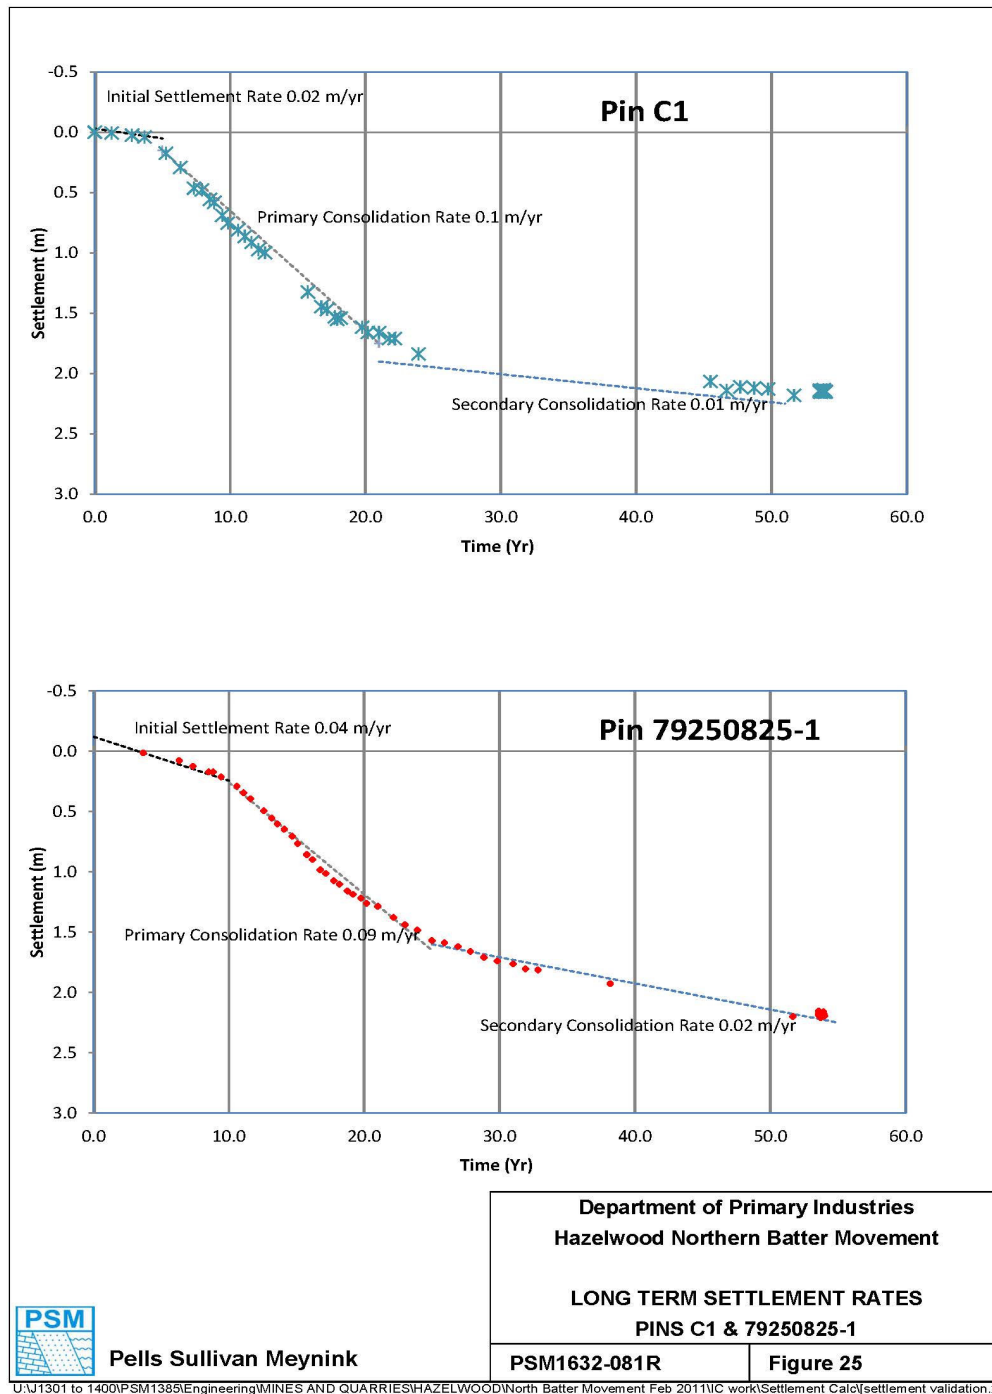
Figure 3: Reproduction of Figure 25 of PSM Report Showing Long Term Settlement Rates

The PSM Report suggests that because the general shape of the two curves shown in Figure 3 is similar to a classical consolidation response curve for a compressible soft clay, consolidation accounts for the long term response of the Northern Batter. However, it is the view of the TRB that this would only apply if the water pressures driving the consolidation process were reduced at the commencement of consolidation and held constant thereafter. In reality, there have been many ongoing significant and complex water pressure changes within the two main aquifers, as shown in Figure 4, suggesting to the TRB that the shape of these two particular long term settlement curves and their similarity with the classical consolidation curve is largely coincidental.

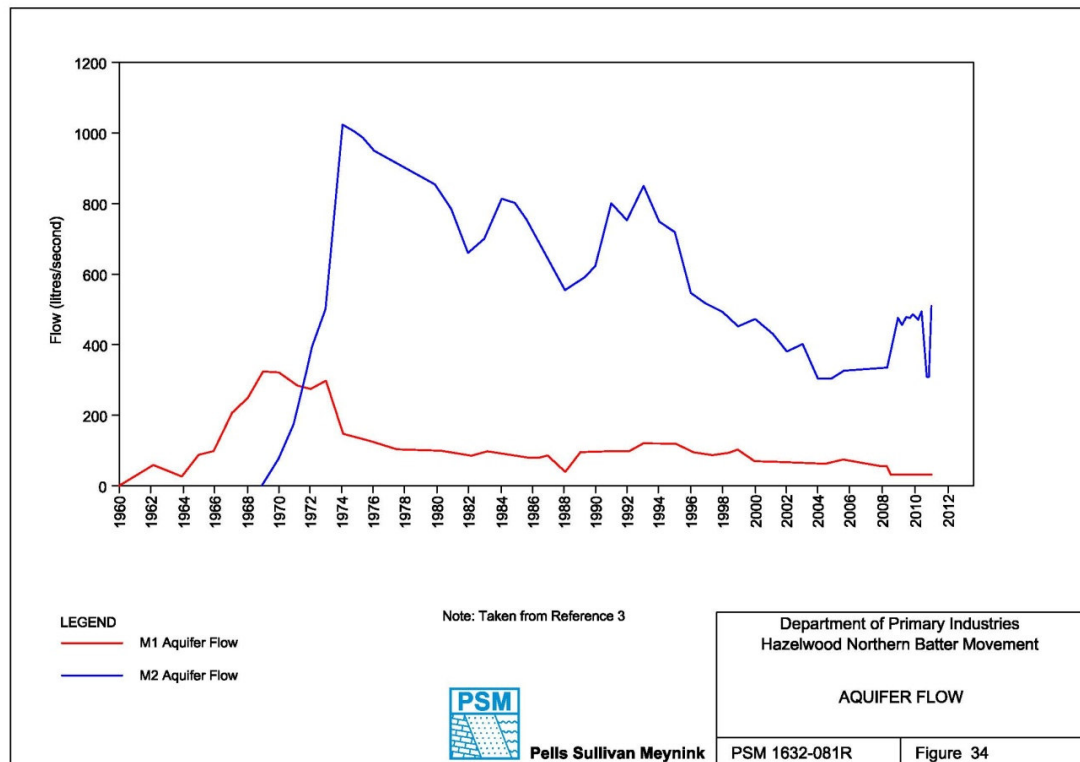
Figure 4: Reproduction of Figure 34 of PSM Report Showing Aquifer Flow
