**YALLOURN OPEN CUT**

**MINE REHABILITATION  
ASSESSMENT OF OPEN CUT STABILITY  
PROPOSED FLOODING OPTION**

**REPORT 1155/2**  
May 1993

**GEO-ENG PTY LTD**

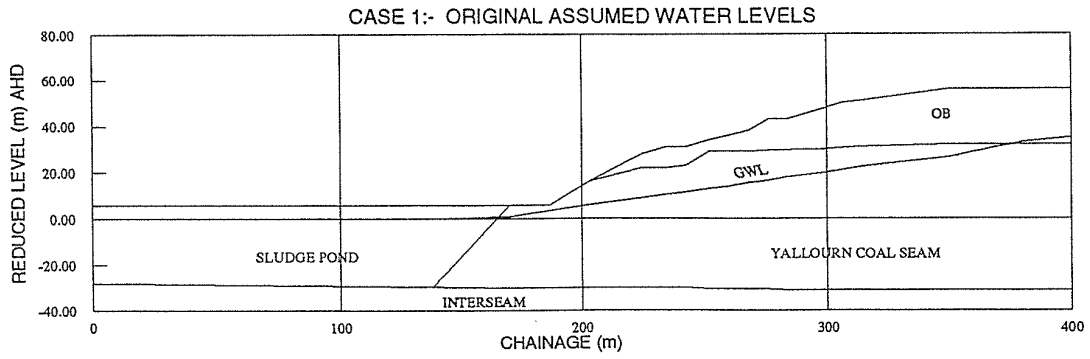
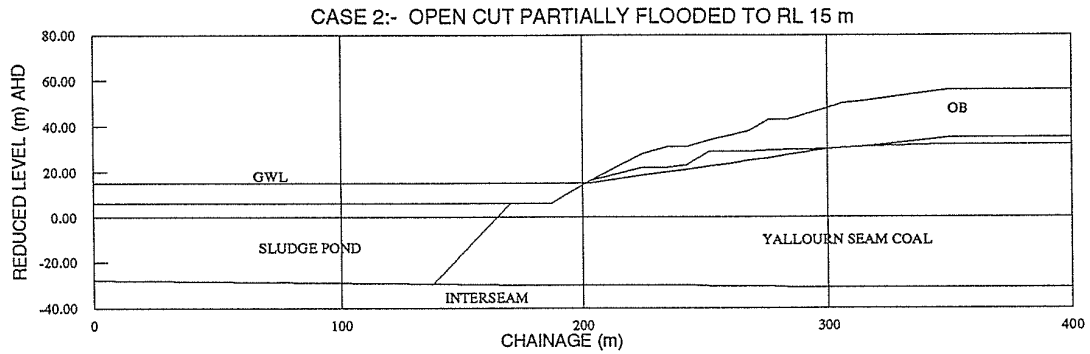
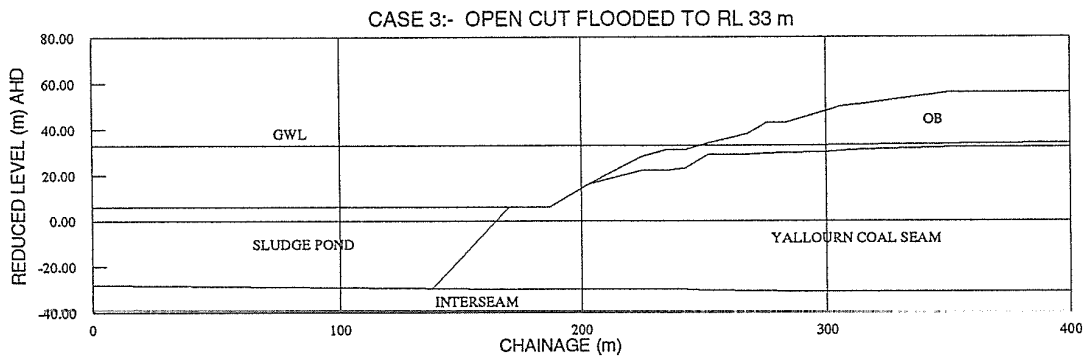
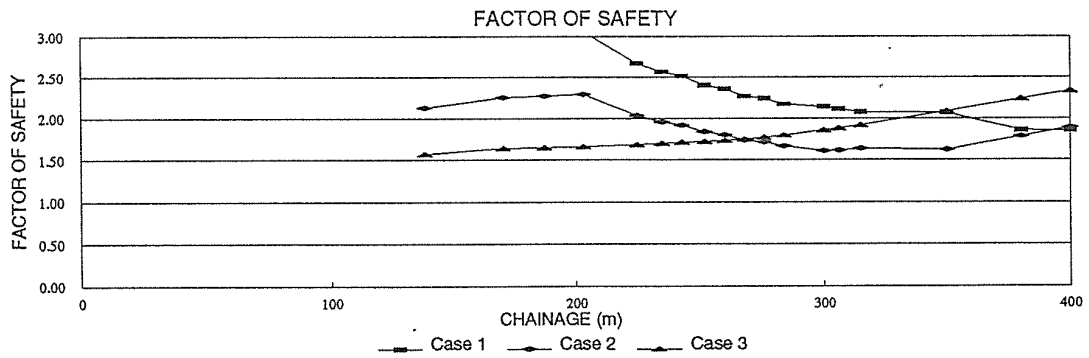
As shown in Figure 2 the toe of the batter is supported by 25 - 30 metres of partially dewatered sludge and ash that improves the overall stability of the batters by providing a stabilising force at the toe. The coal/interseam interface is dipping gently to the north (ie: away from the open cut). The analyses have assumed the presence of the proposed rehabilitation earthworks as shown in Figure 2.

The results of the analyses are shown in Figure 2. As noted above, due to the presence of the toe support provided by the sludge pond material, the overall batter has an acceptable long term factor of safety for all water level scenarios analysed.

Flooding of the open cut to RL 33 metres in this case will provide an additional hydrostatic resisting force which effectively cancels out the destabilising water forces now present in the batters. In addition, the presence of a coal/ interseam interface dipping away from the open cut improves already favourable stability conditions.

- All permanent batters within the existing Yallourn Open Cut are expected to be stable under either proposed partial or full flood conditions
- The results of the stability analyses for the Old Northern Batters (Section A) are shown in Figure 2. Due to the presence of the toe support provided by the sludge pond material the overall batter has an acceptable long term factor of safety for all water level scenarios analysed.

Analyses of the proposed rehabilitation earthworks have indicated that good quality, well compacted material will be required for placement in the top levels to ensure stability when the open cut is flooded. The analyses indicate that top of coal clean-up material containing large percentages of coal will not be appropriate for use in any upper batter rehabilitation work that would later be fully or partly covered by water. It is recommended that soft, wet clean-up material not be used for fire protection cover or rehabilitation works.

- Assessment of the proposed rehabilitation earthworks has indicated that good quality, well compacted earthfill, material will be required for placement to ensure stability when the open cut is flooded. Material from top of coal clean-up work containing a large percentage of coal is not considered suitable for placement as part of the rehabilitation works.

- It is recommended that only good quality, well compacted earthfill should be used in the rehabilitation works proposed for the Old Northern Batters area of Yallourn Open Cut.

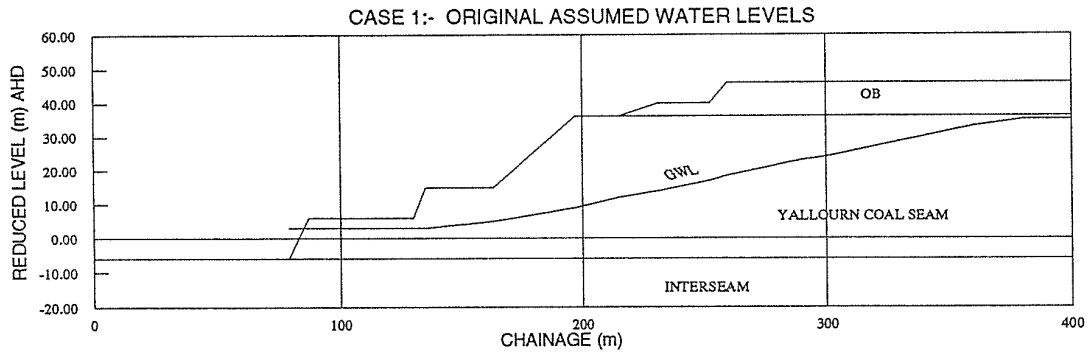
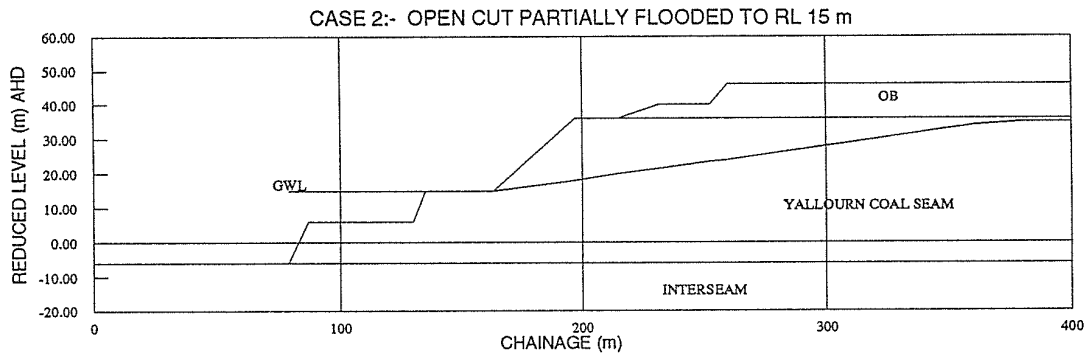
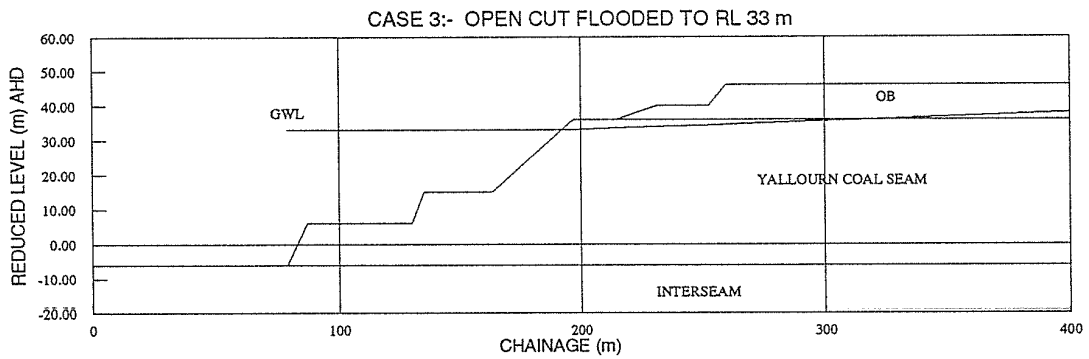
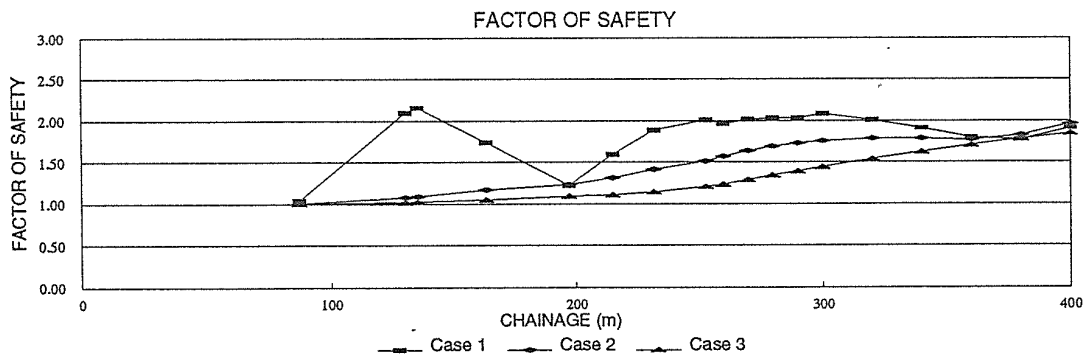
The results of the stability analyses are shown in Figure 3. It can be seen from the graph of factor of safety versus chainage that the analyses indicate minimum factors of safety of 1.1 for sections of the batter above the water table, increasing with distance from the batter crest. The submerged part of the batter have relatively low factors of safety less than 1.1 approaching 1.0.

It is considered however, that the lower sections of the batter are safe despite having a very low factors of safety. This is because for the submerged portion of batter, no additional net destabilising forces can be applied to the coal blocks as they are already totally submerged and lie on a flat surface (coal/ interseam interface). A factor of safety of 1.01 is acceptable in this situation.

It is therefore considered that the batter may be flooded with little possibility of failure.

- The results of the stability analyses for the Floc/Fire Service Ponds South Eastern Batters (Section B) are shown in Figure 3. This area has no toe support and analyses of the section shows that the submerged parts of the batter have factors of safety close to 1.0. However, this is not a serious concern in this case as the stabilising force provided by the flood water balances possible destabilising hydrostatic forces of the water within the batter. With no net destabilising forces able to act on the batter it is therefore considered that the batter may be flooded with little possibility of failure.

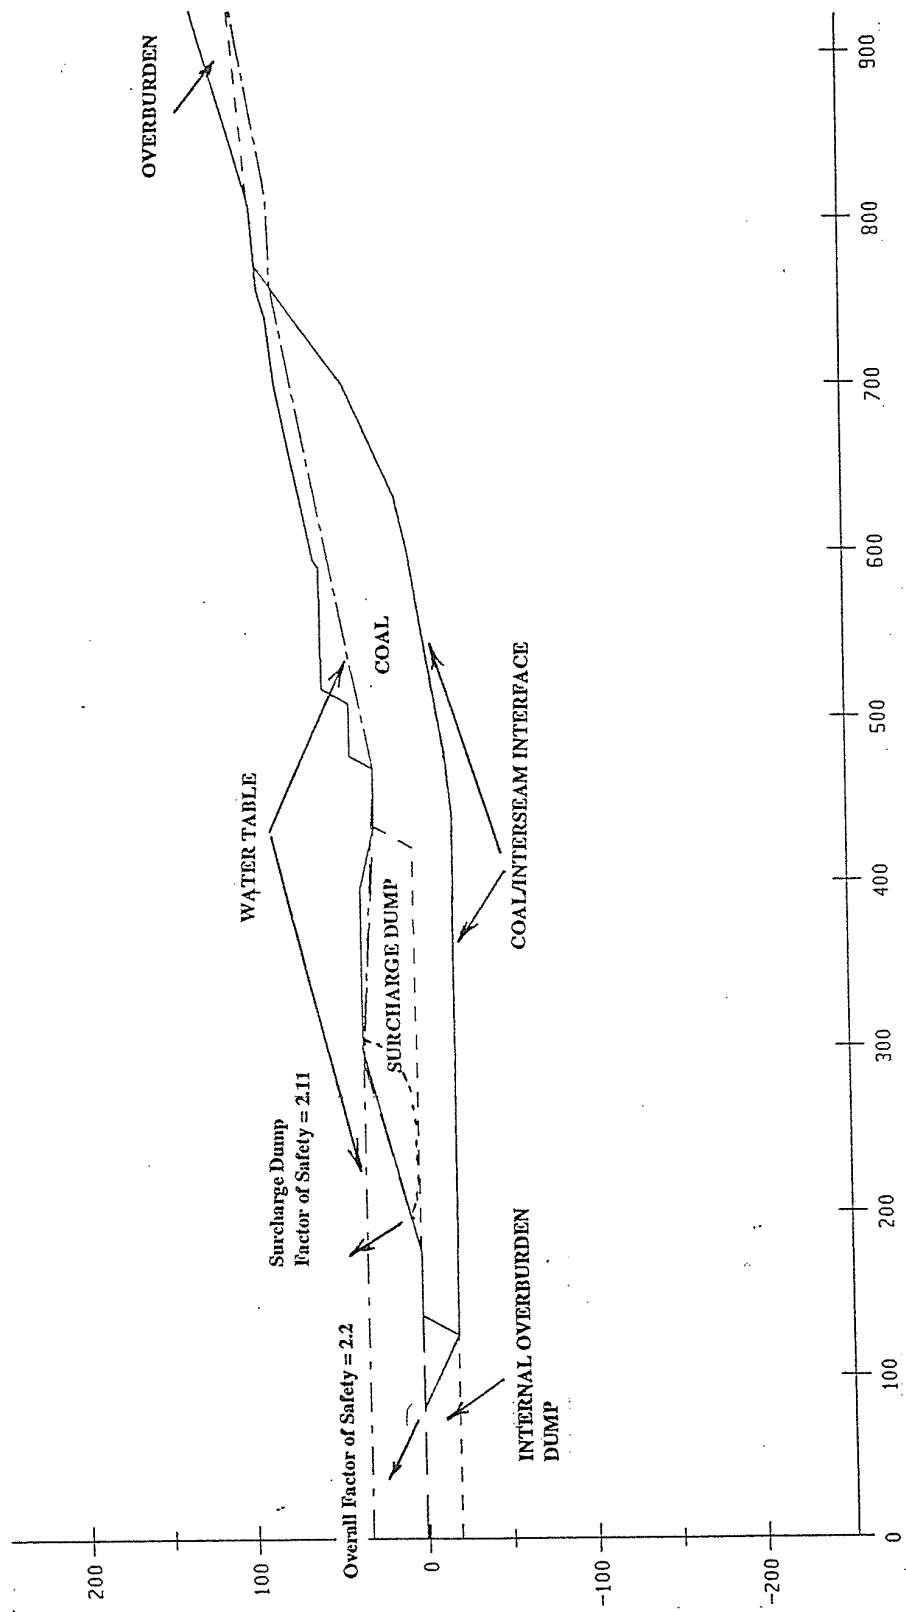
As can be seen in Figure 4 the section is located in an area of steeply dipping strata resulting from the adjacent Yallourn Monocline/Fault. The analysis has assumed that all overburden scheduled for excavation at the top of the batters has been removed and that the Surcharge Dump has been fully developed. In addition, the analysis assumes that the internal overburden dump has been placed as planned along the toe of the permanent Western Batters.

Analyses for overall batter stability were carried out for the three water level scenarios outlined in Section 3.1 of this report and methods outlined in Report MGD 10. When flooded to RL 33 metres and with the internal overburden dump placed against No 4 Cut, the factor of safety against overall batter failure was found to be over 2.0. This figure is well above the required long term factor of safety indicating the overall batter will remain stable if the open cut is flooded.

Stability analyses were also carried out to determine the stability of the Surcharge Dump if the open cut is flooded. These analyses showed the Surcharge Dump will also have an acceptable long term factor of safety of 2.11 when the open cut is flooded.

- Township Field Western Batters (Section C) were analysed using the methods outlined in Report MGD 10. When flooded to RL 33 metres and with the internal overburden dump placed against No 4 Cut the factor of safety against overall batter failure was found to be over 2.0. This figure is well above an acceptable long term factor of safety indicating the overall batter will remain stable if the open cut is flooded

- Stability analyses carried out to determine the stability of the Surcharge Dump on Western Batters when the open cut is flooded showed the Surcharge Dump will have an acceptable long term factor of safety of 2.1

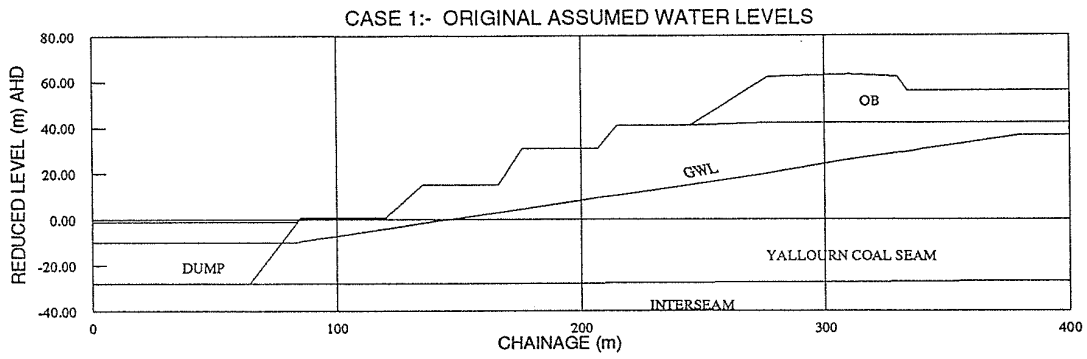
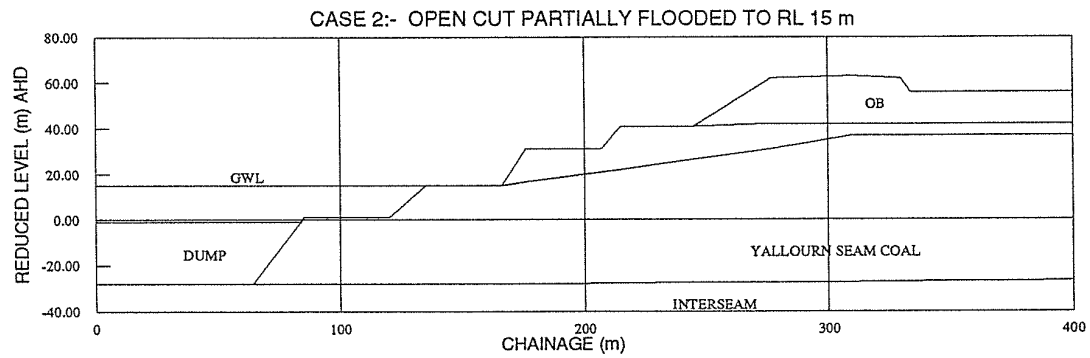
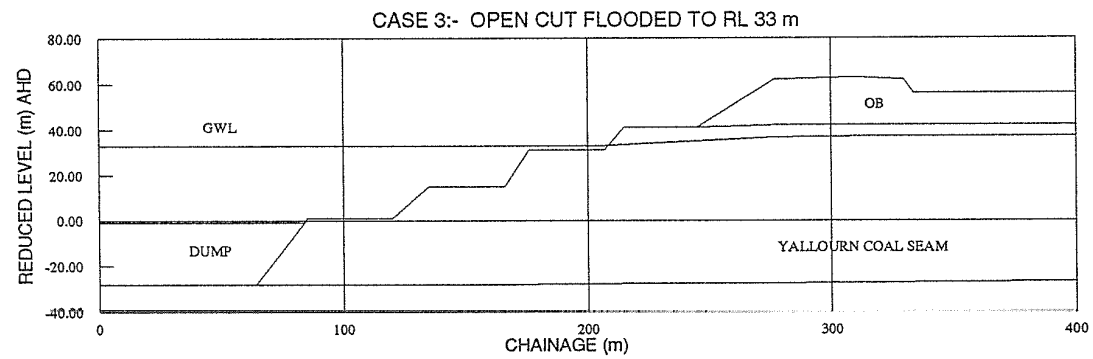
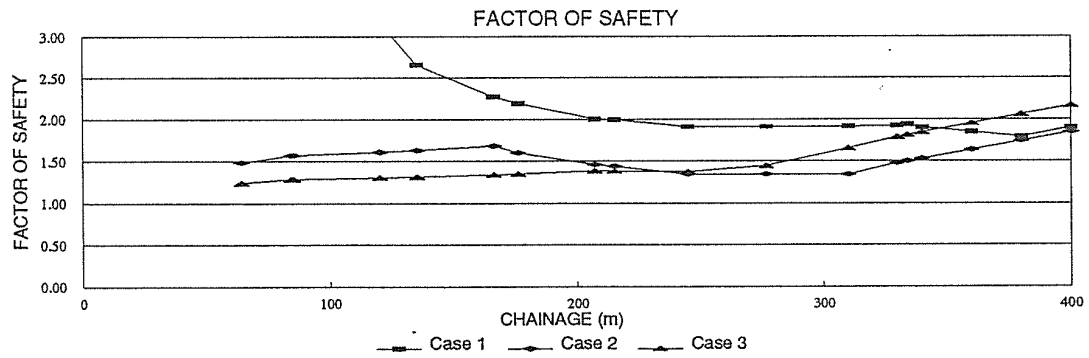
Results of the analyses are shown in Figure 5. As noted above, this section is supported at the toe by the internal overburden dump which accounts for the high factors of safety throughout the section.

- Results of the analyses for Township Field Northern Batters (Section D) are shown in Figure 5. This area of batter is supported at the toe by the internal overburden dump which accounts for the high factors of safety throughout the section. Flooding of the open cut effectively nullifies the presence of a destabilising water table in the batters and therefore the overall batter has an acceptable long term factor of safety.
