# Sheepwash Creek Realignment, Latrobe Valley

## Cultural Heritage Management Plan

AAV CHMP No.: 11386

Project Code: LYPM6  
Report Date: 12 January 2011  
Status: Final

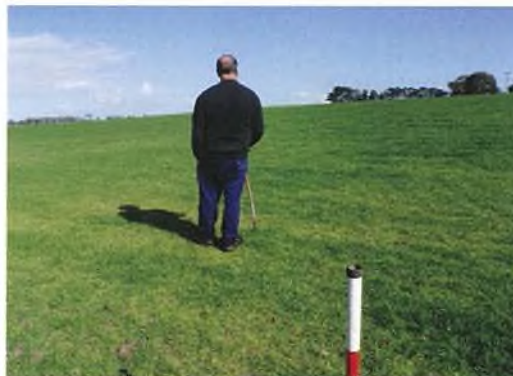
Plate 6: Moderately to steeply inclined rise of IA-5A\_14September10\_Melinda Albrecht

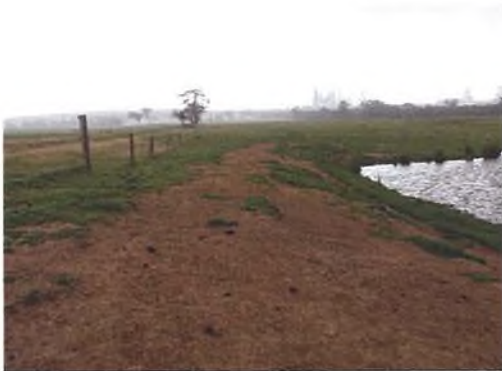
**Plate 7: Dam bank where surface artefact was identified during standard assessment, facing south\_13Sept10\_Melinda Albrecht**

One Aboriginal cultural heritage place (8221-0158, Cummings Road 7), an isolated surface artefact found in a highly disturbed context, was identified as part of the standard assessment within Investigation Area 1B. Due to the possibility that Aboriginal cultural heritage could be present within the lesser disturbed sections of the activity area, further investigation of the activity area was required. It was therefore deemed necessary to undertake subsurface testing as part of a complex assessment to identify the nature, extent and significance of potential Aboriginal cultural heritage in accordance with Regulation 60 (1b).
