**FIRE RISK ANALYSIS OF  
THE WORKED-OUT AREAS OF  
MORWELL OPEN CUT**

**JUNE 1992**

**Richard Oliver International Pty Ltd**  
(ACN 006 256 908)  
71 Queens Road, Melbourne Vic. 3004  
Telephone: (03) 529 5122  
Facsimile: (03) 521 1634

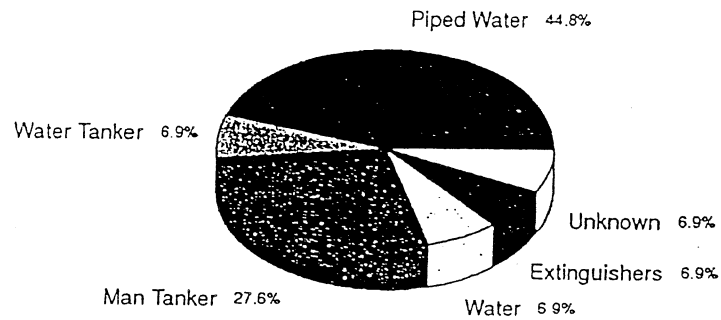
Figure 23

- (iii) loose coal was primarily the material burnt.
- (iv) piped water was the major means of fire suppression.
- (v) in terms of manhours and equipment hours reported for extinguishment, the fires in the worked-out areas are of similar severity on average to those occurring in the working areas of the mine.

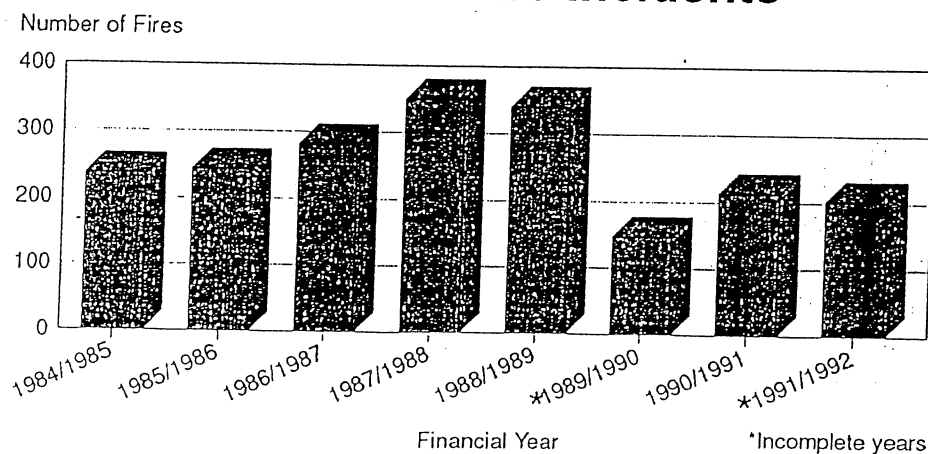
Figure 25

- (i) there have been 28 fires reported in the worked-out areas in this period. This suggests occurrence of around 11 fires per year.
- (ii) primary causes are motor vehicles and burning/welding. "Unknown" causes could include bushfire spotting, lightning, electrical causes like conductor clashing on power feeders, falling power poles, etc. These have occurred in the worked-out areas.

- i. Keep all M.O.C. fire reports on a P.C. data base and regularly review this data for causes and trends. This data analysis will assist to systematically reduce fire risks. Note that we have provided the 1989-1992 data on diskette with this report.
- ii. Examine restrictions to roadways in the worked-out areas. For example, a permit system could be adopted to control access to specified roads and incorporate a check or control upon vehicle exhaust systems, at the same time.
- iii. Stop dumping of dirty coal adjacent to the 260 series conveyors. Look to relocate such dumping.
- iv. Relocate power feeders 15 and 16. We understand a relocation to near the 260 series conveyors is already proposed.
- v. Commence a pole replacement programme for the 4, 5 and 16 power feeders, replacing timber poles with concrete ones.

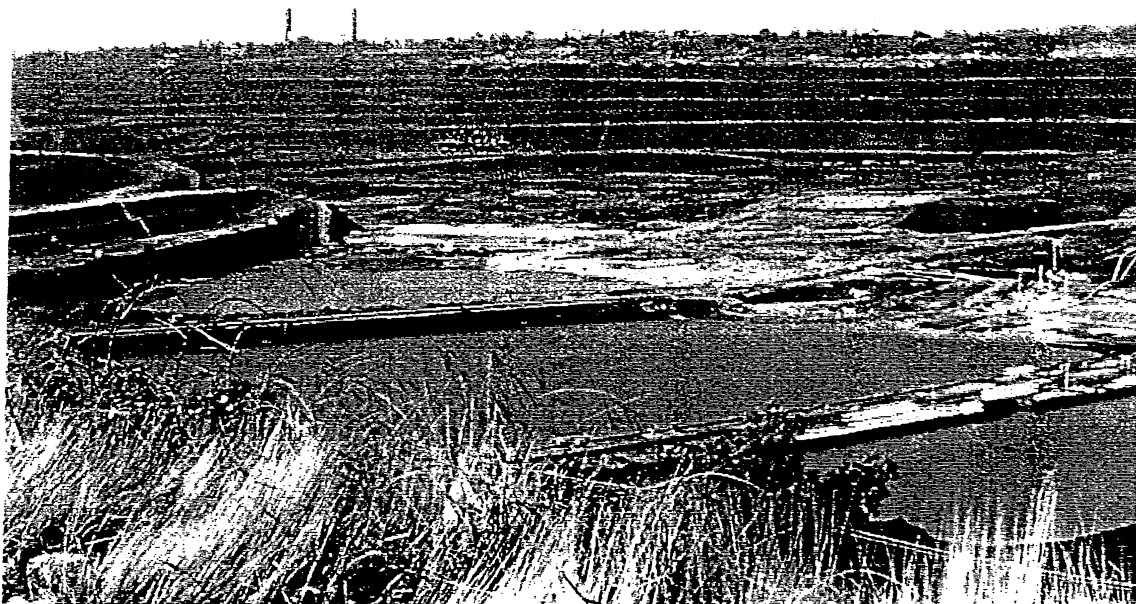
FIGURE 1: General view of the worked-out area of Morwell Open Cut (M.O.C.), looking at the eastern batters over No. 5 groyne in the foreground.

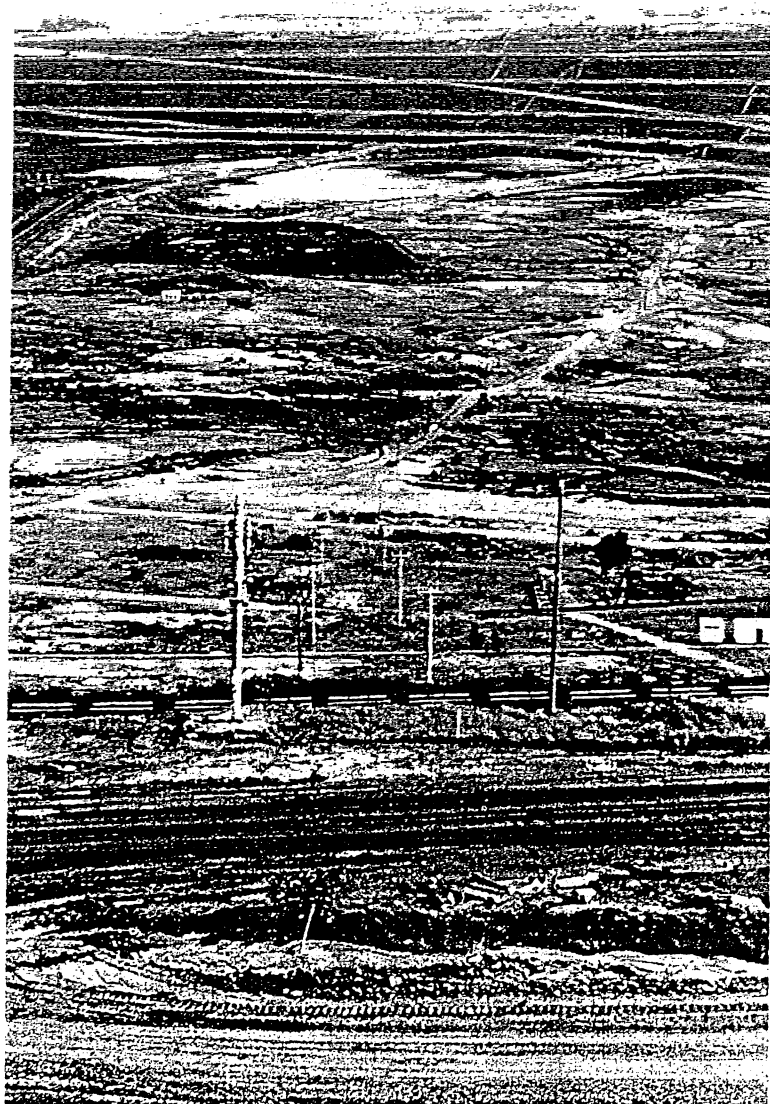
Loss of power to pumping stations or 20 series conveyor, through damage to feeders 4, 5, 15 and 16, is an evident exposure as are electrical cubicles, transformers and associated power supply cables linked to bores located in the worked-out areas.

**FIGURE 10:**  
Feeders 15 and 16  
coming down the  
eastern batters  
and across the  
worked-out area  
(looking west).

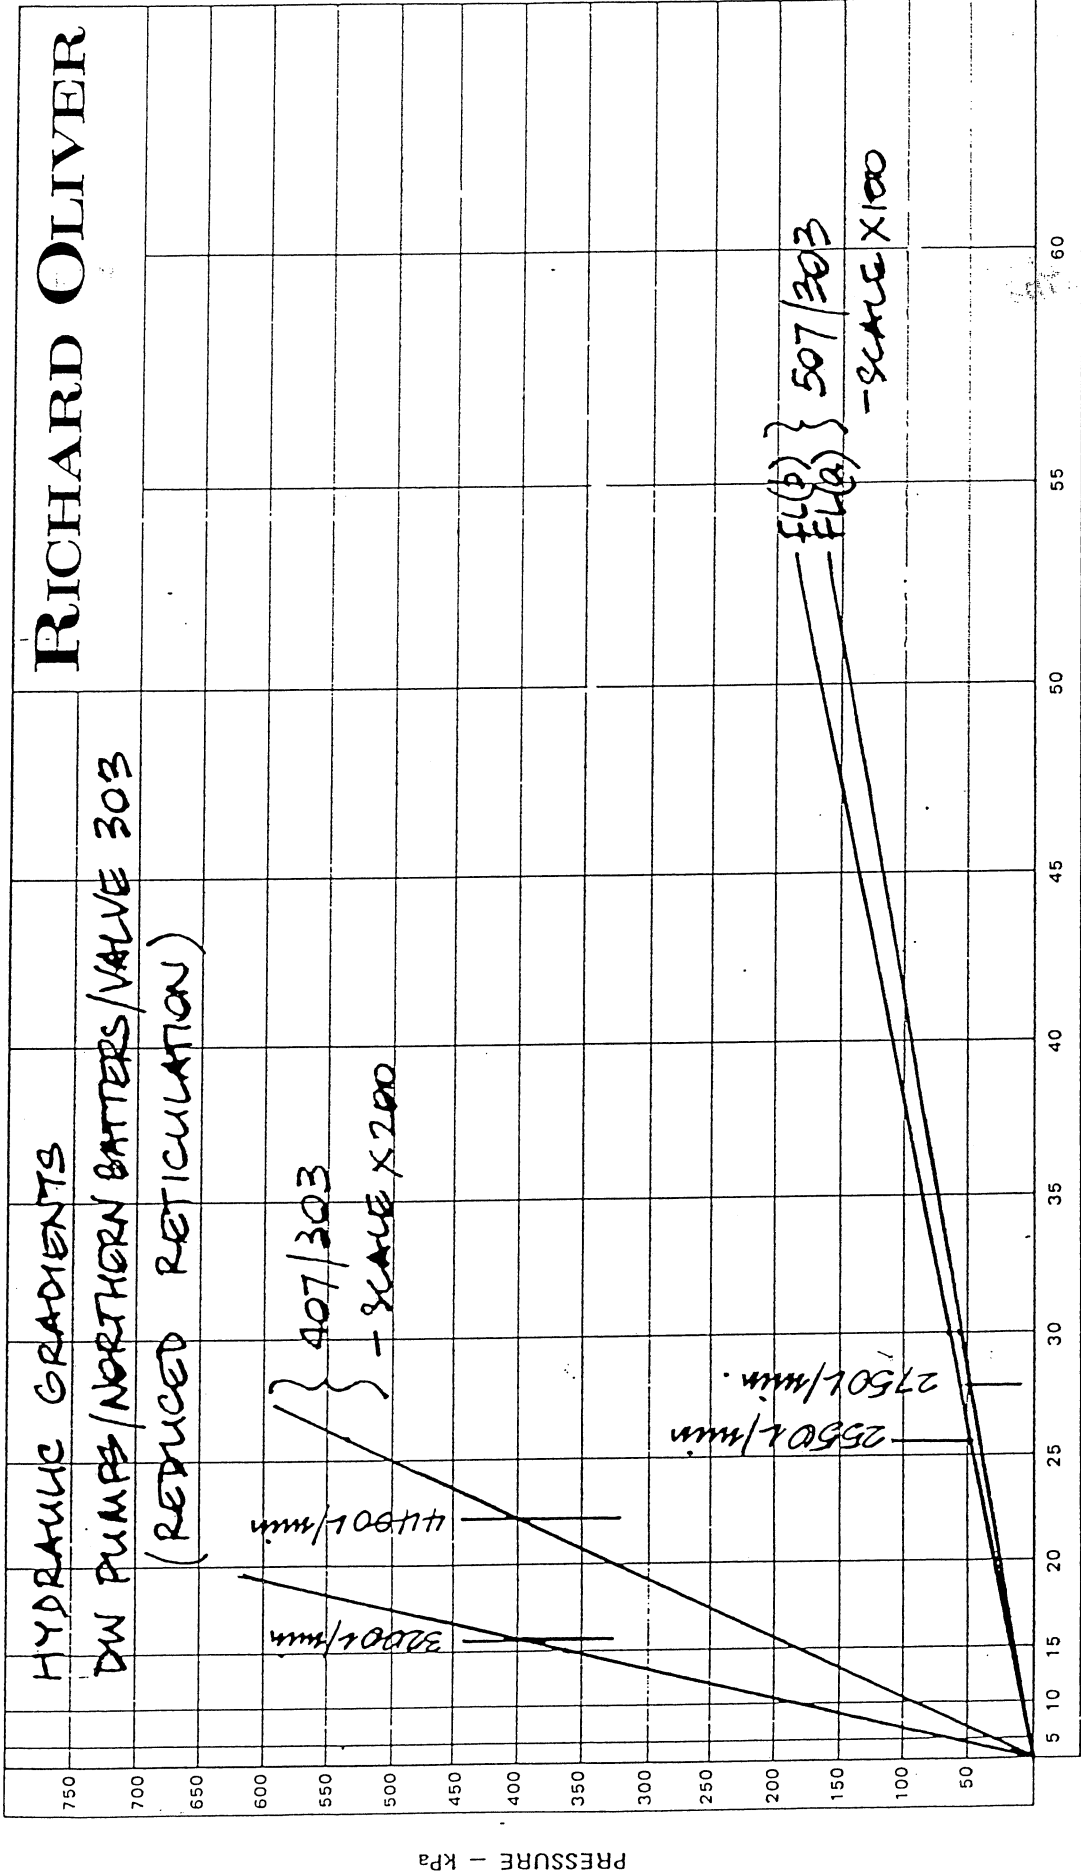
NAME OF INSURED <b>SECV / MOC</b>	DATE <b>6/92</b>	ENGINEER <b>BUNLEVIE</b>	INDEX No. <b>1 OF 2</b>
--------------------------------------	---------------------	-----------------------------	----------------------------

WATER SUPPLY ANALYSIS GRAPH

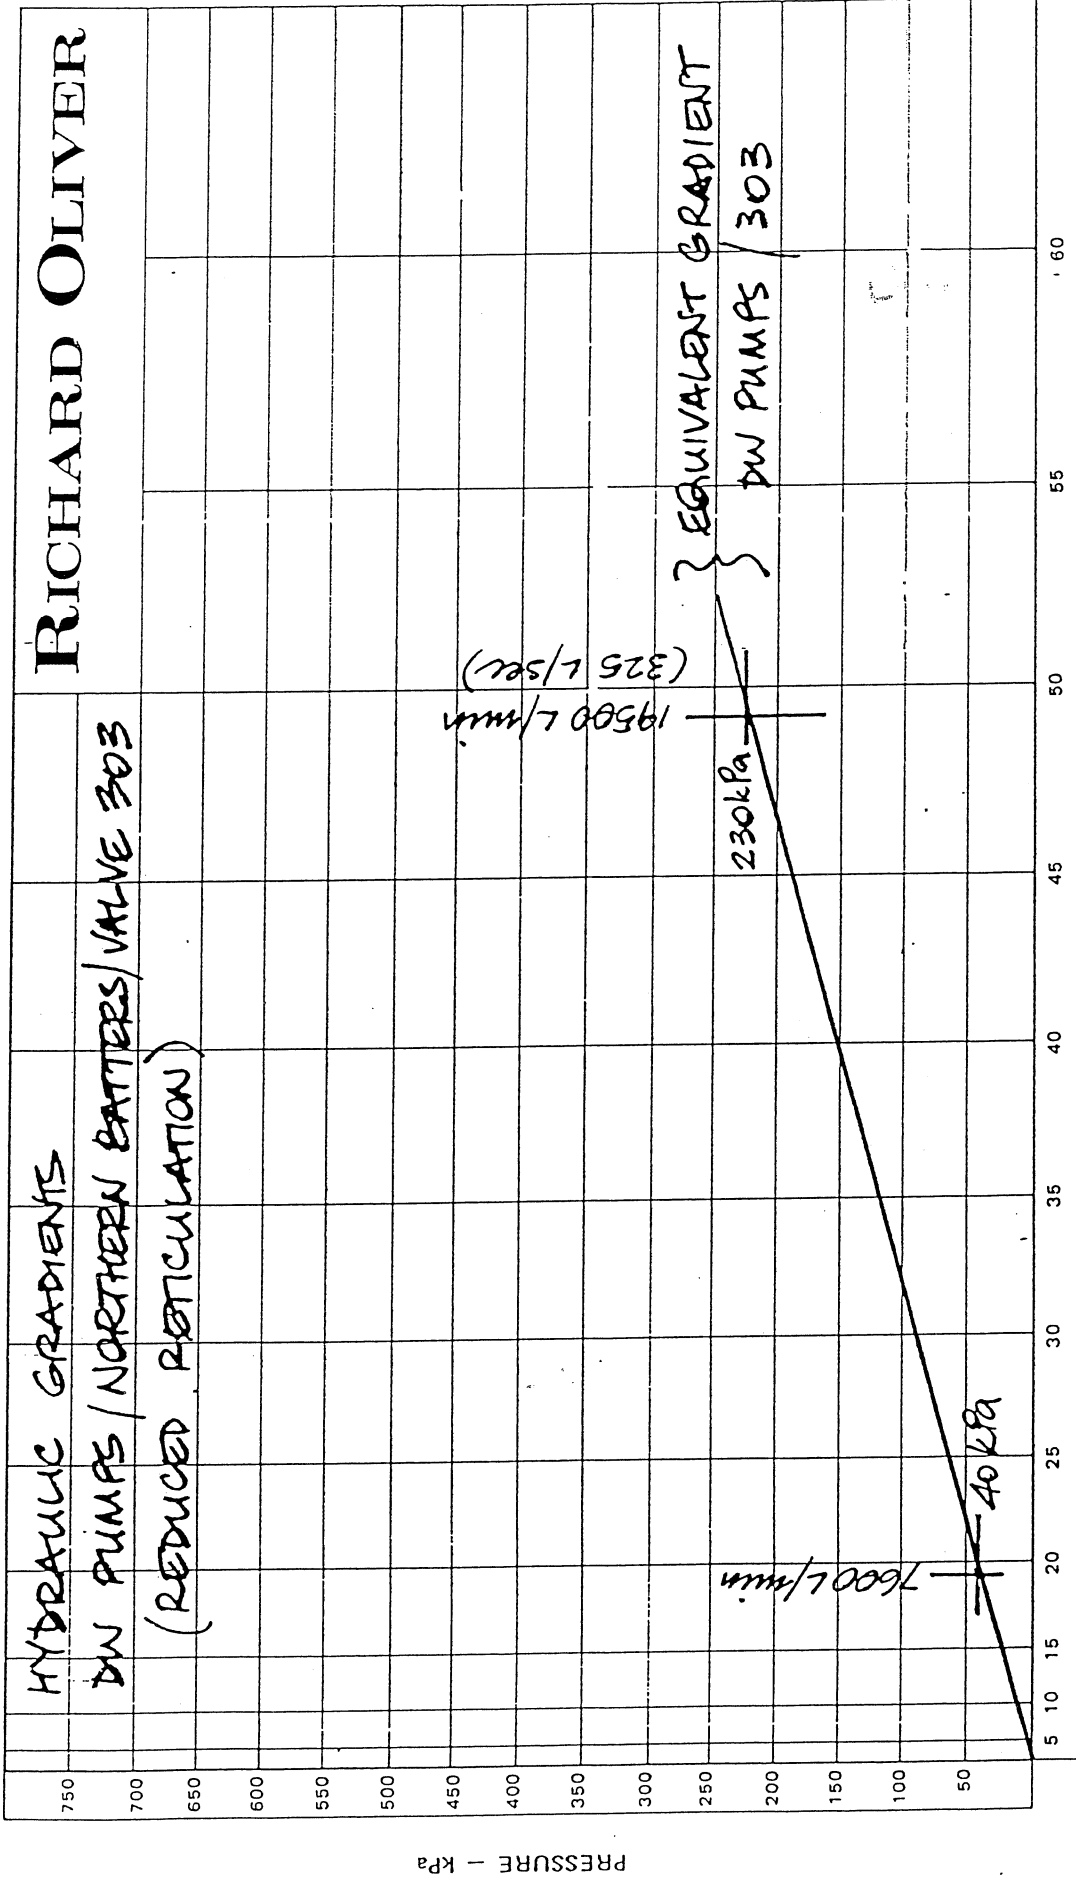
NAME OF INSURED <b>SECY/MOC</b>	DATE <b>6/92</b>	ENGINEER <b>DUNLEVE</b>	INDEX No. <b>2 of 2</b>
------------------------------------	---------------------	----------------------------	----------------------------

# WATER SUPPLY ANALYSIS GRAPH

FLOW - L.P.M. **3400**
