11 DREDGER CENTRE CHUTE FIRE INCIDENT

FINAL INCIDENT INVESTIGATION REPORT

**Incident Date 21/1/2012
AT 06:10 HOURS**

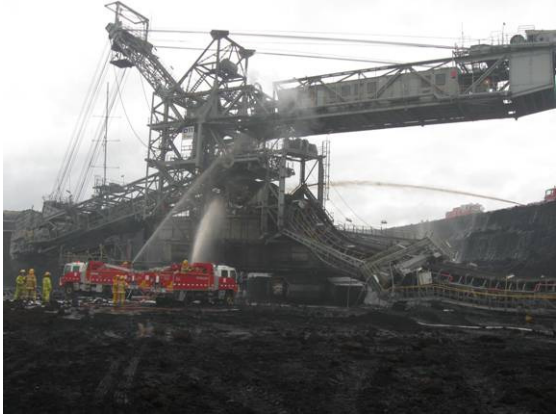
Photo #13

- D11 centre chute area acted as a chimney (once the discharge boom belt had burnt through). The machine configuration, with the discharge boom being elevated, may have made the chimney more effective in concentrating the fire and drawing air into the combustion area.
- A significant amount of flammable material, other than coal, is located in and above the chute area which fuelled the fire
- Weather conditions were calm and pleasant, no wind apparent which assisted in preventing the spread of fire to other areas of the mine.
- Visibility was good as the fire occurred just prior to sunrise at 06:23hrs.
- The fire origin was located approximately 12 metres above the coal surface. The closest access to the fire from the ground outside the machine was 25 metres from the fire source on the machine (refer photograph 13). This severely limited the effectiveness of some fire equipment.

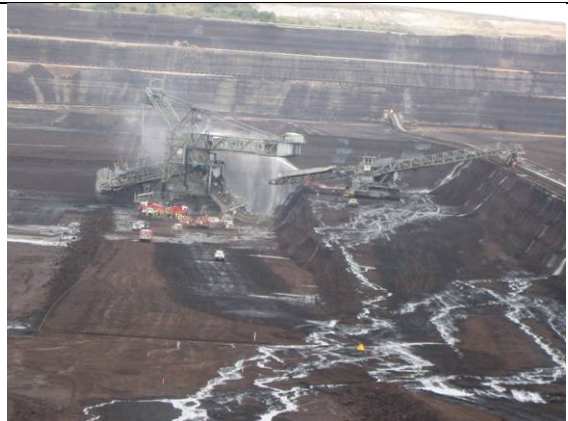
Photo #18

The operator of S96 confirmed that a small fire was present at D11's centre chute, he then informed D11's crew of the fire via the local communication system between the dredger, mobile slew conveyor and hopper. The two Dredger 11 operators went to assess the fire, as required by the Fire Instructions. A small fire was found at the mid point of the centre transfer chute burning on the bottom of the carry side of the discharge conveyor belt. The fire was observed to be 1 metre wide on the left hand side of the discharge conveyor chute. The fire was very hot with little flame evident. The operators believed they could extinguish the small fire. At this point they did not contact the Control Centre to report the fire. The two operators on D11 proceeded to fight the fire with resources at hand which included fire extinguishers and hose reels located on the machine. At times the fire was almost extinguished however it continued to reignite; the operators only accessed the left hand side of the transfer chute. The other two operators one on S96 and one on the hopper commenced to connect a water supply to D11 from the nearest water supply source (M820 West header hydrant connection). This required the running out and connection of 5 lengths of 30m long, 90mm diameter percolating hoses. (Involved collecting the hoses from storage on the various machines, running them out over the coal faces and dropping hose over two batters – refer Appendix 6.5 for digging configuration and photo #18 for overview)

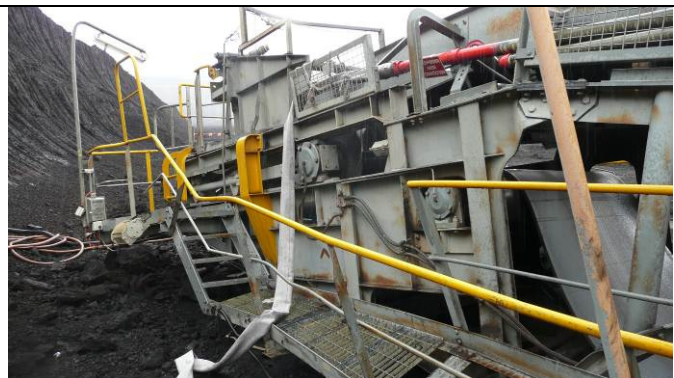
Photo 83

D11 Senior Operator dropped the machine's wash down hose off the end of the discharge boom (photo #84) to allow connection to a water supply once received. This would have provided a significant water supply directly at the centre chute area via a rubber hose (photo #83). This water source is used to enable off line cleaning of the centre area of the machine.

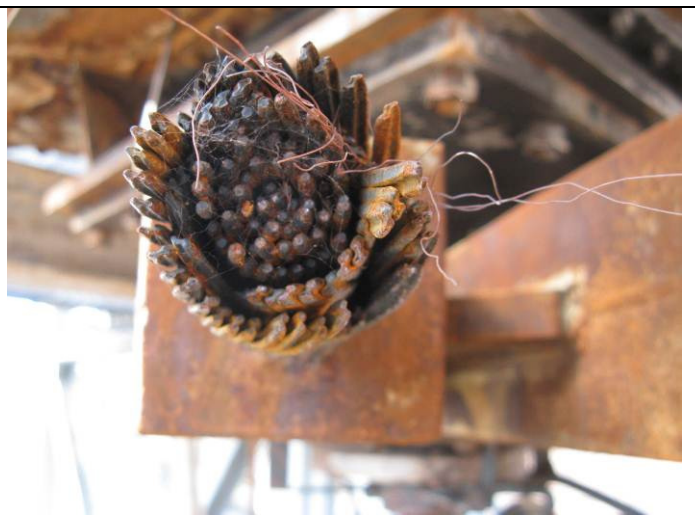
Photo 87

The investigation team, upon inspection with HRLT representatives, found that the RHS (in direction of conveyor belt travel) fixed stay rope at the centre tower socket connection had sustained a tensile failure as observed by "Necking" of the rope at the point of failure (photo 87 and 88). The RHS rope socket had also sustained cracking at its connection to the tower (photo 59). The LHS rope at the point of failure did not have the same tensile failure (photo 89). The conclusion from this is that the LHS rope failed due to the fire followed by the RHS rope due to overloading.
