International Power Hazelwood

October 2006 Mine Fire Investigation Incident Investigation Report

January 2007

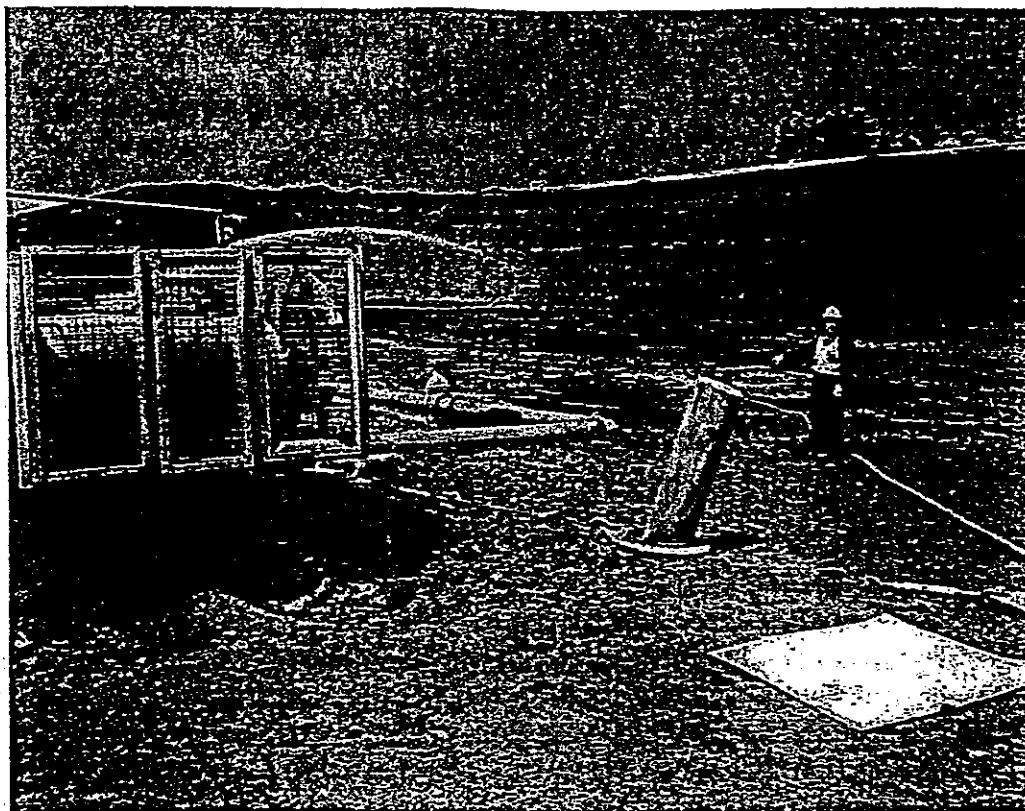
The first workers who attended the spot fire on M620 tailend, stated the fire was burning in close proximity to the M620 tailbox, and was between the conveyor and the topside and bottomside fire service pipelines. An anchor post for the tailbox was on fire and there was fire burning in loose coal on the bottomside of the conveyor. These workers recalled there were a lot of embers moving around and the wind was quite strong. They stated the fire moved away from them towards the head of M620 as well as progressing down to M720 also. When they arrived at the tailend they did not recall seeing any other fires on the formation. The photo on page 14 shows indicating where the fire was burning between the fire service main and the M620 conveyor tailbox.

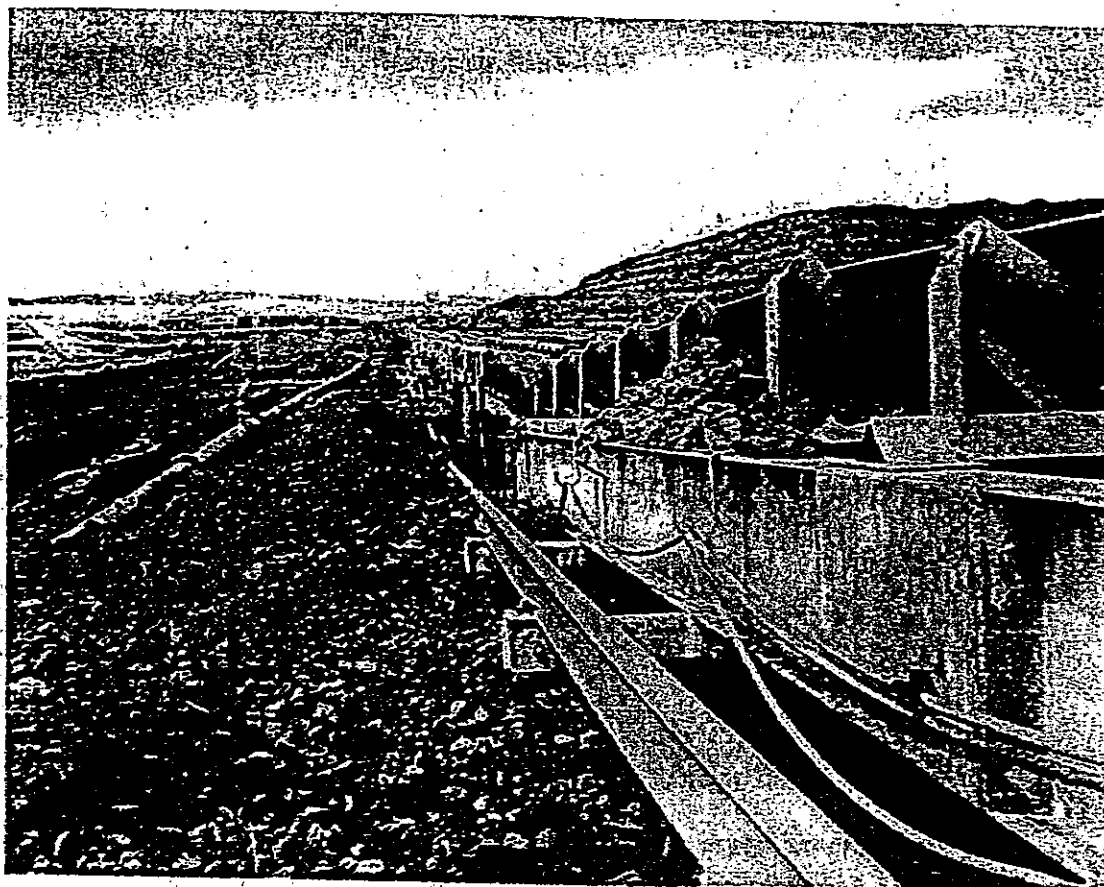
Eye witness reports from multiple sources observed the fire only at the tail end of the M620 level. The first workers to the tail end described the fire as being in the vicinity of the M620 conveyor tailbox. The fire was between the bottomside of the M620 conveyor and the bottom side fire service, and also between M620 and the topside fire service. There was also fire around the M620 tailbox. The most probable area of origin was at the tailend of M620 in close vicinity to the conveyor tailbox.

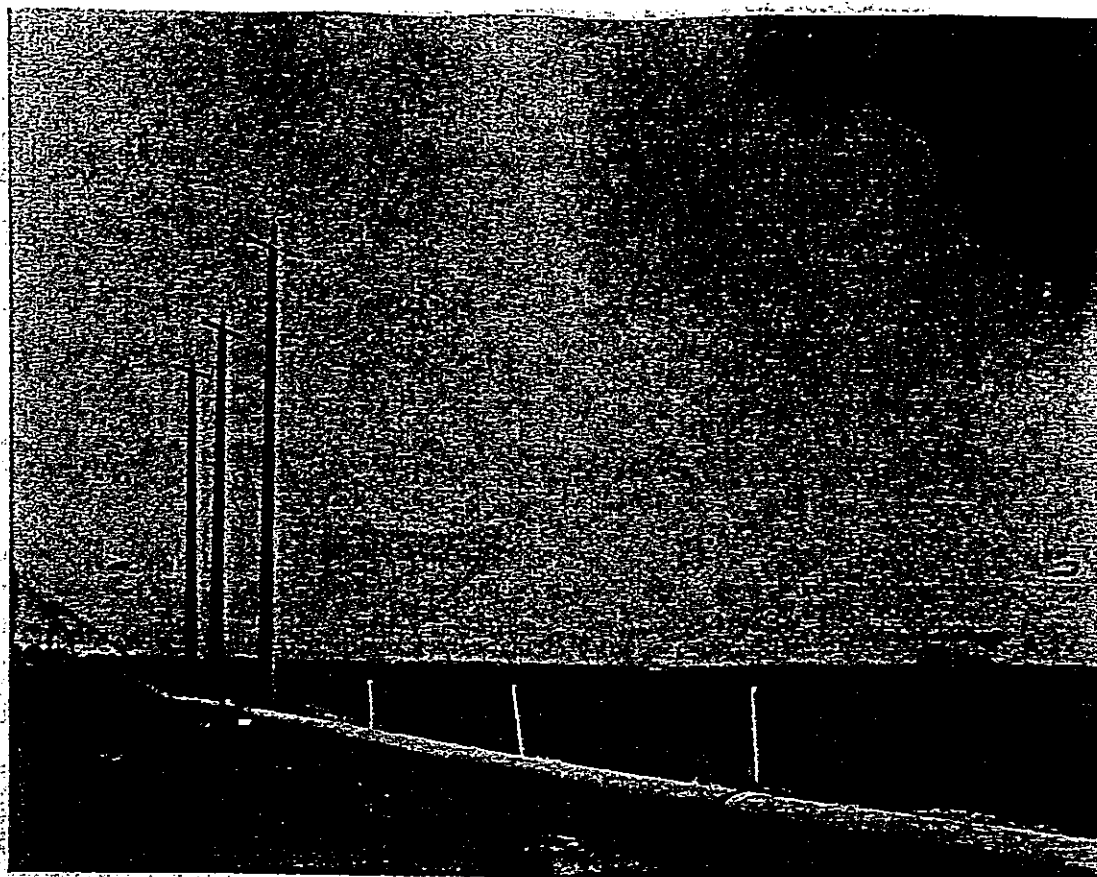
Photo taken by _____ while approaching the fire from the headend at 1229 hours. DR 11 and S94 both in view.

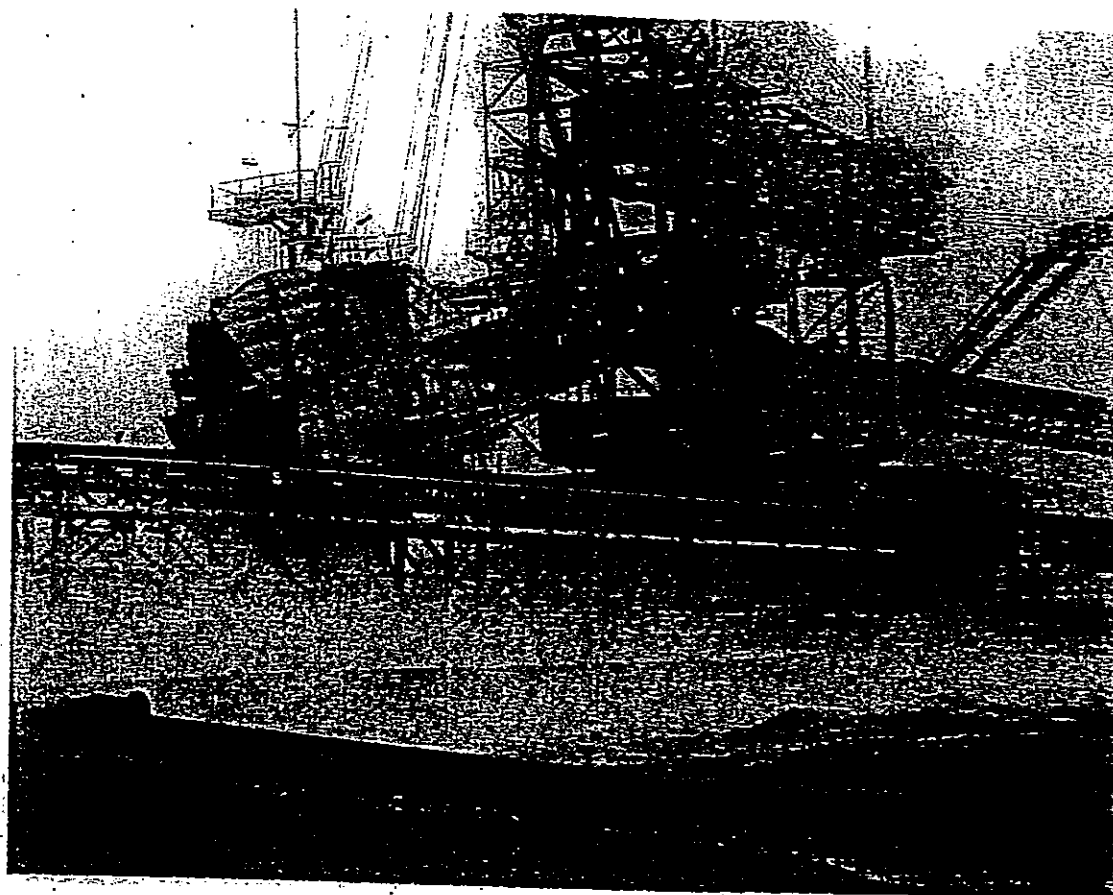
**Photo taken by
hours.**

while approaching the fire from the headend at 1229

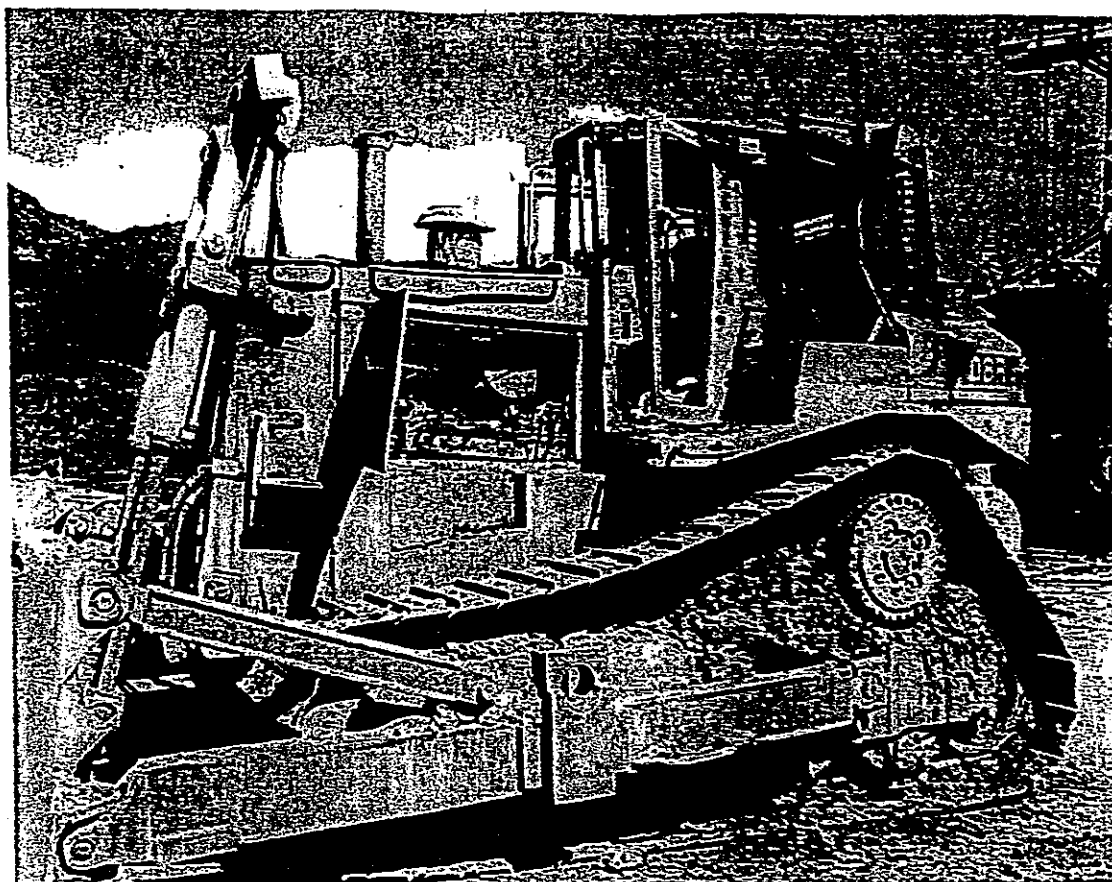
Description: Destroyed Bulldozer at head of M620.

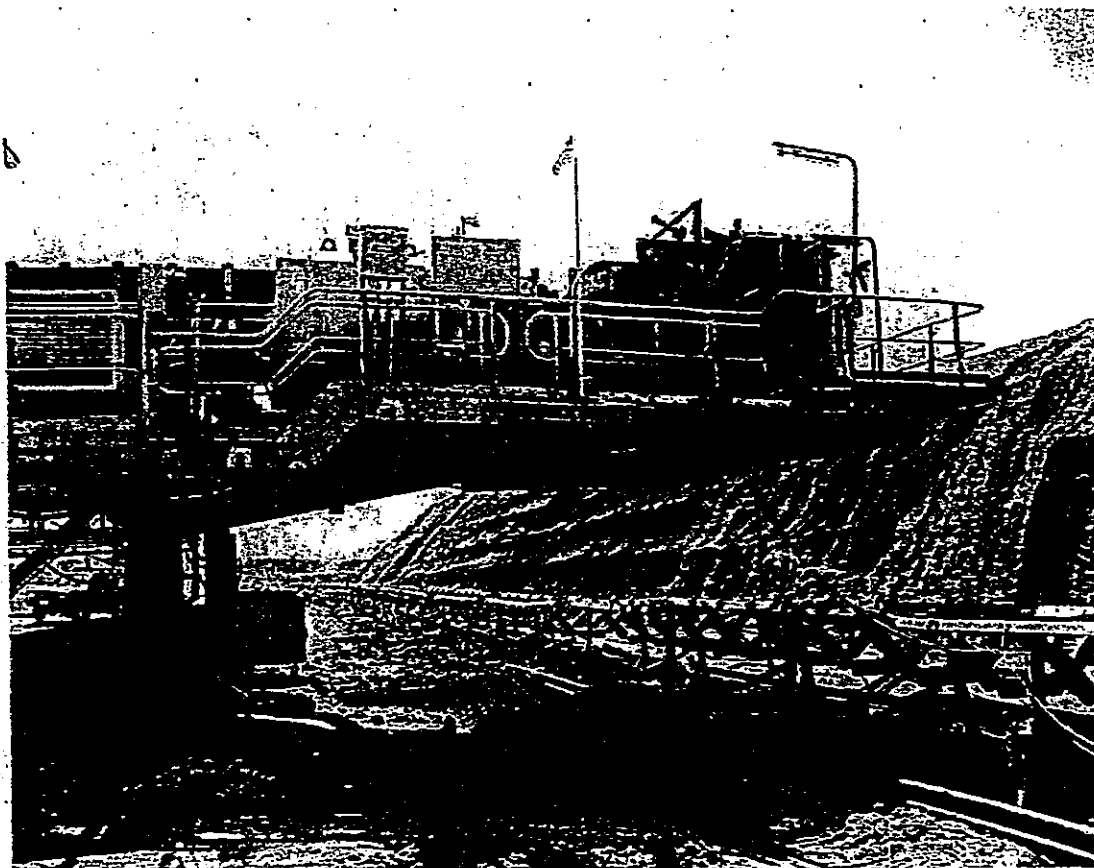
Description: Destroyed head unit from the M620 conveyor and the M640 conveyor underneath it.

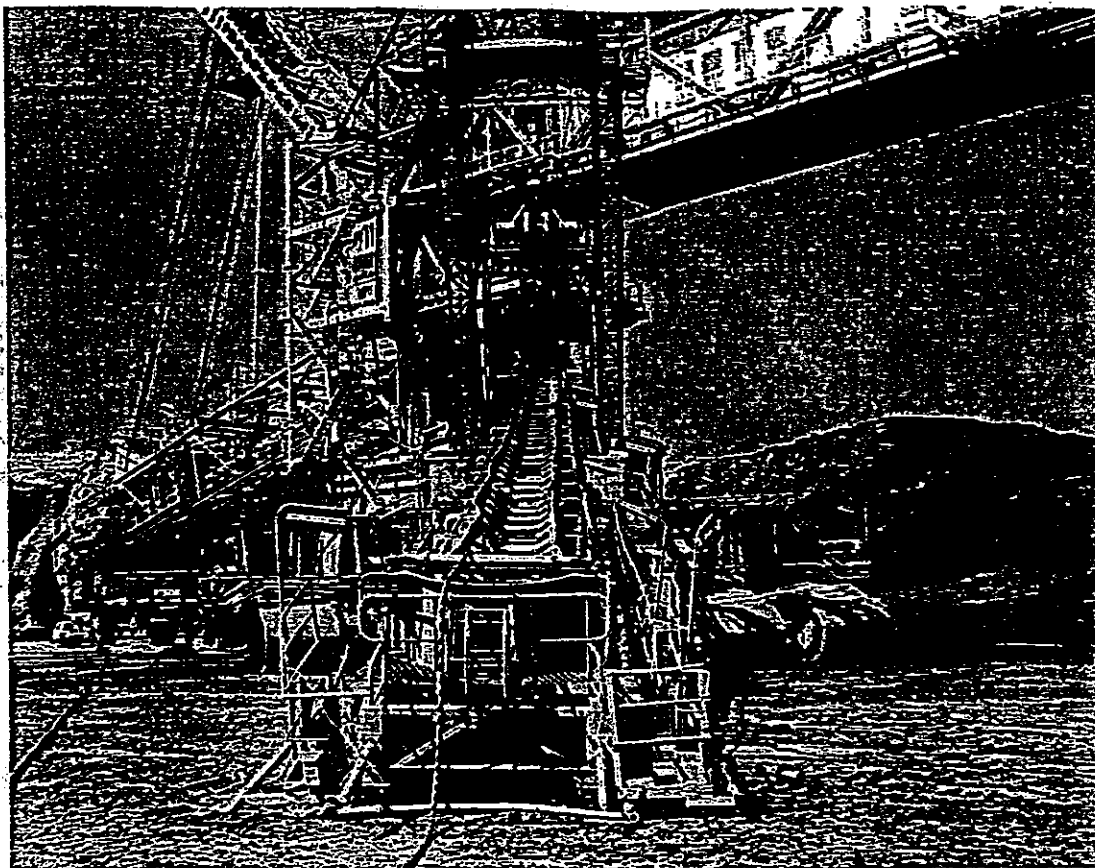
Description: North end of the damaged DR 11. This photo shows the conveyor that exits the rear of the unit.

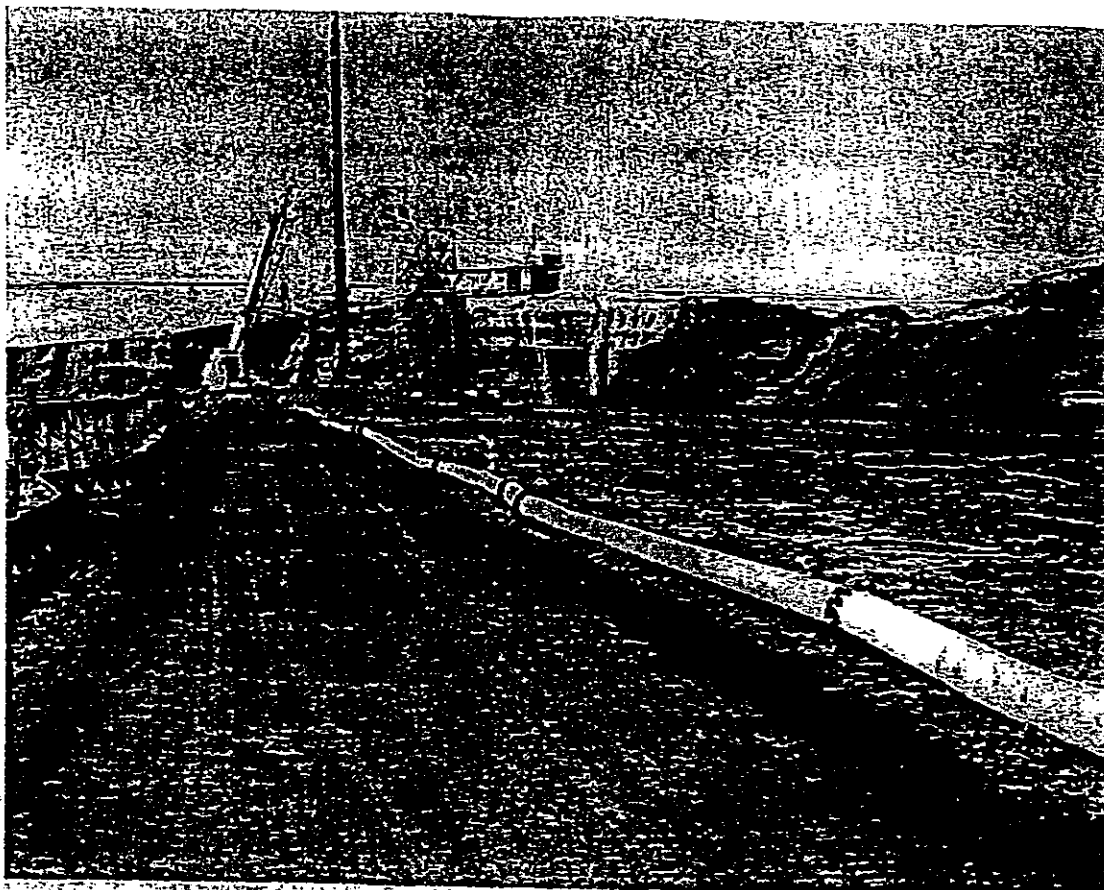
Description: View of the M620 profile and batter, repair work was underway prior to our arrival on site.

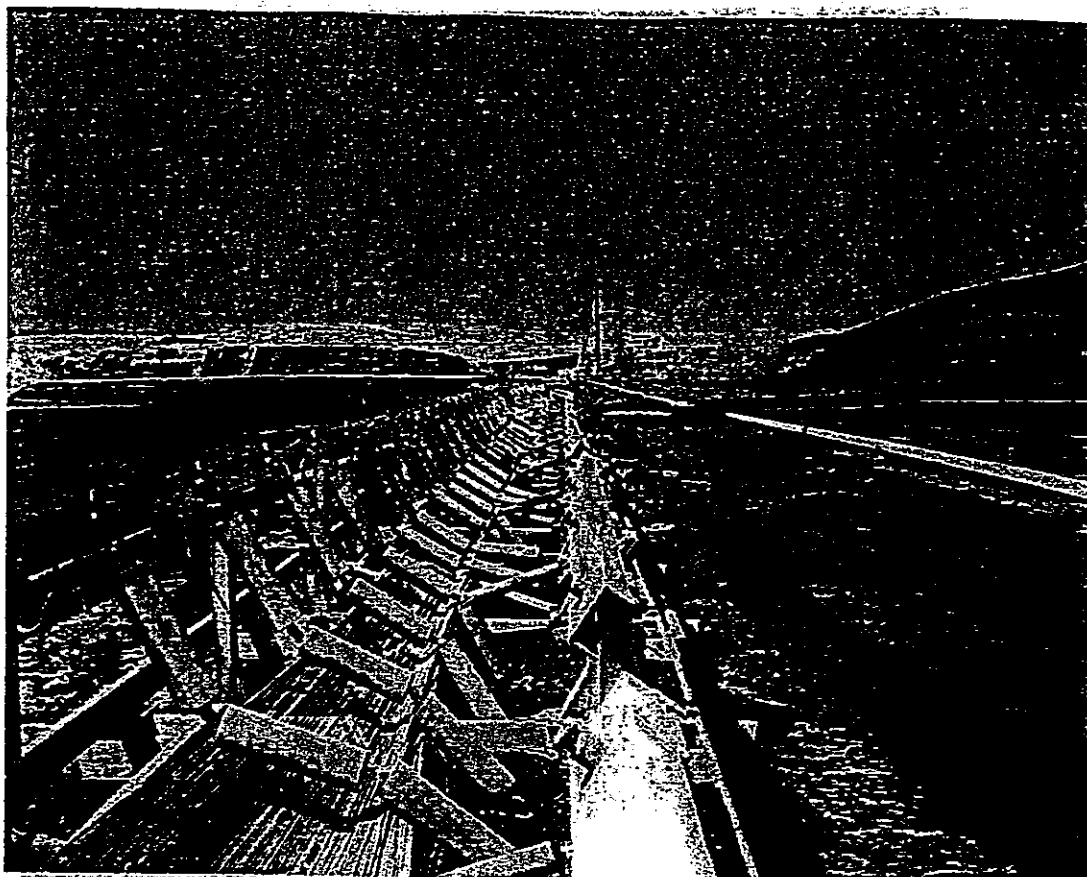
Description: View of the M620 conveyor, profile and batter, repair work was underway prior to our arrival on site. The feed belt had been removed and topside idlers already released. This picture was taken from the conveyor unit 157 with the damaged idler bearing.

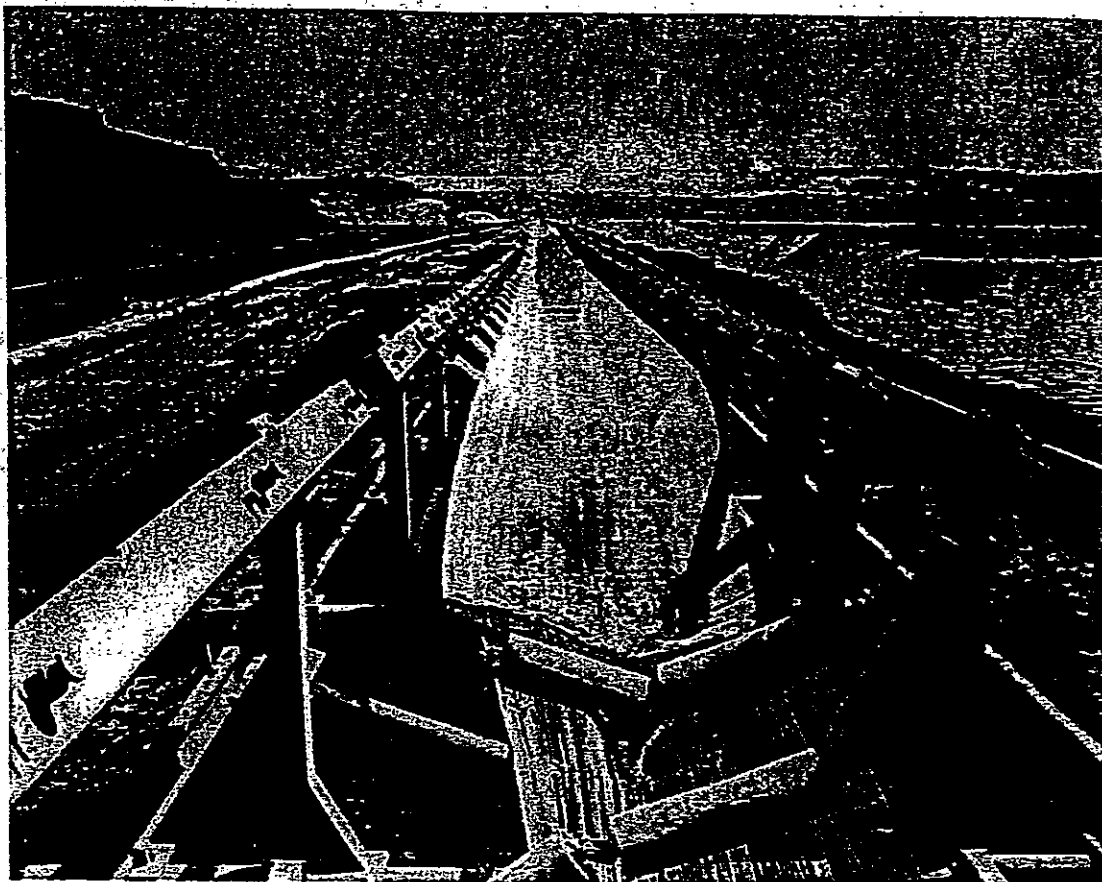
Description: View of the M620 conveyor, looking towards the tailend of the system. Note where the damaged belts finish, the third idler on the right hand side of the image is the damaged one.

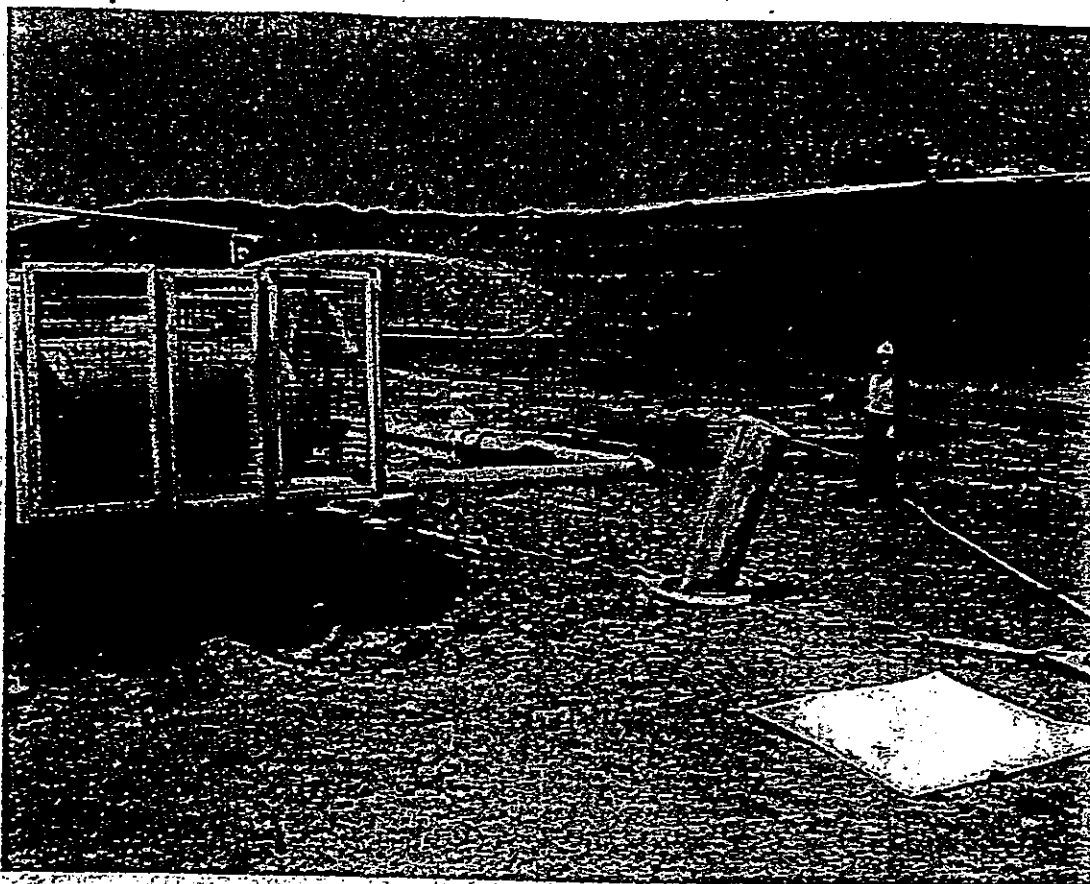
Description: The initial fire was also on the topside of the M620 conveyor when crews arrived. It was burning between the conveyor and the topside fire service pipe work, as pointed out by

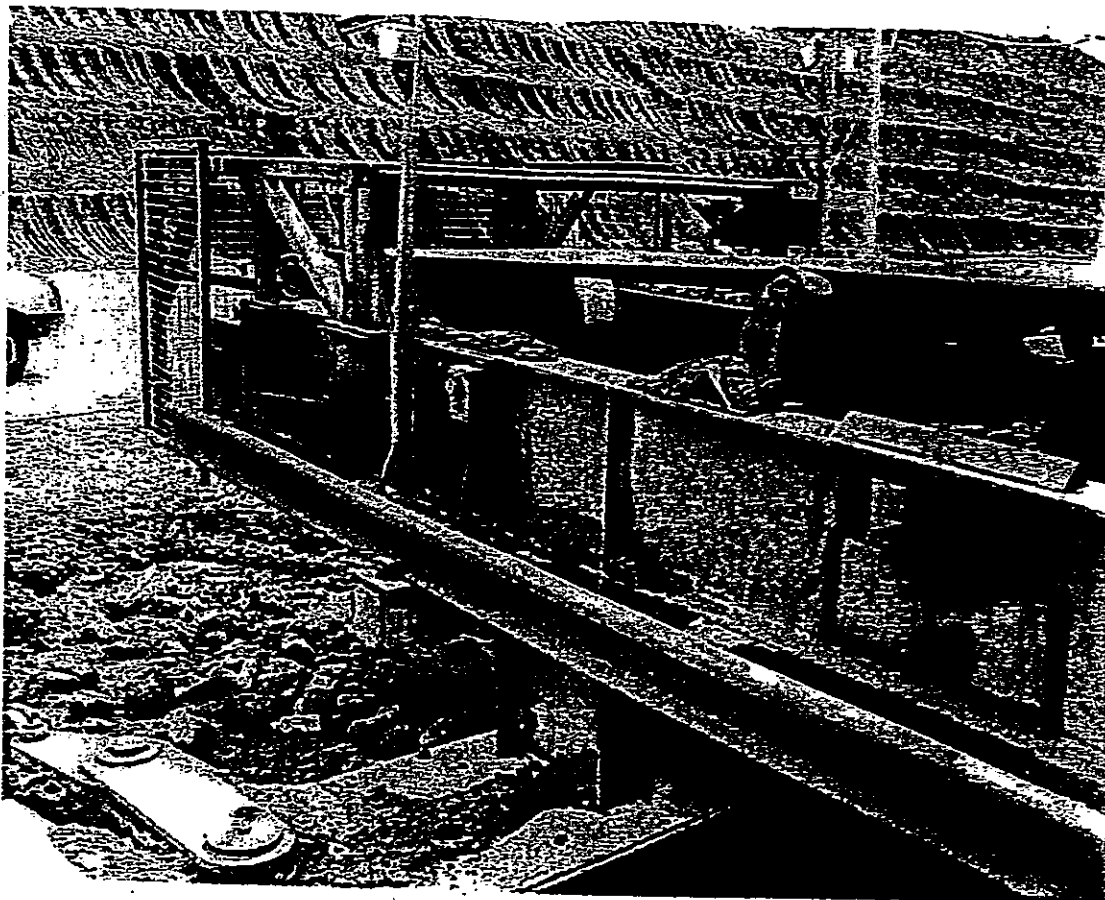
Description: Tailbox of conveyor M620, note the coal build up on the unit. The fire was in the vicinity of this unit when the first crews arrived.

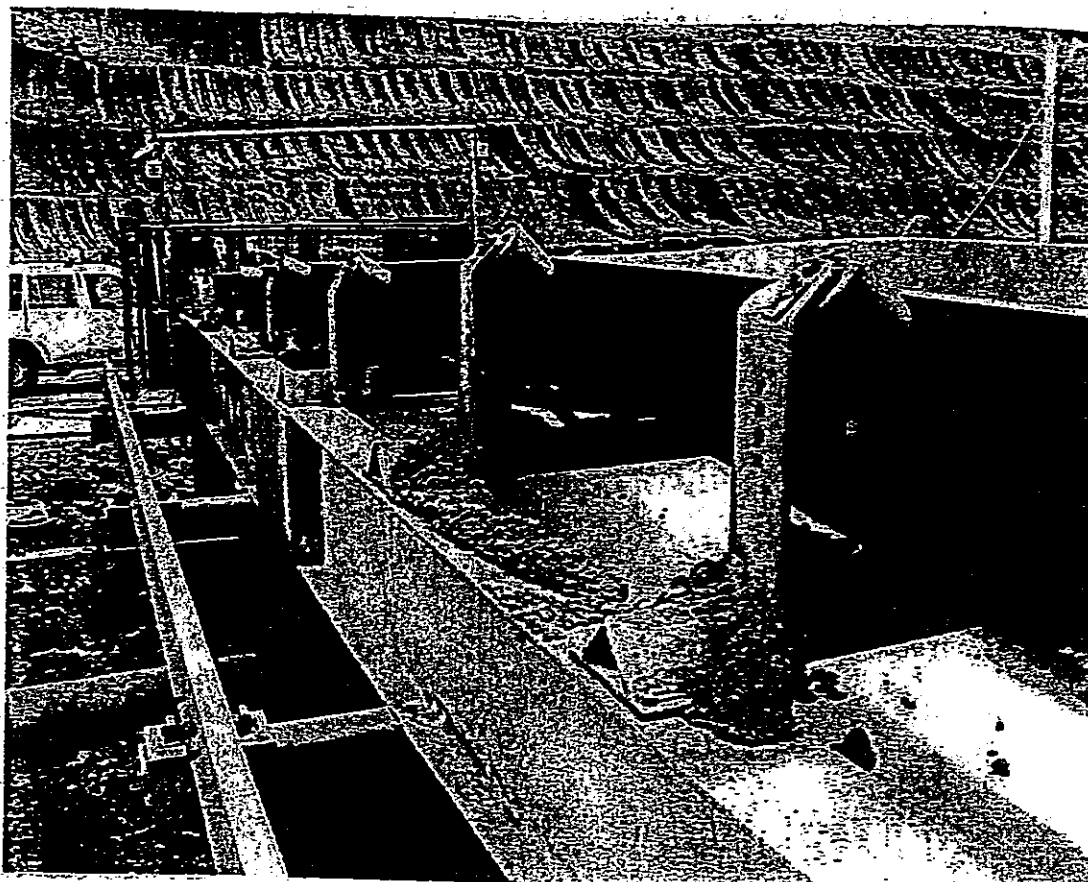
Description: Tailbox of conveyer M620, note the coal build up on the unit.

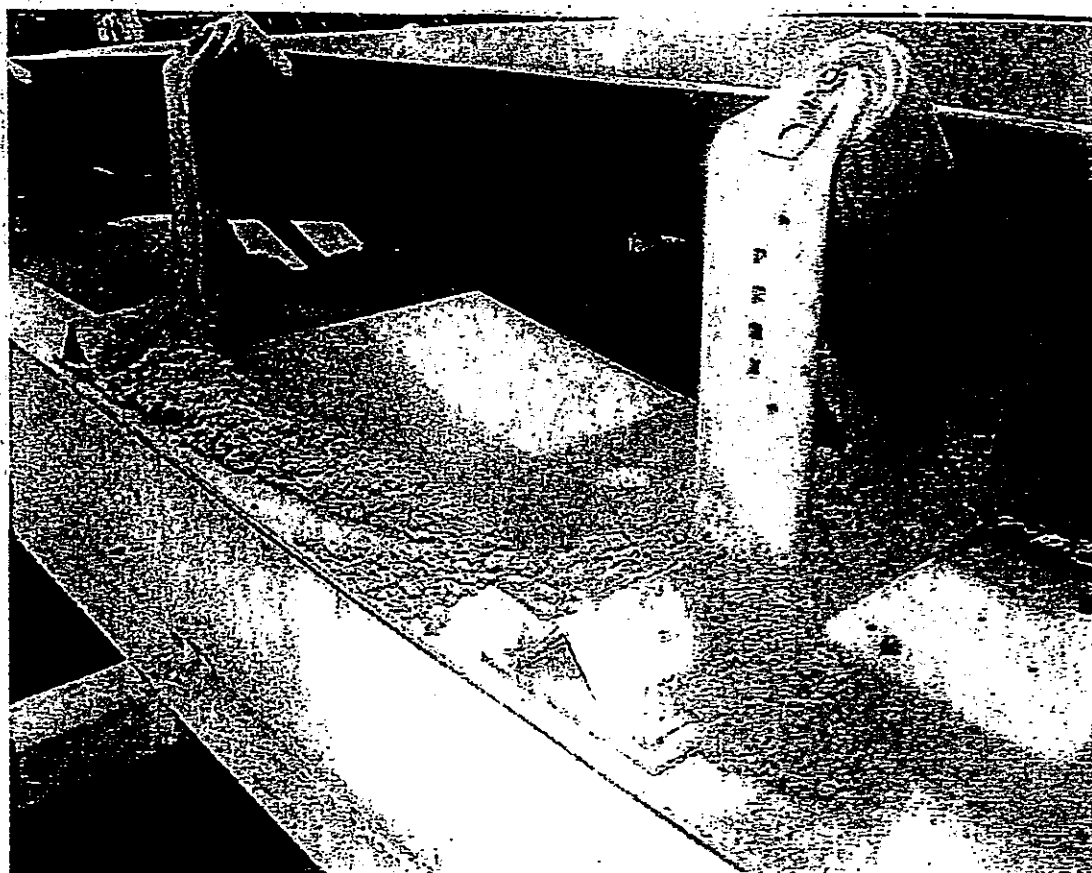
Description: Tailbox of conveyor M620, note the coal build up on the unit.

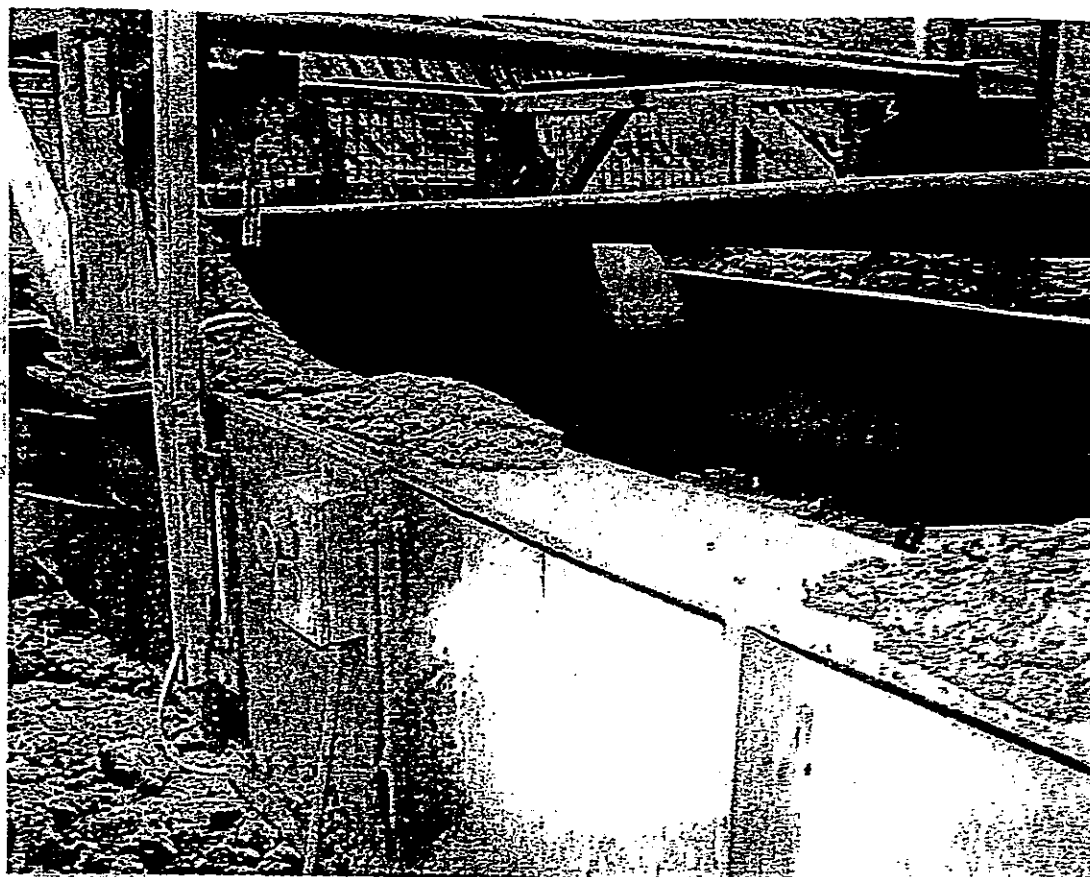
Description: Tailbox of conveyor M620, note the coal build up on the unit.

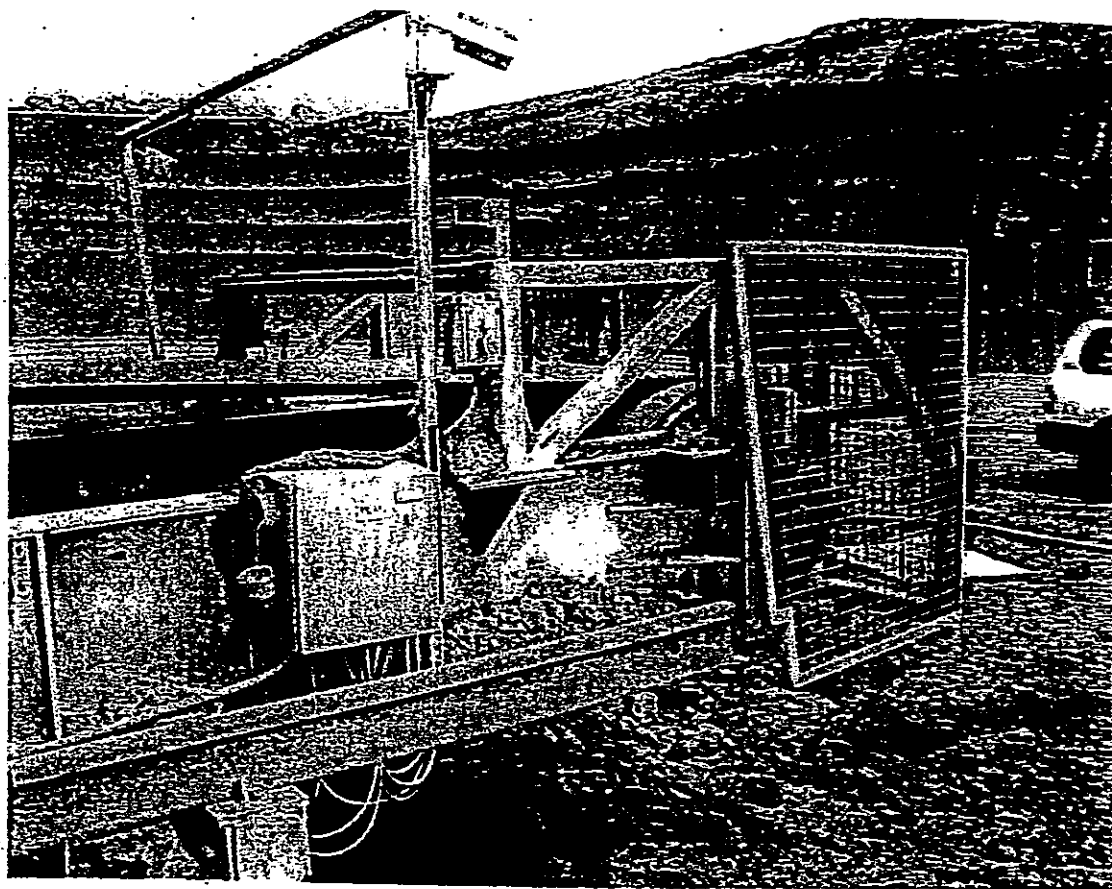
Description: Tailbox of conveyor M620, note the coal build up on the unit.

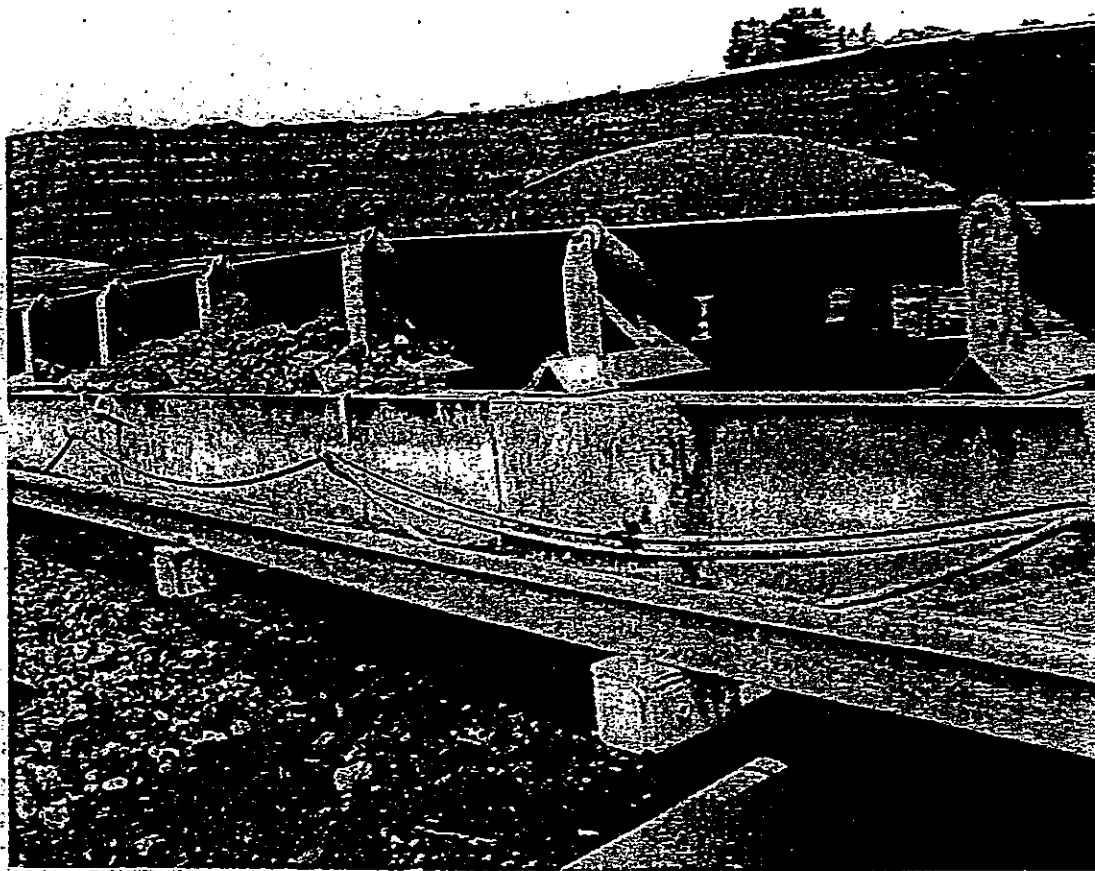
Description: Tailbox of conveyor M620, note the coal build up on the unit. The fire was in the vicinity of this unit when the first crews arrived.

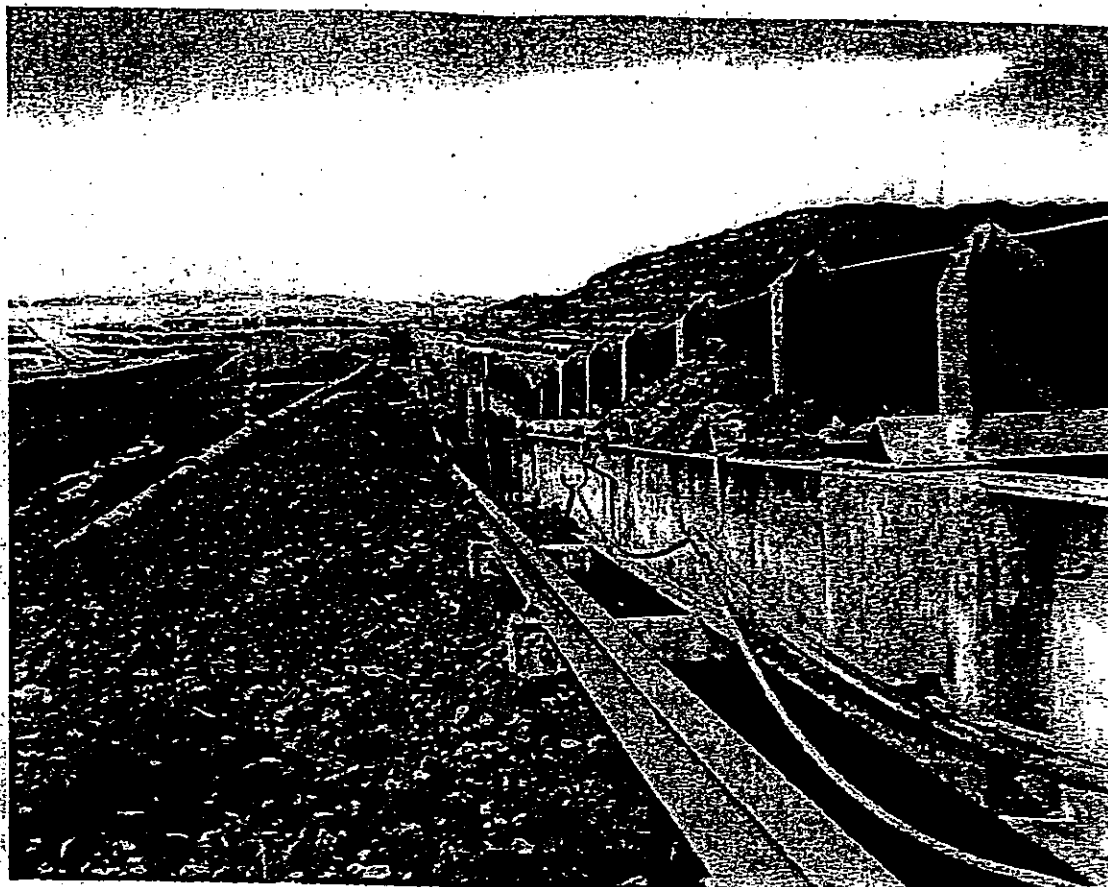
Description: Tailbox of M620 looking towards the head.(south) There was loose coal on fire on this side of the conveyor when crews arrived. Once again note the build up of coal debris on the plant.
