**Country Fire Authority
Fire Investigation Report
Fire & Incident Reporting System (FIRS) Number: 1074299**

**FINAL REPORT
MORWELL OPEN CUT MINE FIRE,
MORWELL, VICTORIA, 3840.**

12/10/2006

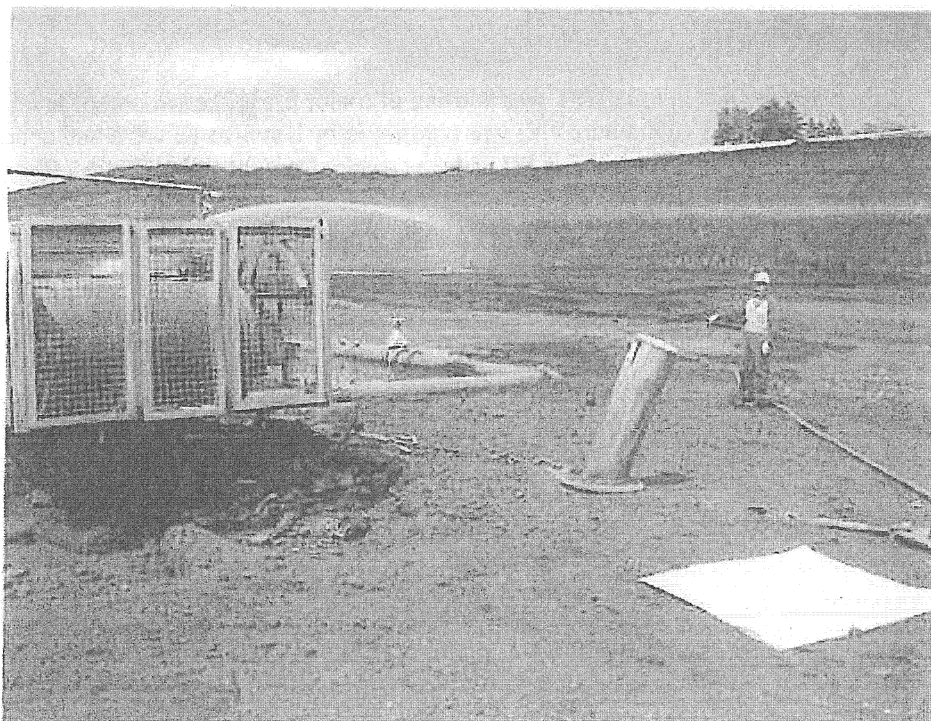
The first workers who attended the spot fire on M620 tailend, stated the fire was burning in close proximity to the M620 tailbox, and was between the conveyor and the topside and bottomside fire service pipelines. An anchor post for the tailbox was on fire and there was fire burning in loose coal on the bottomside of the conveyor. These workers recalled there were a lot of embers moving around and the wind was quite strong. They stated the fire moved away from them towards the head of M620 as well as progressing down to M720 also. When they arrived at the tailend they did not recall seeing any other fires on the formation. The photo on page 14 shows mine worker [REDACTED] indicating where the fire was burning between the fire service main and the M620 conveyor tailbox.

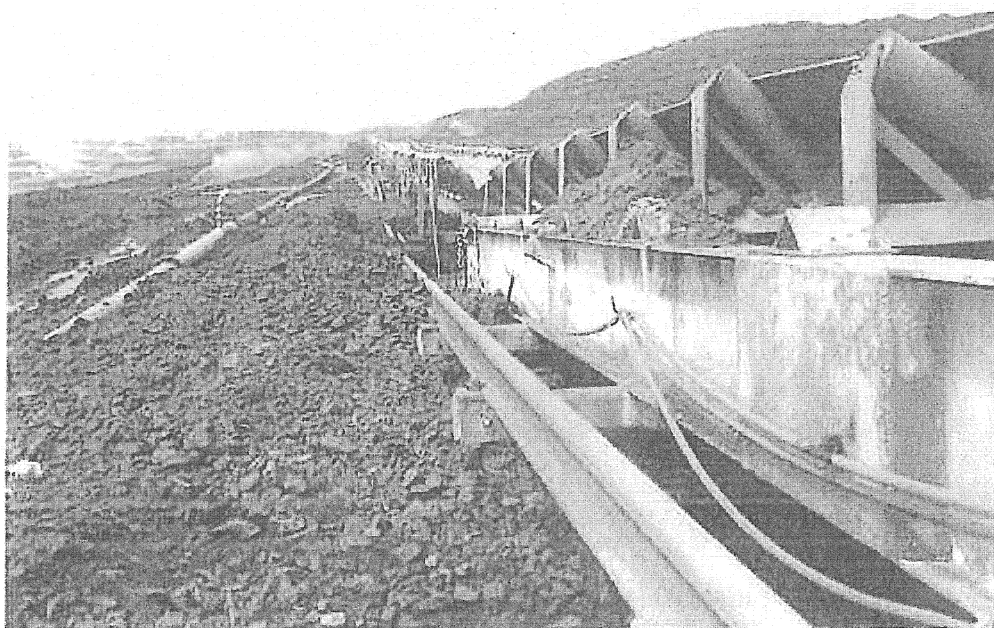
Eye witness reports from multiple sources observed the fire only at the tail end of the M620 level. The first workers to the tail end described the fire as being in the vicinity of the M620 conveyor tailbox. The fire was between the bottomside of the M620 conveyor and the bottom side fire service, and also between M620 and the topside fire service. There was also fire around the M620 tailbox. The most probable area of origin was at the tailend of M620 in close vicinity to the conveyor tailbox.

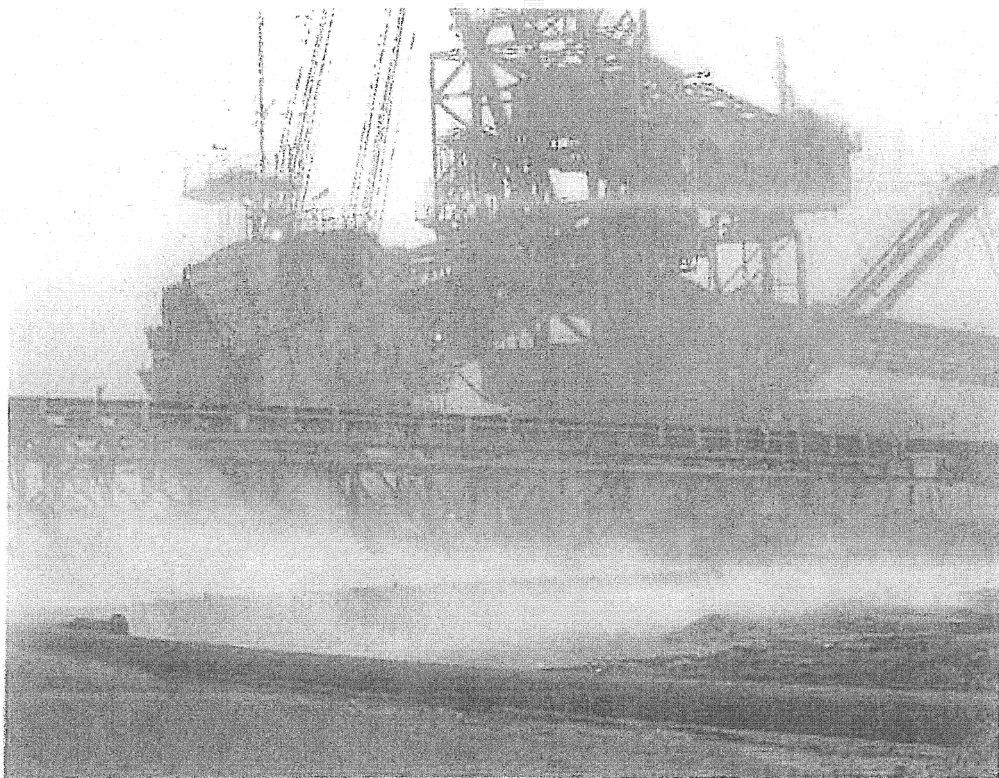
Photo taken by [REDACTED] while approaching the fire from the headend at 1229 hours. DR 11 and S94 both in view.

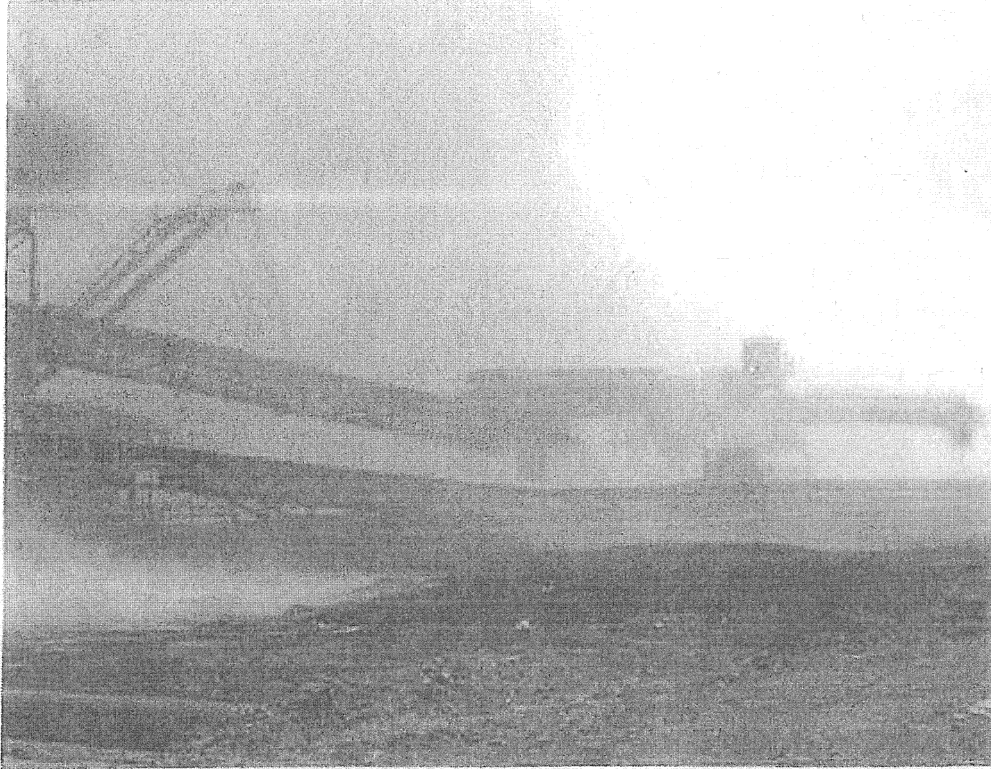
Photo taken by [REDACTED] while approaching the fire from the headend at 1229 hours.

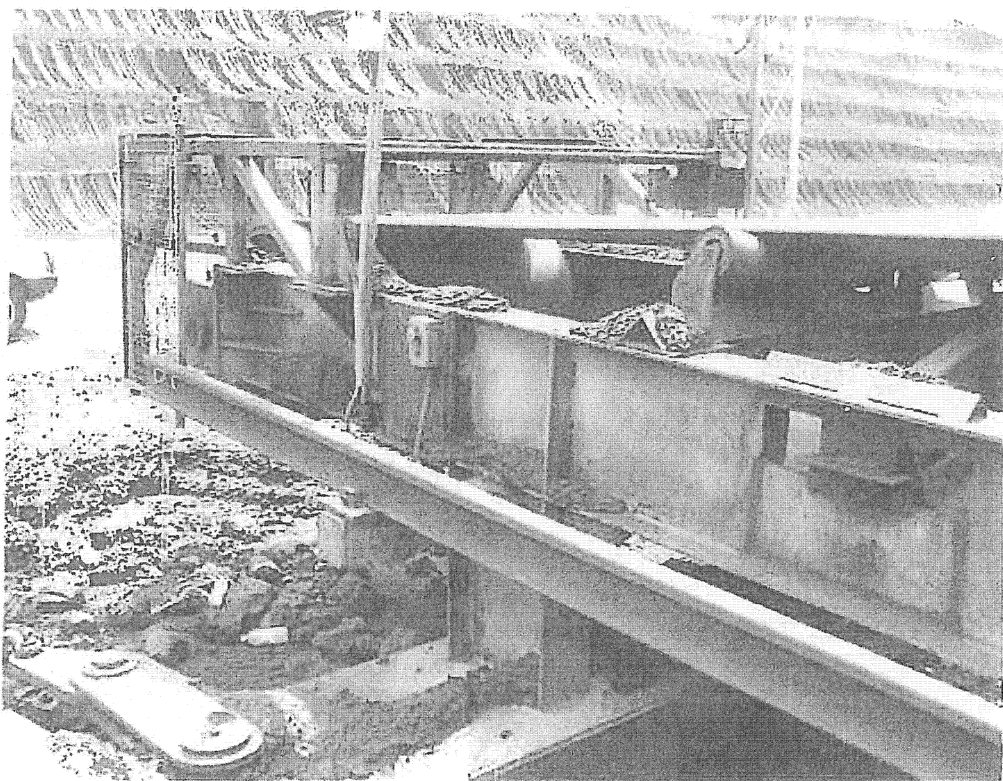
Description: The initial fire was also on the topside of the M620 conveyor when crews arrived. It was burning between the conveyor and the topside fire service pipe work, as pointed out by [REDACTED]

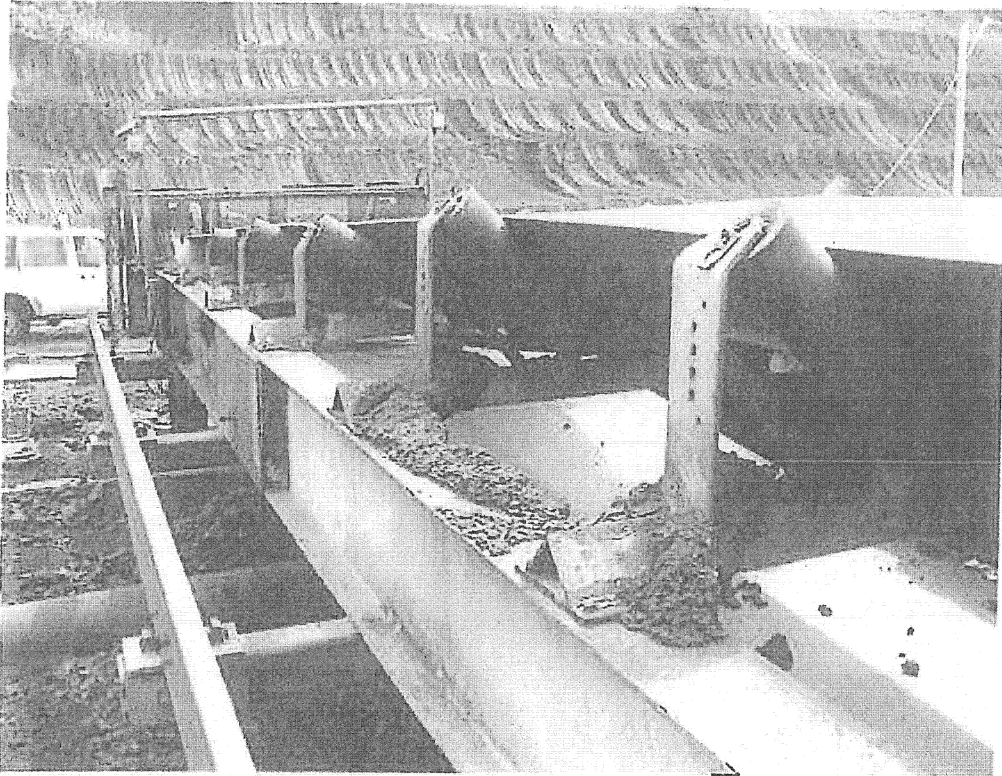
Description: Tailbox of conveyor M620, note the coal build up on the unit. The fire was in the vicinity of this unit when the first crews arrived.

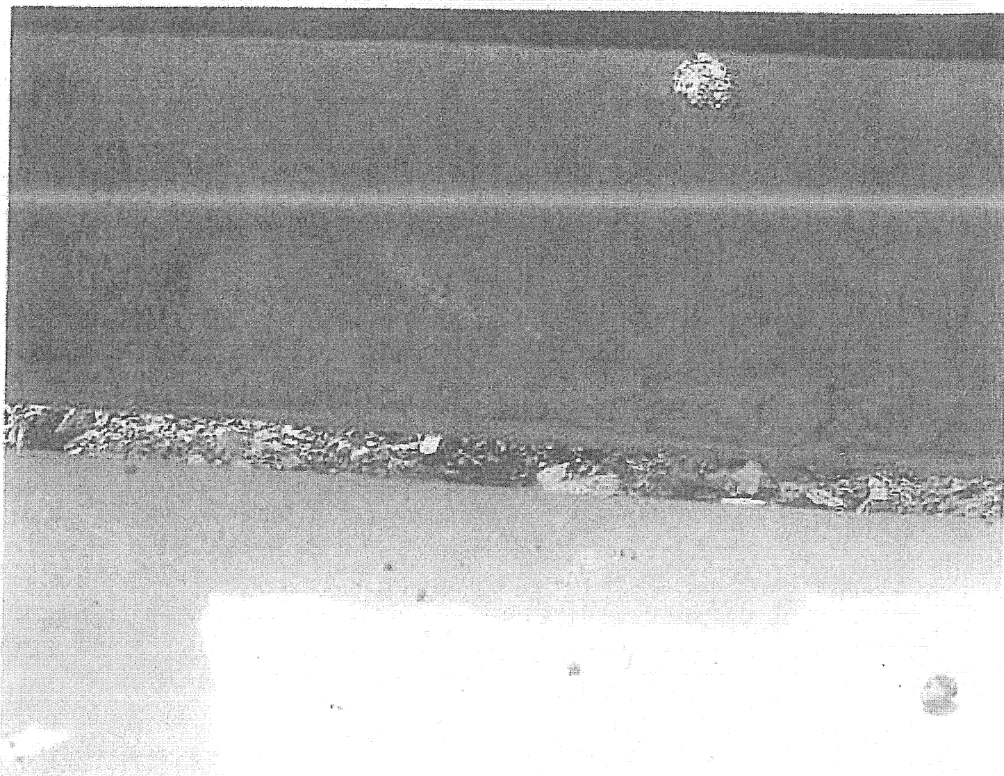
Description: Tailbox of conveyer M620, note the coal build up on the unit.

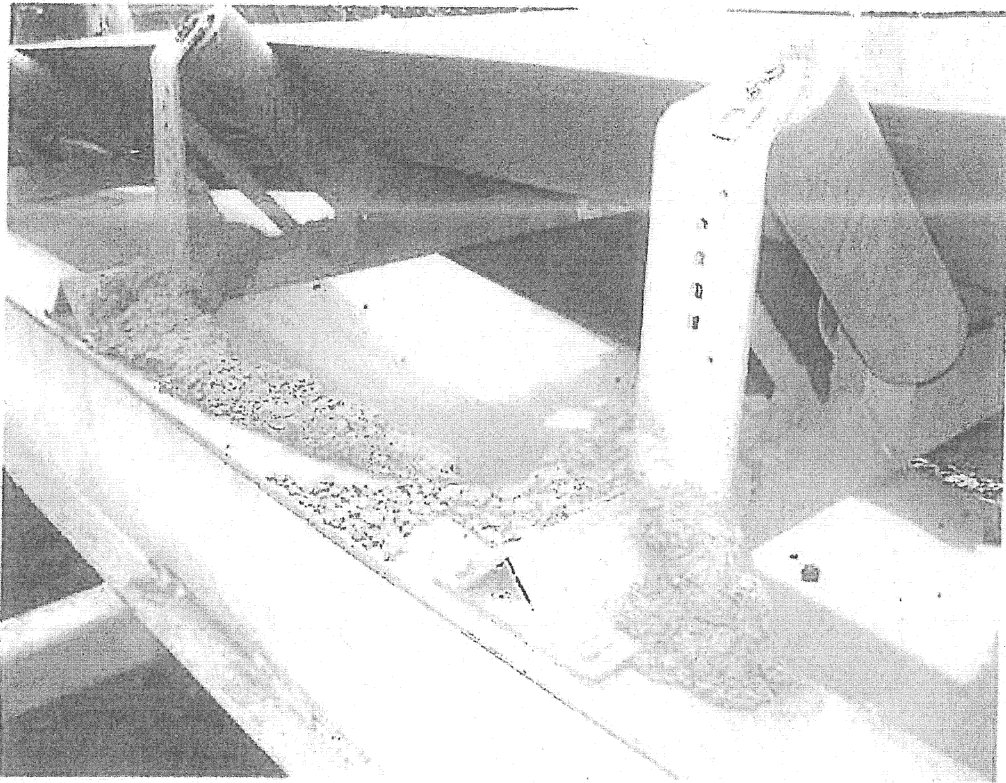
Description: Tailbox of conveyor M620, note the coal build up on the unit.

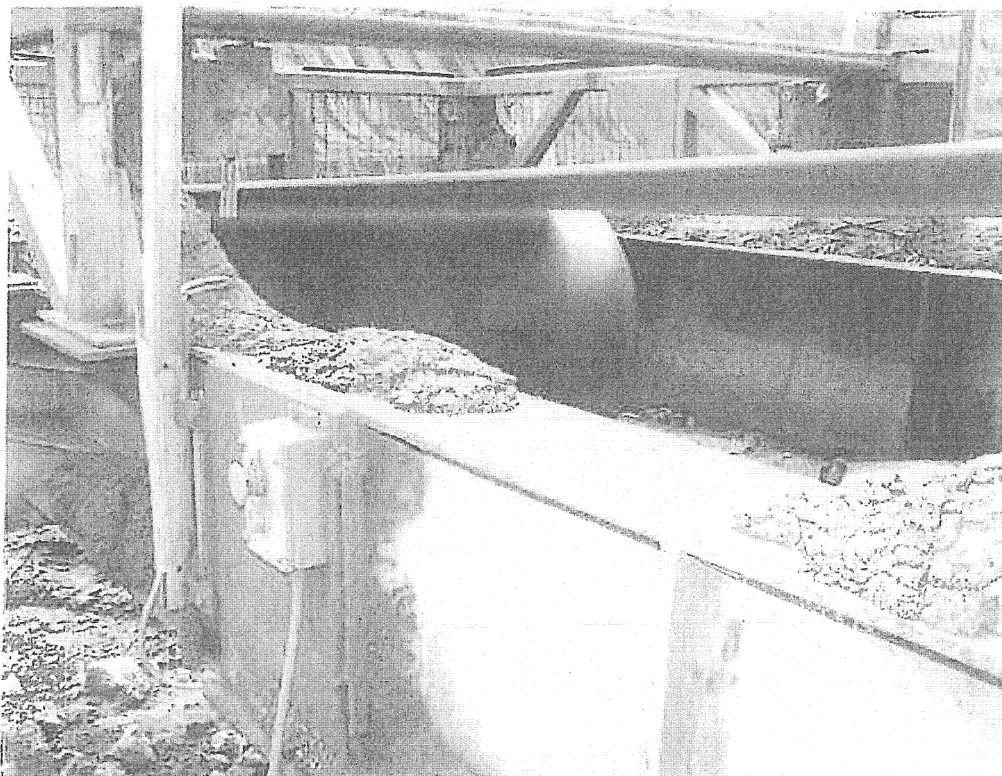
Type: Digital
Direction: North-East
Taken By: Fire Officer [REDACTED]
Description: Tailbox of conveyor M620, note the coal build up on the unit.

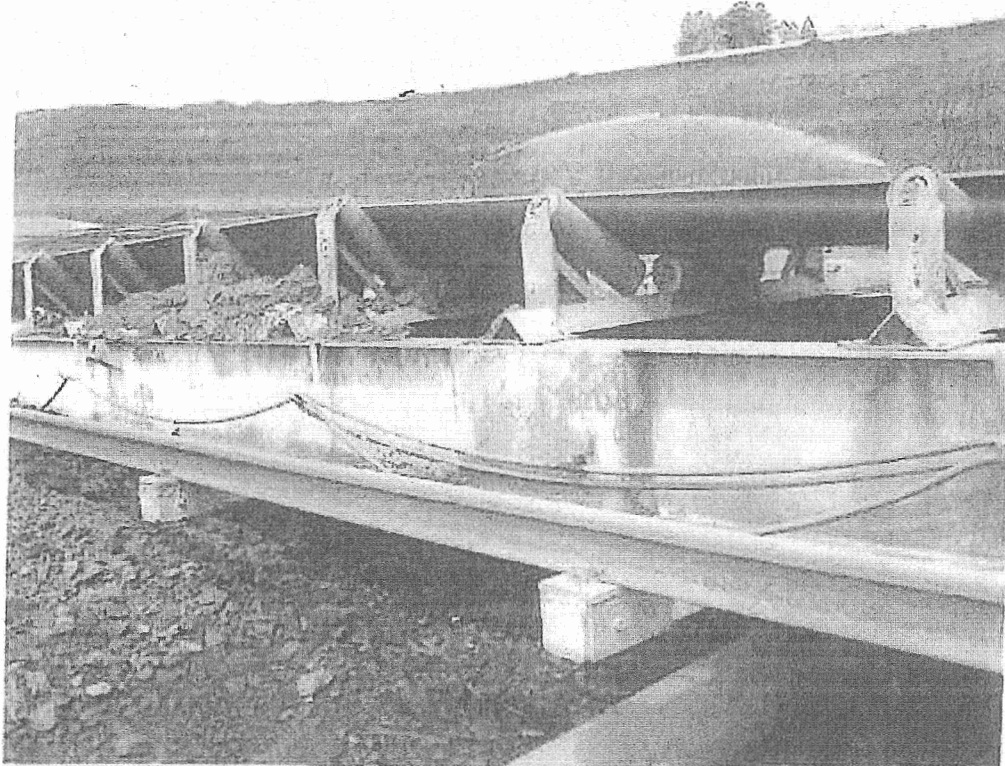
Type: Digital
Direction: North-West
Taken By: Fire Officer [REDACTED]
Description: Tailbox of conveyor M620, note the coal build up on the unit.
