International Power Hazelwood

**October 2006 Mine Fire
Investigation
Incident Investigation Report**

January 2007

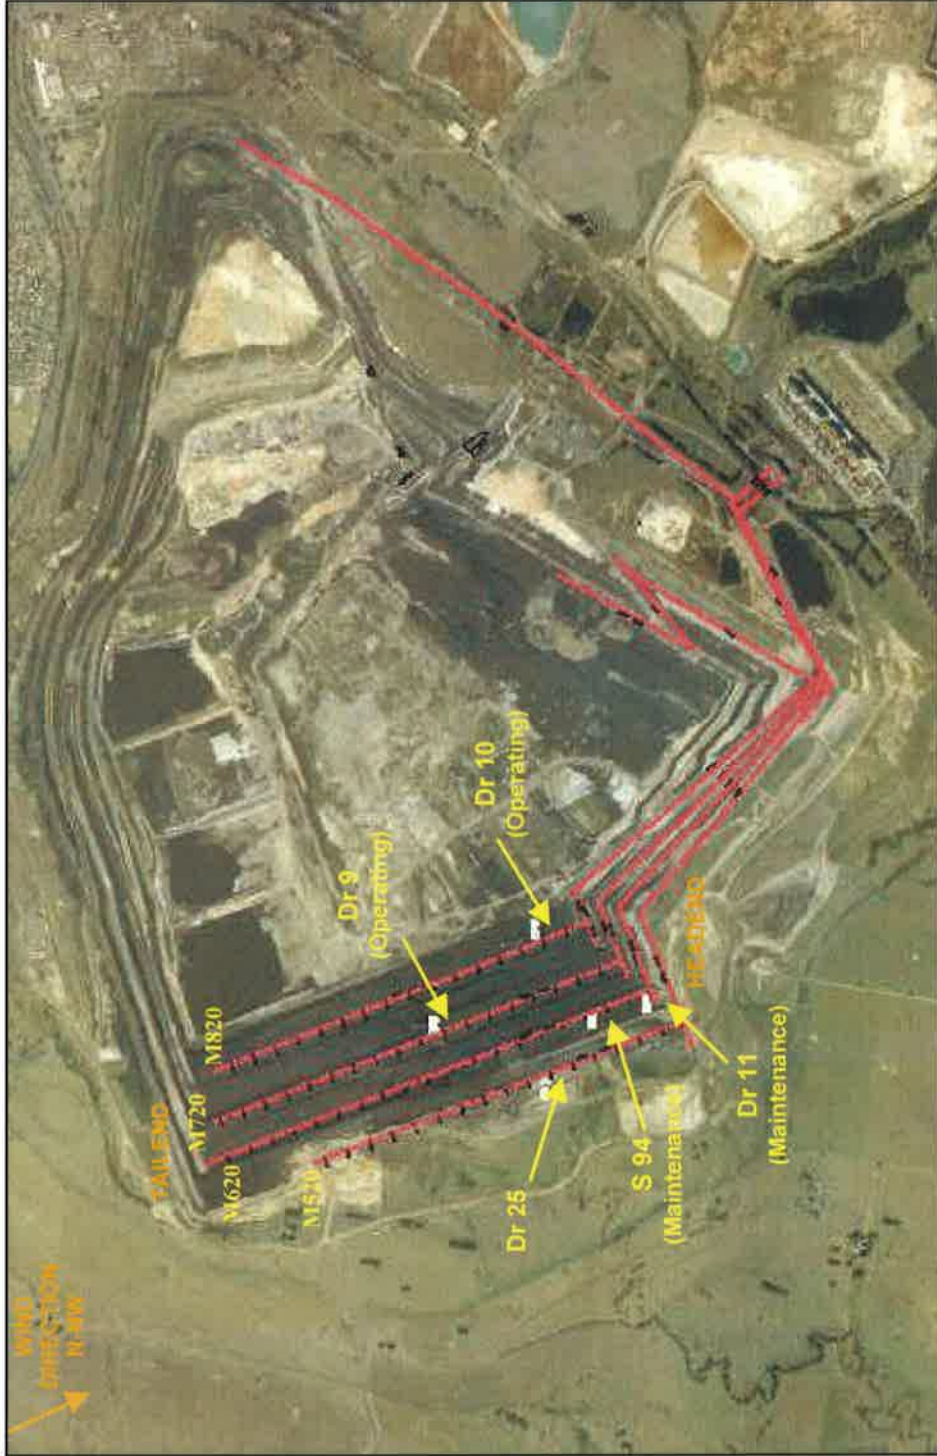
Figure 5 – Location of Plant at time of fire (12/10/06 – 10:45am)

Refer to Figure 5 in Appendix B for an overview of the Plant situated on the coal levels on the 12th October '06.
