Hazelwood Mine Fire Inquiry

Morwell Open Cut Fire Report

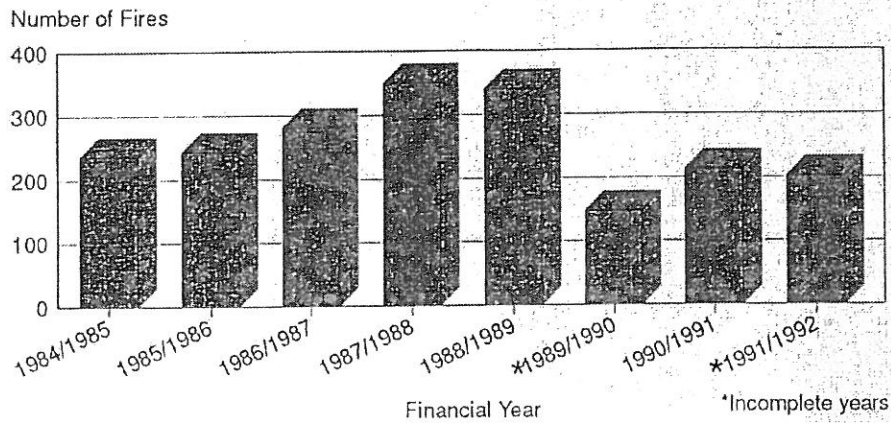
Figure 25

Figures 25 and 26 opposite illustrate these trends.

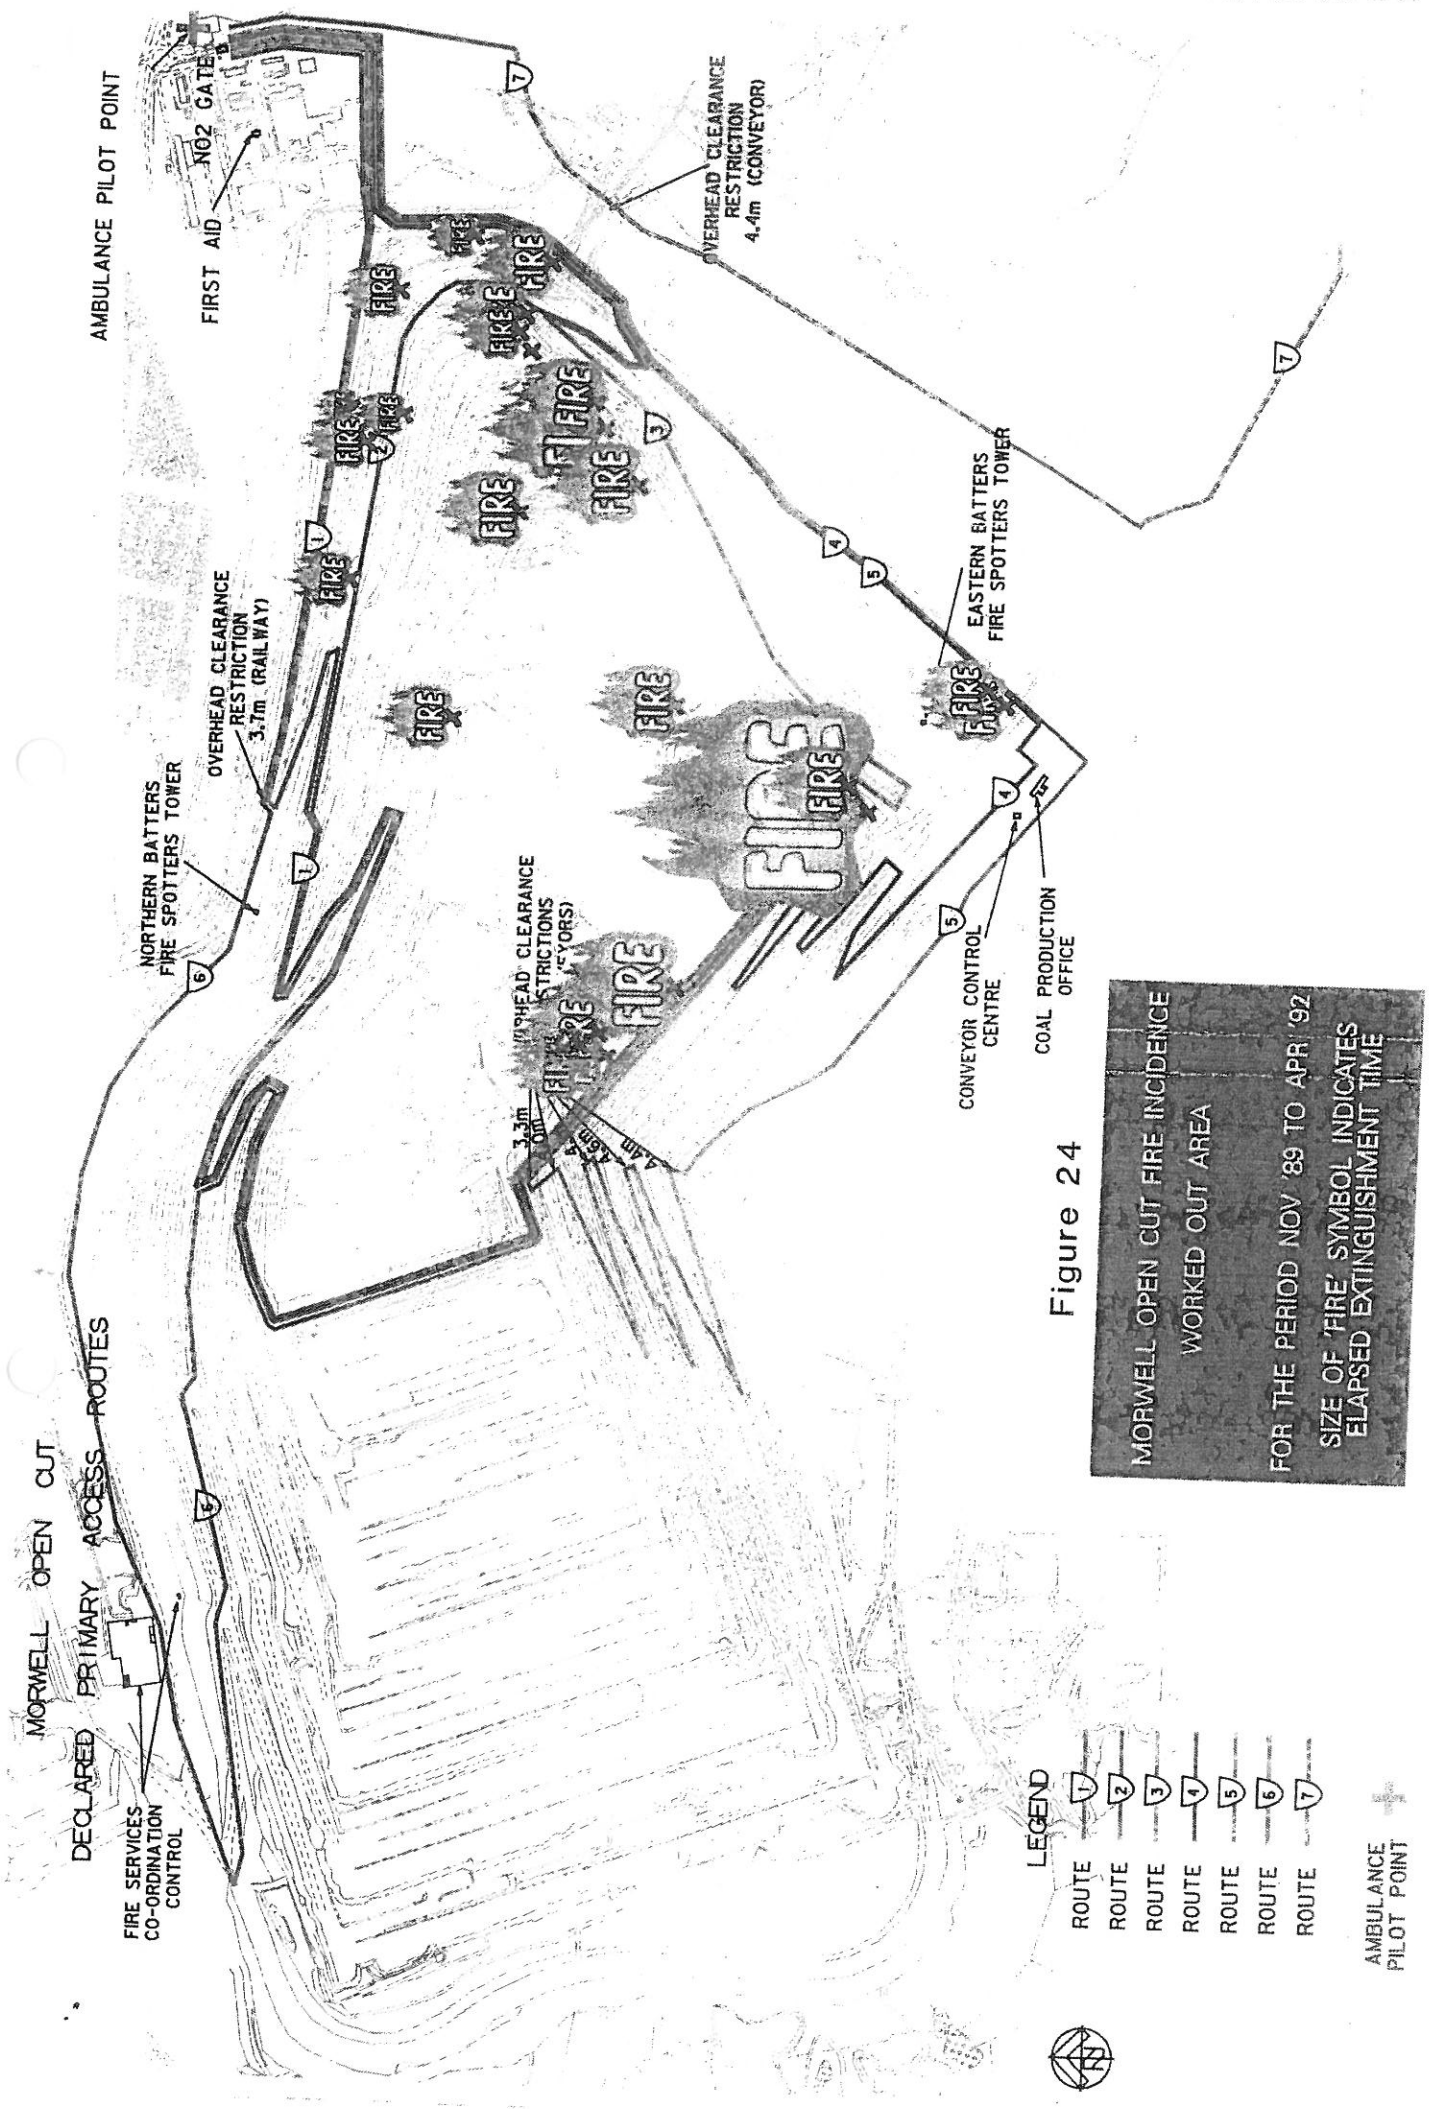
- (vi) the fires are most frequently located in the dirty coal dump and the coal production operation in the North East corner of the pit. Figure 24 overleaf shows locations of all fires and also indicates their relative severity.

MORWELL OPEN CUT FIRE INCIDENCE
 WORKED OUT AREA
 FOR THE PERIOD NOV '89 TO APR '92
 SIZE OF 'FIRE' SYMBOL INDICATES
 ELAPSED EXTINGUISHMENT TIME

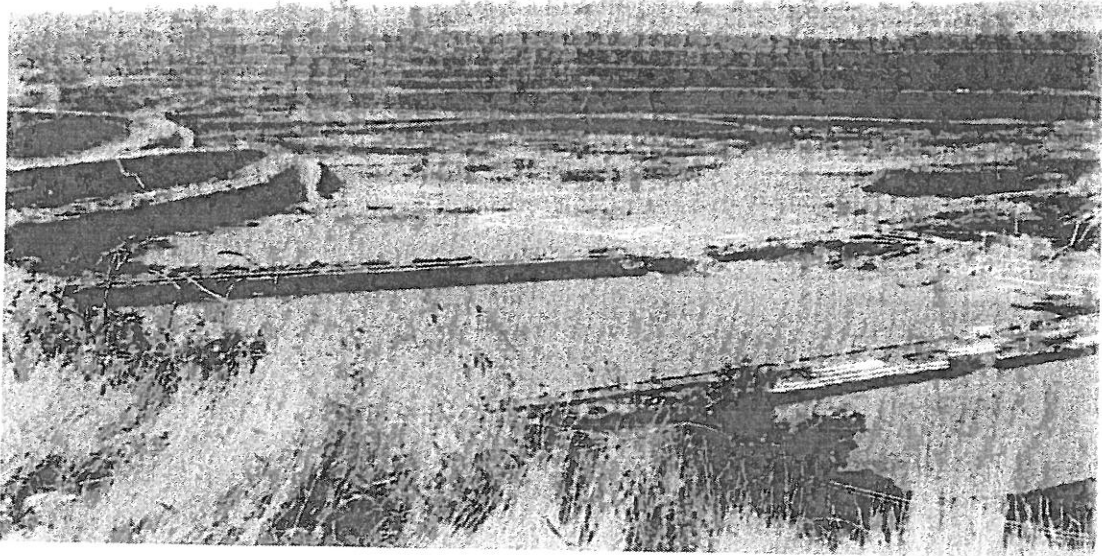
The worked-out areas and batters considered in this study cover the mine area extending eastwards from No. 4 groyne and including the north-eastern and eastern batters. These areas are shown pictorially in figures 1 to 6 inclusive.

FIGURE 1: General view of the worked-out area of Morwell Open Cut (M.O.C.), looking at the eastern batters over No. 4 groyne in the foreground.

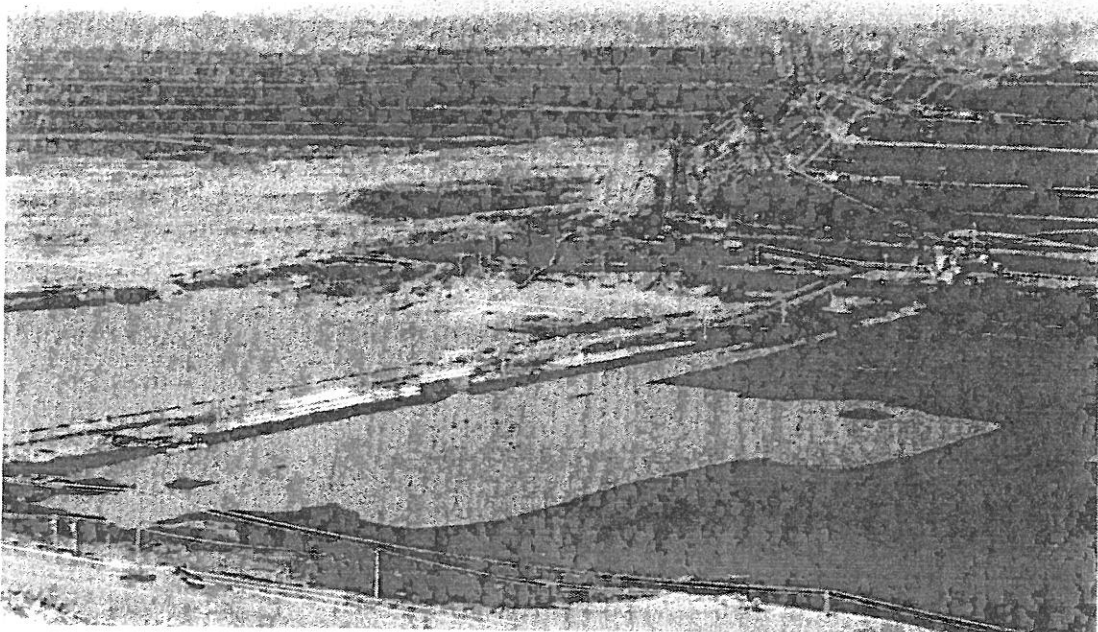
FIGURE 2: General view of the right hand portion of the worked-out area, looking east along the southern batters and the "200 series" conveyors. No. 4 groyne and the start of the present working area of the mine are in the lower half of the picture.

- . All benches are to be clay covered.
- . All berms are to be eliminated by trimming or by filling with clay such as to shed fretted coal provided that batter stability calculations indicate that neither of these options will cause batter failure.
- . Fire break zones extending down to full depth of batter should be established such that the length of exposed coal in any one batter is not greater than 500 m. These zones can be in the form of metallised vehicle access ramps, a minimum of 8 m wide or in the form of a 20 m width clay covering.
- . Alternatively, fixed spray breaks may be used, but it should be noted that water for these sprays has not been included under the maximum demand conditions, and this protection should not be considered as reliable as clay fire breaks or vehicle access ramps.
- . Figure 2 shows an example of this protection.

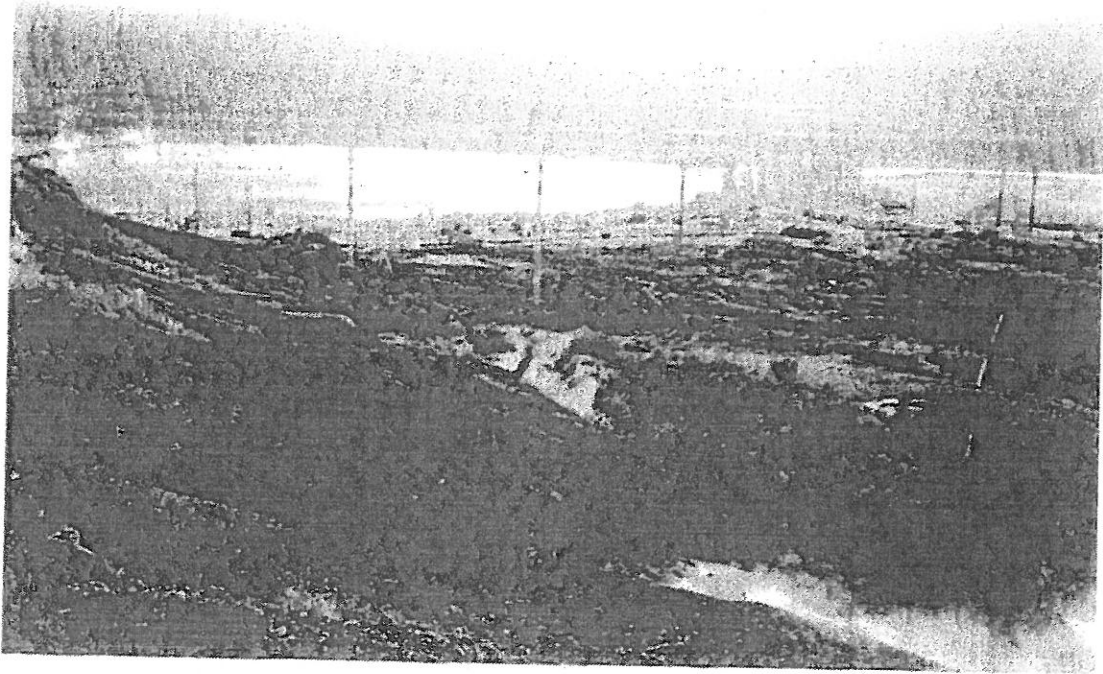
FIGURE 5: Looking north across the worked-out area along No. 3 groyne and across the dirty water reservoir.

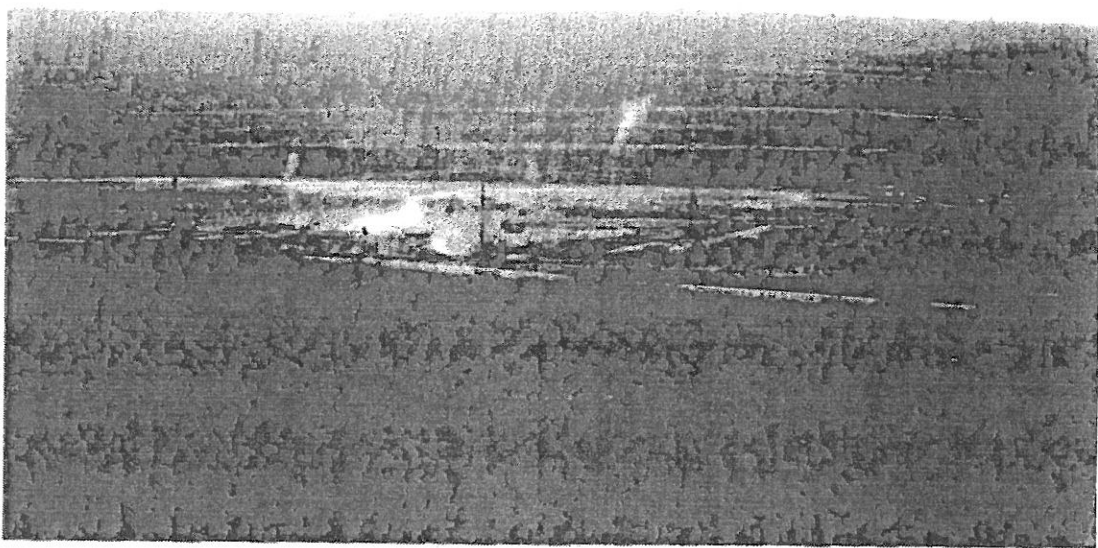
FIGURE 6: Looking north-east to the northern batters across the worked-out area (from same location as for Figure 5 above). Note foliage, vehicular traffic and the 1050 mm diameter dirty water main in mid-picture.

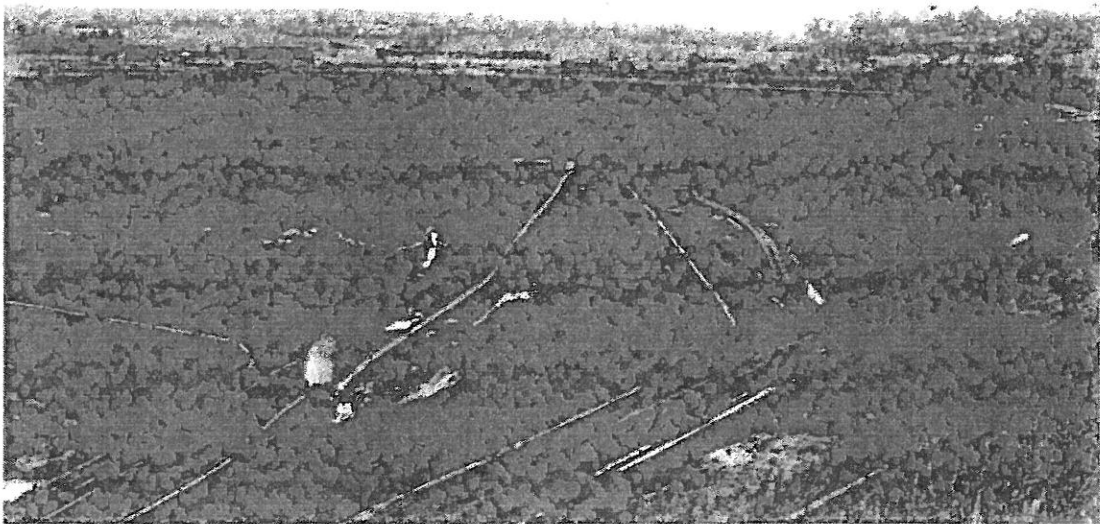
Loss of power to pumping stations or 20 series conveyor, through damage to feeders 4, 5, 15 and 16, is an evident exposure as are electrical cubicles, transformers and associated power supply cables linked to bores located in the worked-out areas.

FIGURE 8: Looking north-north-east down onto "20 series" conveyor, showing their power feed lines (feeders 5, 16 and 4).

- iv. Relocate power feeders 15 and 16. We understand a relocation to near the 200 series conveyors is already proposed.
- v. Commence a pole replacement programme for the 4, 5 and 16 power feeders, replacing timber poles with concrete ones.

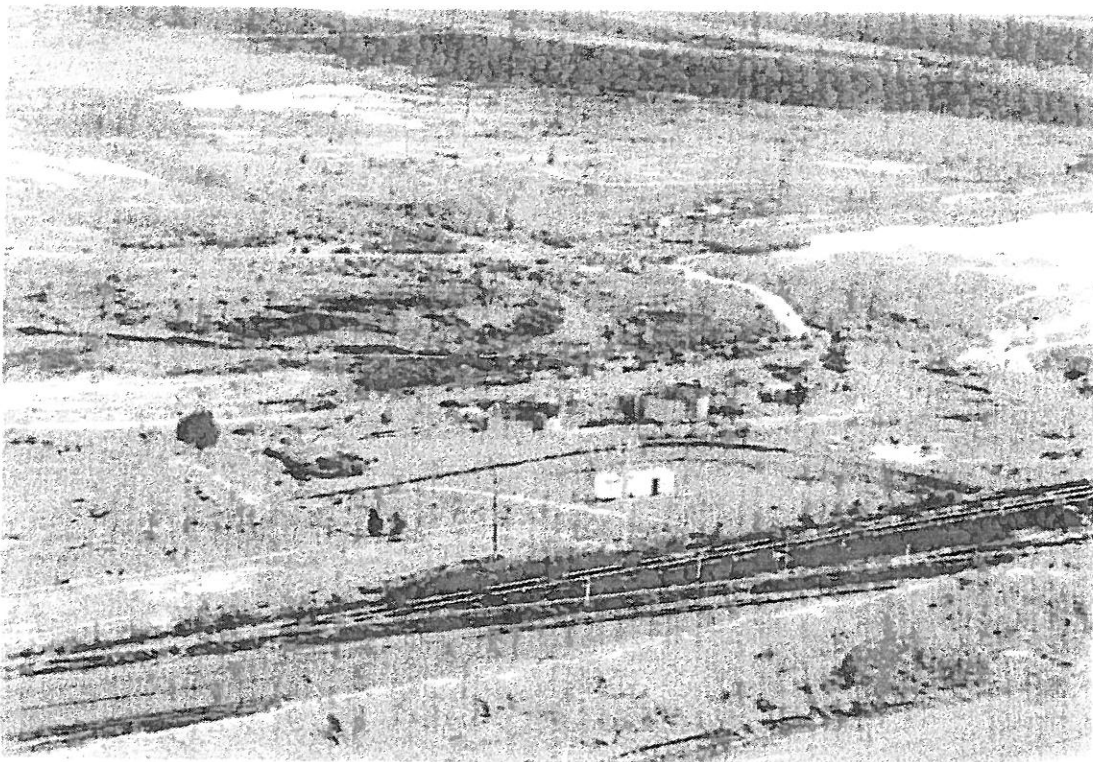
FIGURE 14: Two 100,000 gallon steel tanks, previously used for clean water storage, located on level 2 at the eastern end of the worked-out area. Viewed across "20 series" conveyor in the foreground.

- i. Undertake a detailed engineering survey of the fire water system, and include assessment of the North-East corner coal production area in this.
- ii. Update reticulation drawing and hydraulic analysis using computer modelling.
- iii. Use both old clean water tanks for fire water storage and fit a tanker filling point to these (refer Figure 14).

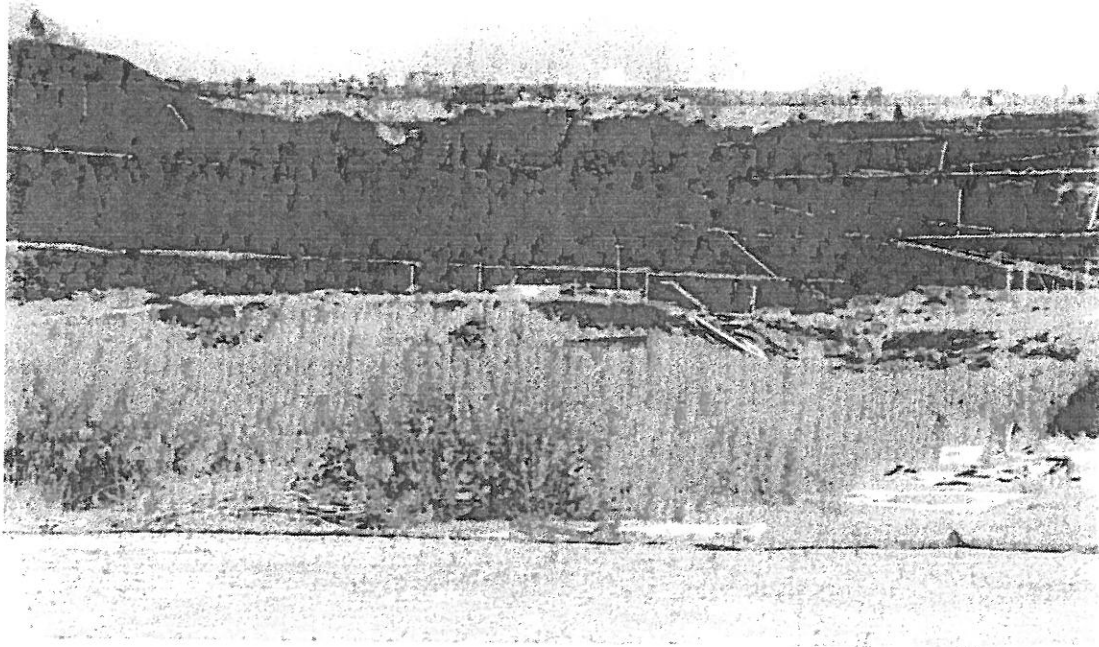
FIGURE 15: Fire detection capability indicated by view from eastern batters fire tower (extreme upper left) and control centre. Top of the two old clean water tanks (reference Figure 14) visible in mid-picture.

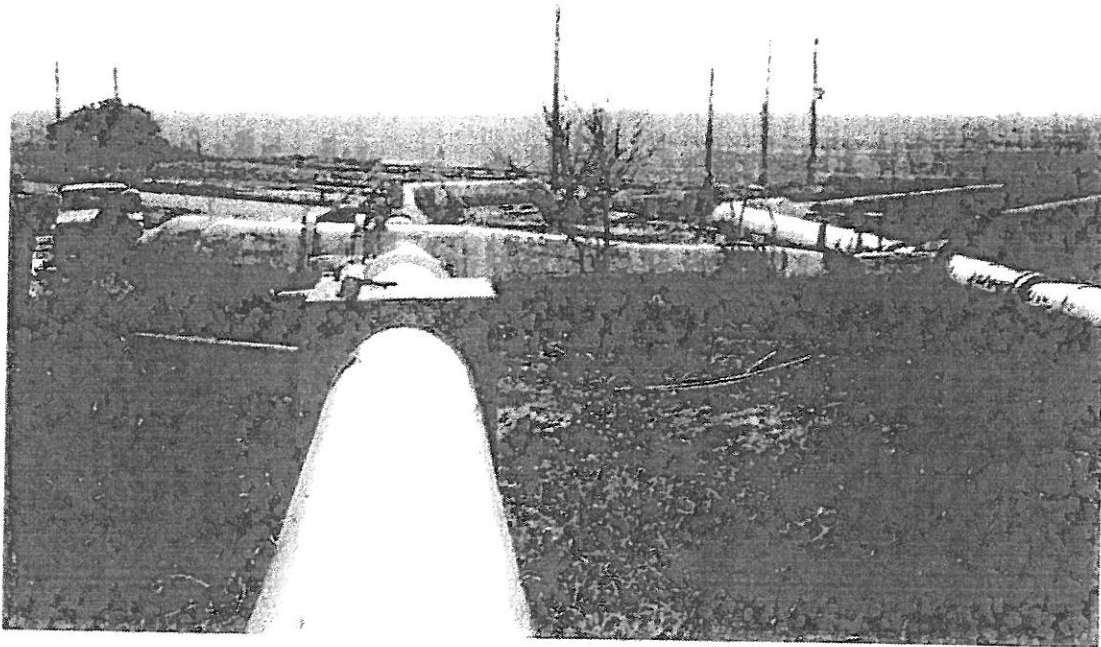
FIGURE 17: "H Section" located on grass level above the mine for valve control and mixing of clean and dirty water. Looking along the clean water line towards the mine, dirty water main on the right.

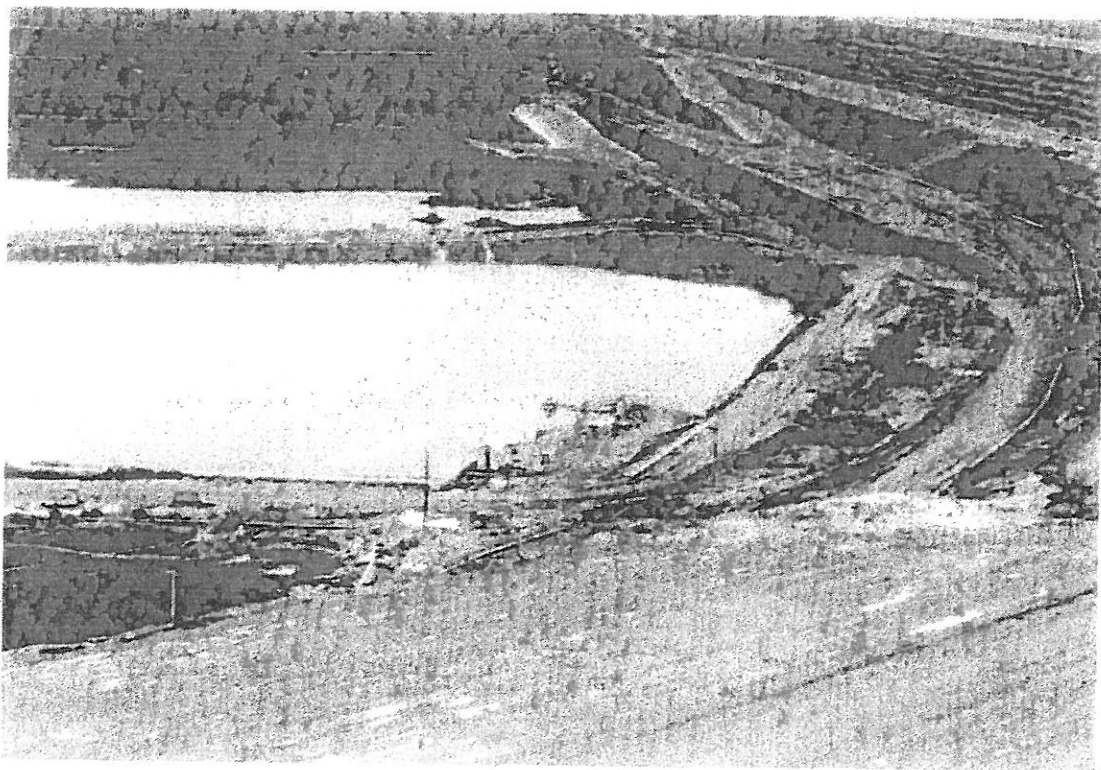
FIGURE 18: View from northern batters down onto dirty water reservoir and dirty water pumping station in mid-picture. Note clay and gravel on the bench/roadway in the foreground.

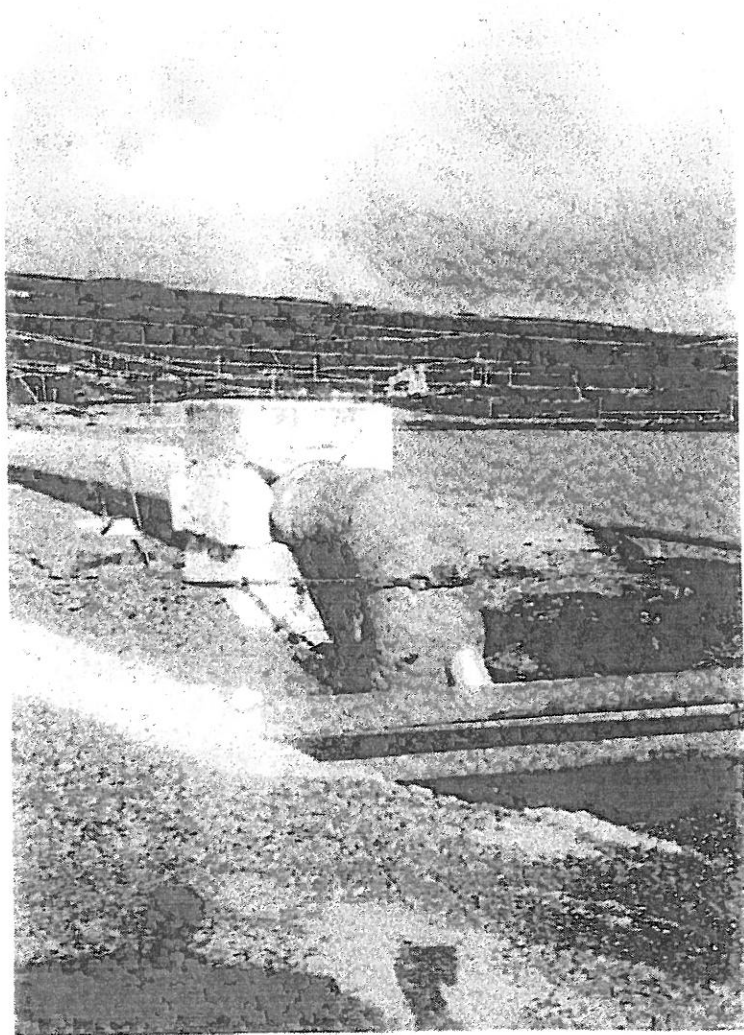
FIGURE 20: Clean water pumping station (looking towards southern pivot); three of five pumps out for repair.

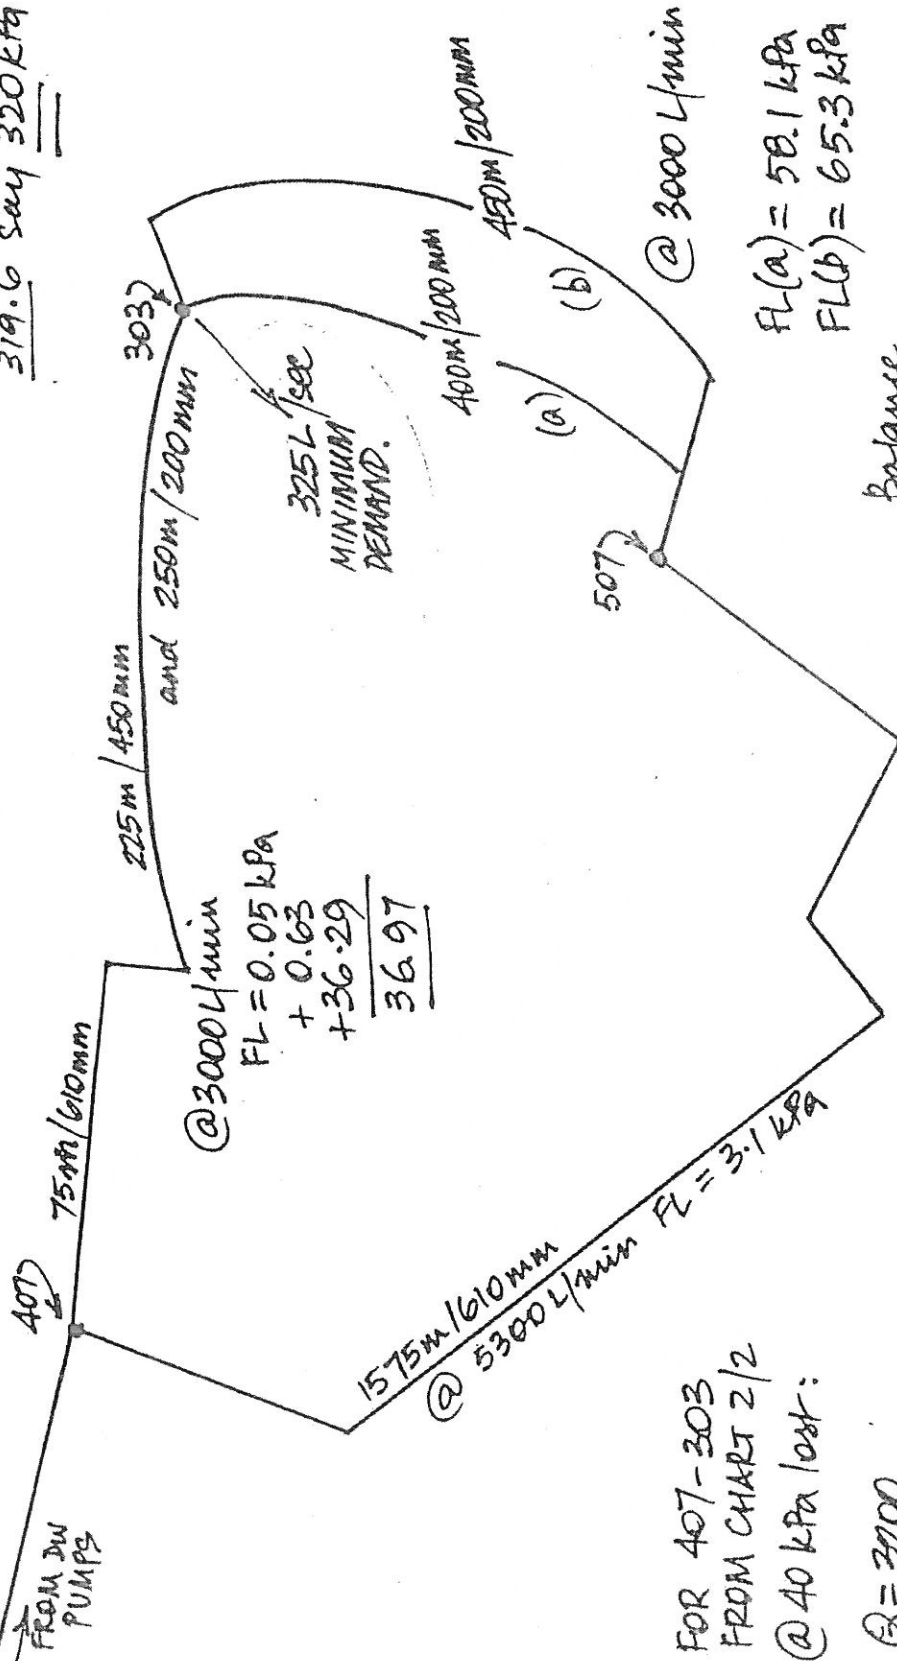
TOTAL LOSSES ARE
 DW PUMPS → 407: 89.6 kPa
 407 → 303 : 230
319.6 say 320 kPa

355m/1000mm 0.59 kPa
 1000m/450mm 89 kPa
89.6 kPa

@3000 L/min
 FL = 0.05 kPa
 + 0.63
 + 36.29
36.97

FOR 407-303
 FROM CHART 2/2
 @ 40 kPa lost:

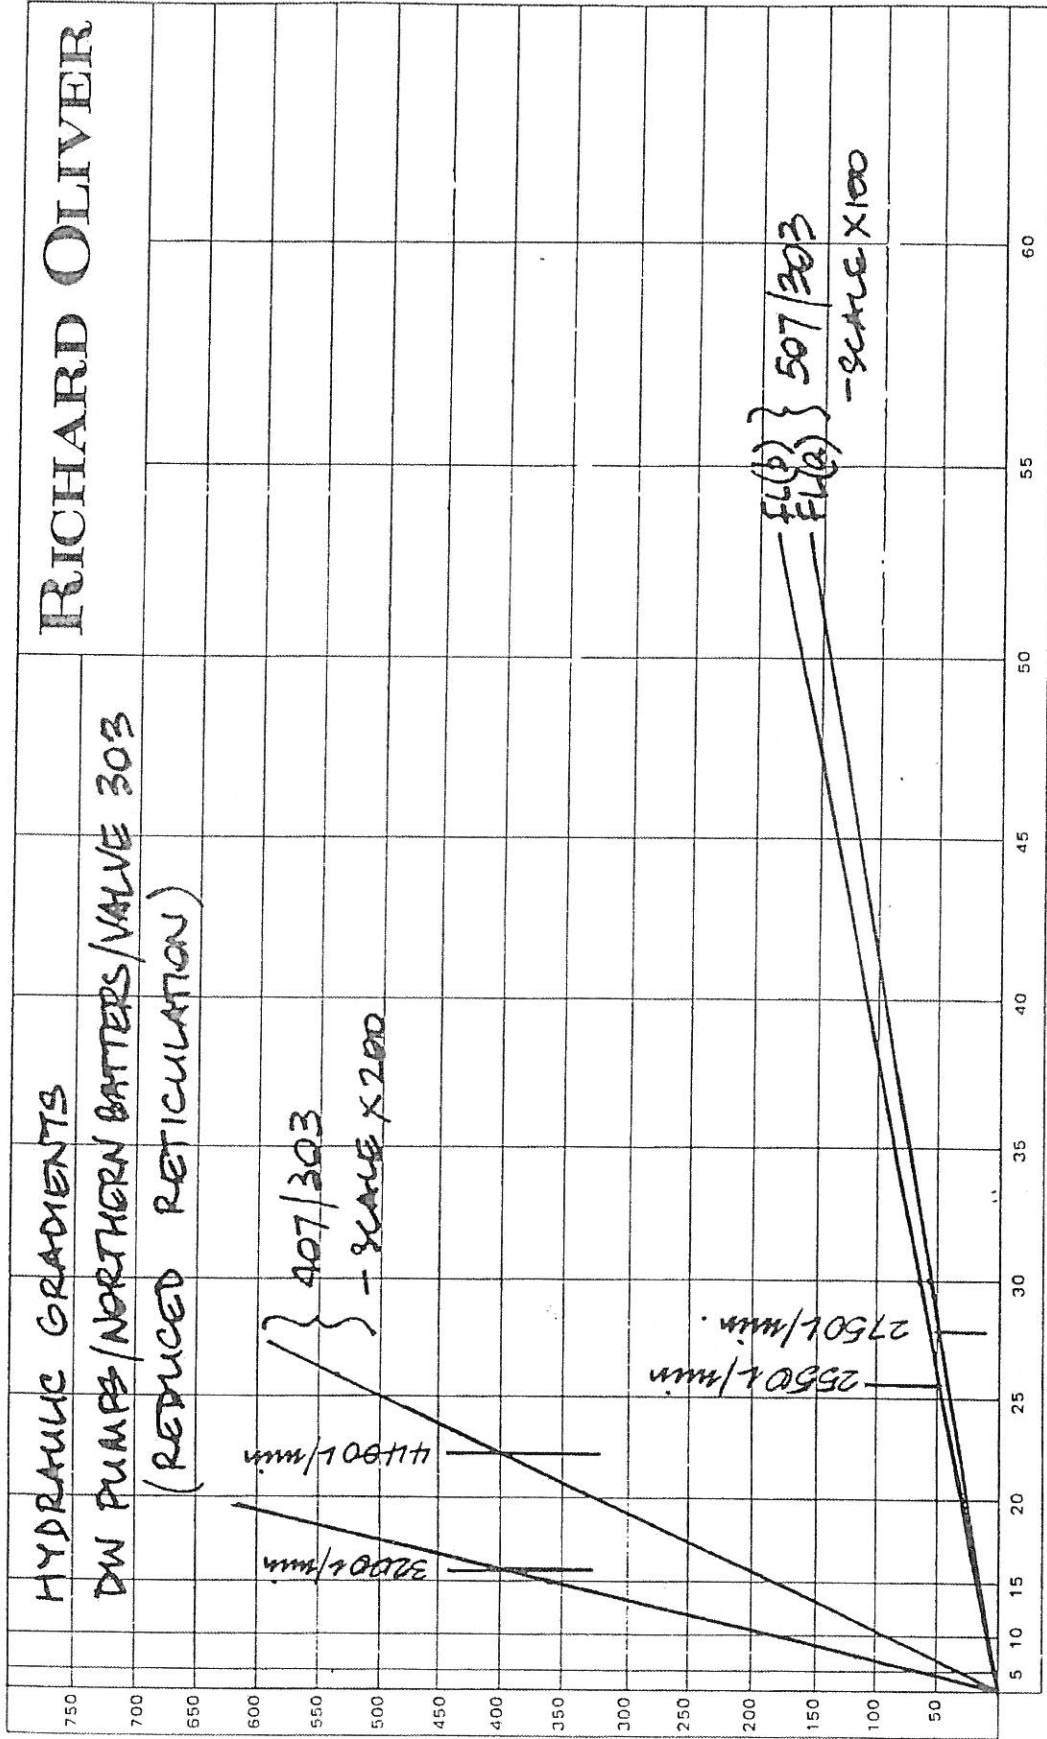
VALVE SUPPLY ANALYSIS GRAPH

NAME OF INSURED SECV / MOC	DATE 6/92	ENGINEER RUNLEVIE	INDEX No. 1 OF 2
--------------------------------------	---------------------	-----------------------------	----------------------------

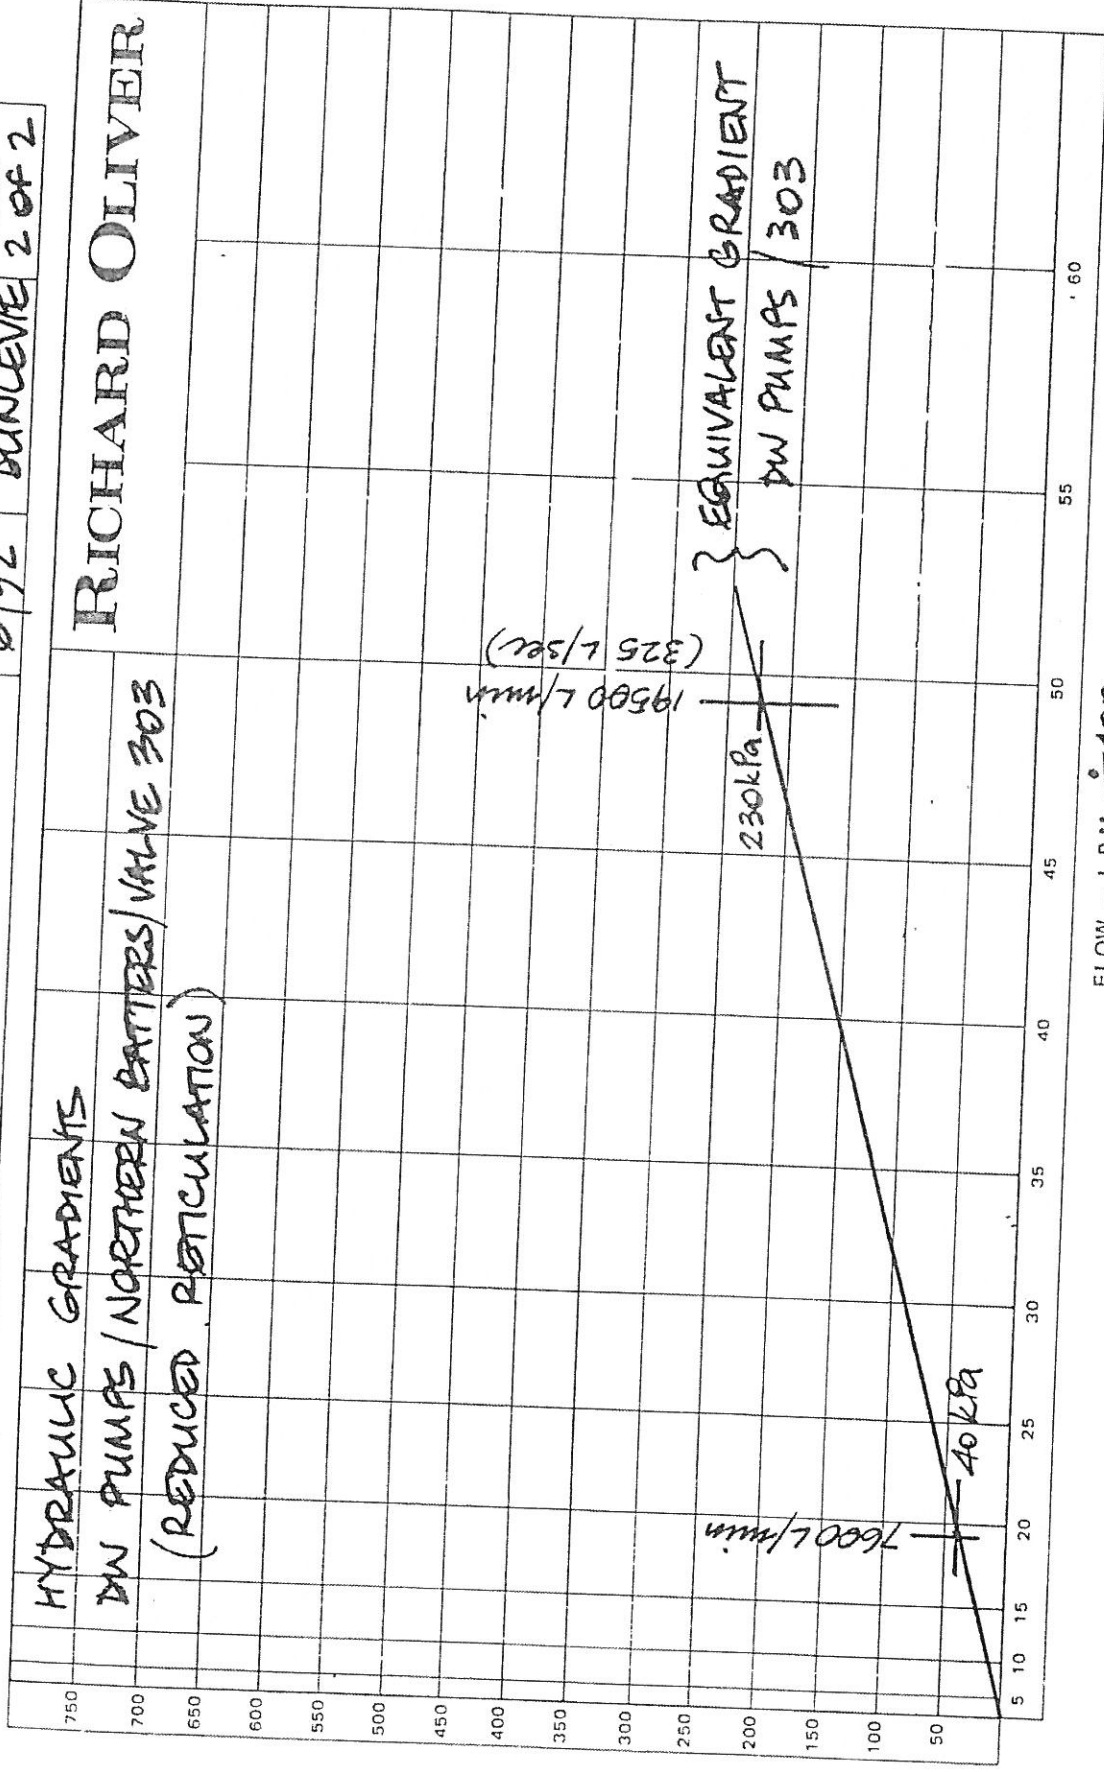
HYDRAULIC GRADIENTS
DW PUMPS / NORTHERN BATTERS / VALVE 303
(REDUCED RETICULATION)

FLOW - L.P.M. @ 400
