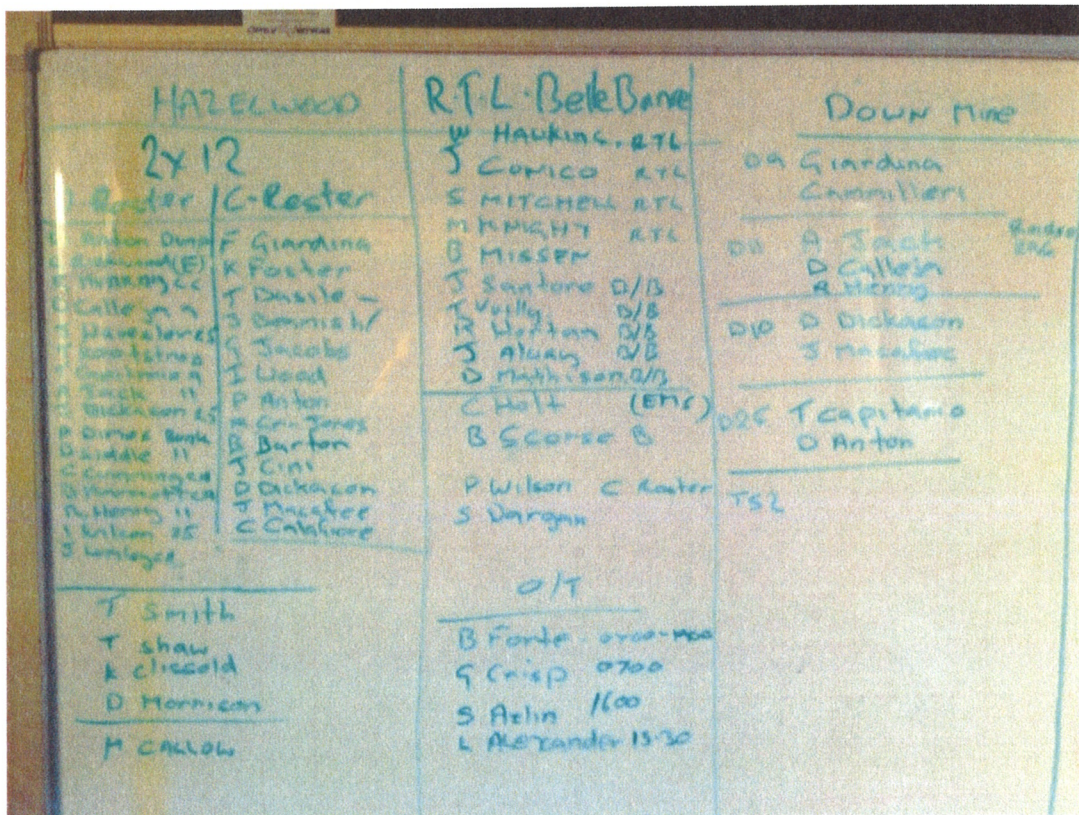
95. Prior to leaving the Fire Services Office at 7:45 pm, I took the following photo of the various personnel at the Mine, which at that time was being tracked on a whiteboard:
