ANGLESEA MINE COAL COVERAGE PROJECT REVIEW

TECHNICAL REVIEW

ALCOA

FINAL REPORT

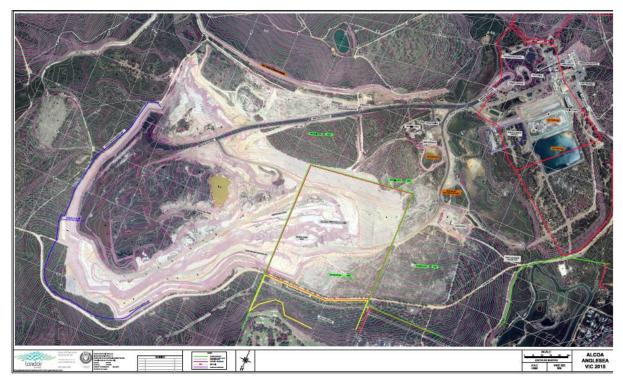
Figure 3-1 : Anglesea Mine Showing the Entire Site

Mining One attended site on the 23rd of June 2015 to conduct an inspection of the mine (Figure 3-1) and to review the mine shutdown strategy for the operation. This visit established that the mine shutdown and closure would occur in two stages. The initial stage, called the shutdown phase, would focus on securing the site against ash attack and spontaneous combustion events while the second stage, called the closure phase, would see the final landform be established and definitively secure the coal asset located within the pit area, including the vertical exposure of the coal seam. The power station and associated infrastructure were not included in the site visit nor are they included in the scope of work.

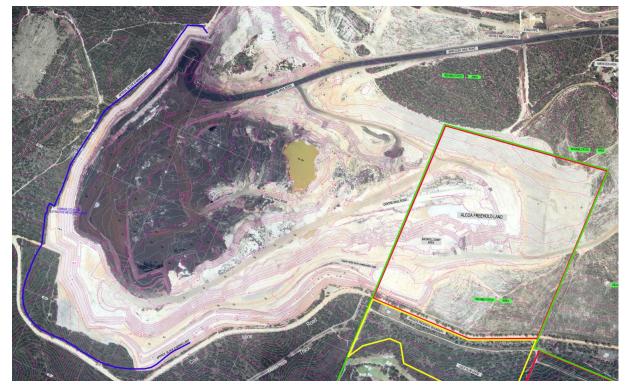
Figure 3-2 : Anglesea Pit

The site visit was primarily focused on critiquing the initial phase of the mine shutdown strategy and to make recommendations on ensuring that the initial shutdown would secure the coal for a period up until the initiation of the final closure and rehabilitation phase.

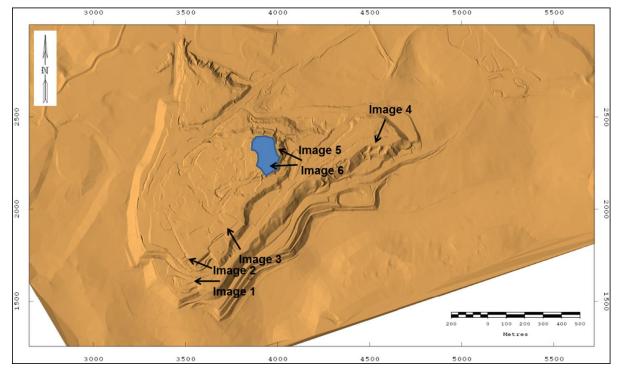
Figure 3-4 : Demographics of Photos

At the time of the visit, coal was still being excavated from the south western corner of the pit and capping of the coal had commenced within the central region of the pit. The following suite of slides provides an overview of the status of the pit at the time of the site visit. Figure 3-4 is an overview of the approximate location of the photos contained herein.
