Review of Future Rehabilitation Options for Loy Yang, Hazelwood and Yallourn Coal Mines in the Latrobe Valley

Hazelwood Mine Fire Inquiry

Final Report

IW101000-001 16th November 2015

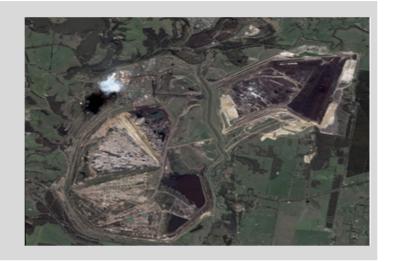
Figure 2-2 : Yallourn Coal Mine (source Department of Primary Industry, 2013)

Several diversions of local water courses, including a diversion of the Latrobe River following a batter failure in 2007, have been undertaken to progress and maintain mining operations. A notable feature of the mine is the Morwell River Drain which carries the Morwell River between the Township and East Fields.
