**IN THE MATTER OF THE SECOND HAZELWOOD MINE FIRE INQUIRY**

**WITNESS STATEMENT OF JAMES ANTHONY FAITHFUL**

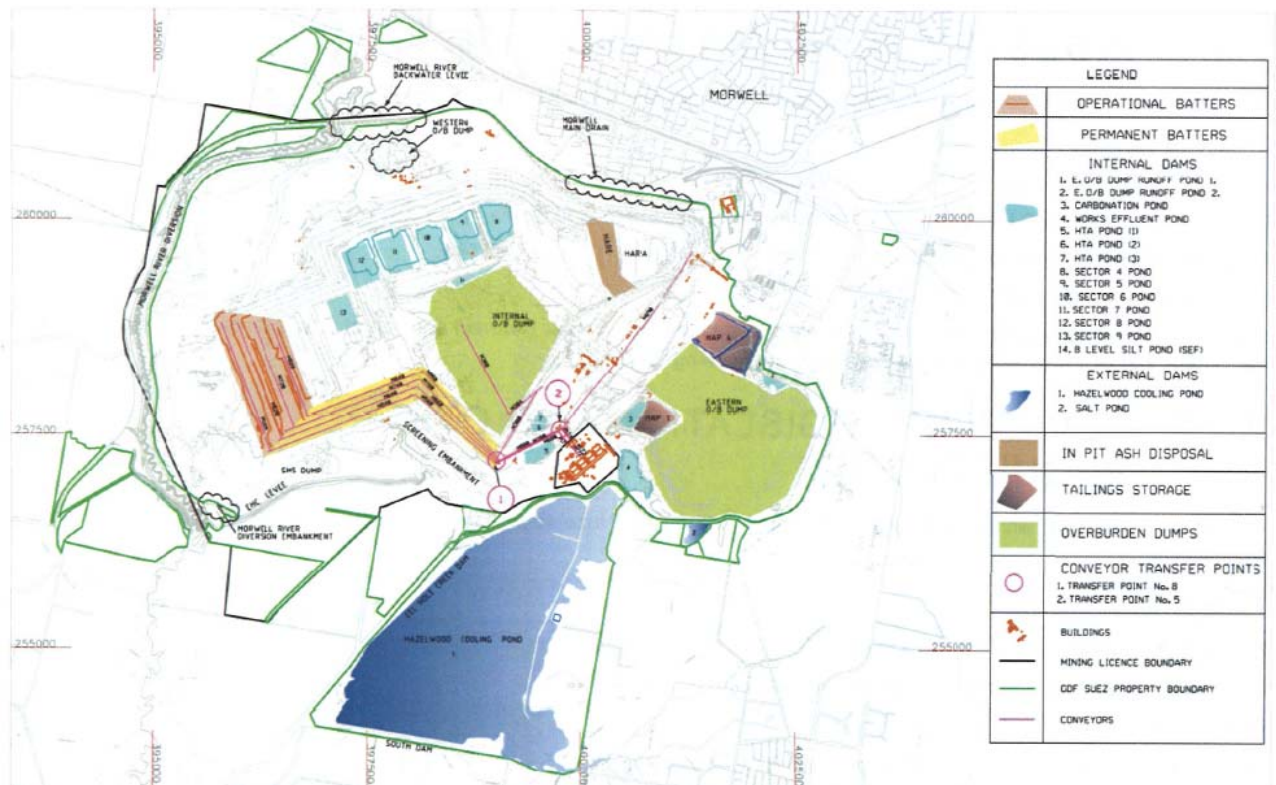
Figure 2: Key infrastructure of the Mine

- 52 Relevant external infrastructure associated with the Mine’s operations includes:
- (a) external tailings storage facilities (Hazelwood Ash Pond 4 (“HAP4”) and Hazelwood Ash Pond 1 (“HAP 1”));
  - (b) external overburden dumps to the east and west of the Mine (Eastern Overburden Dump and Western Overburden Dump) – which are not active operational dumps; and
  - (c) external dams (e.g. Hazelwood Cooling Pond, Treated Effluent Pond).

53 The location of the infrastructure referred to above is depicted in the plan below:

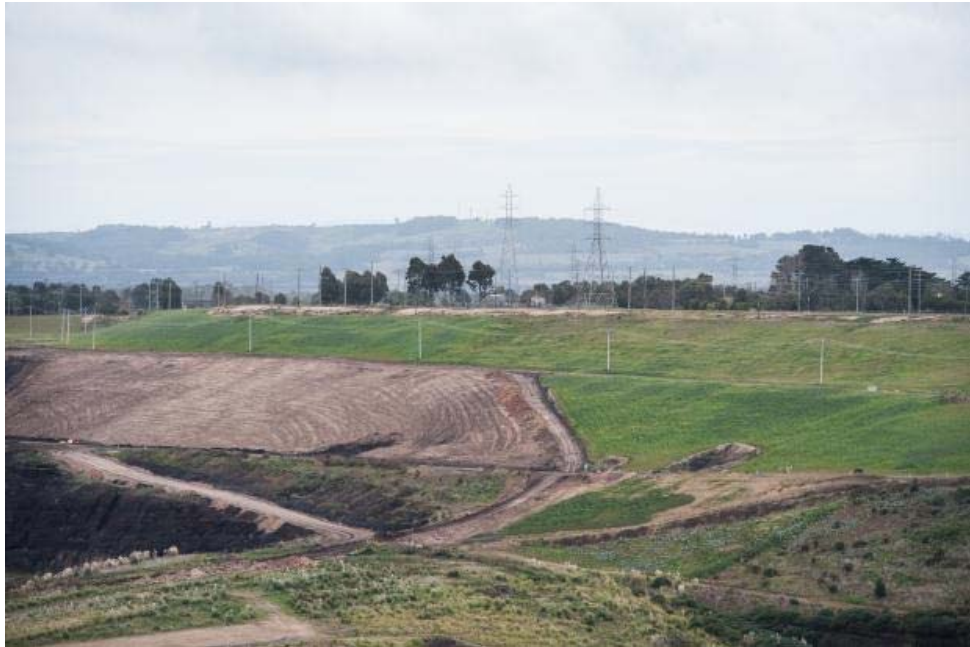
**Figure 10: Northern Batters rehabilitation works in progress – late 2014/2015**

128 A photograph of certain of these rehabilitation works, whilst in progress, is set out below:
