The Thomson Reservoir Triggered Earthquakes

TREVOR ALLEN⁽¹⁾, GARY GIBSON⁽²⁾ AND COLIN HILL⁽³⁾
MONASH UNIVERSITY⁽¹⁾, SEISMOLOGY RESEARCH CENTRE⁽²⁾
AND MELBOURNE WATER CORPORATION⁽³⁾

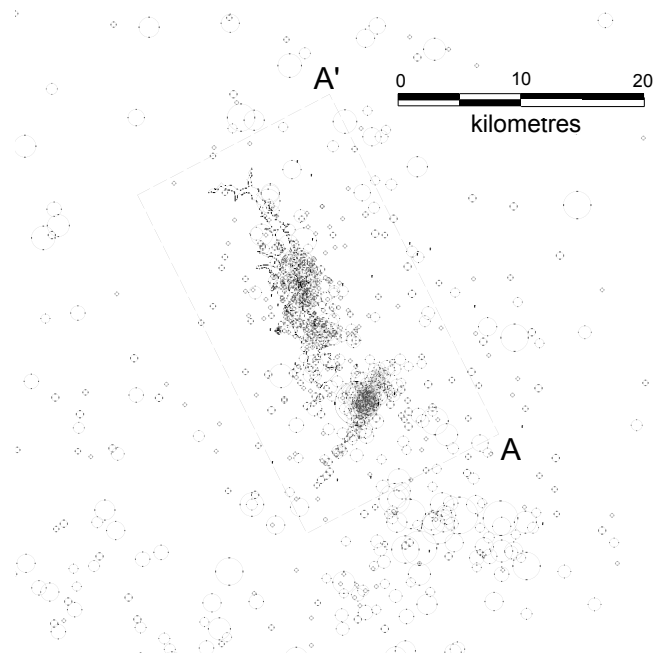
Fig. 1. Total earthquake activity about the Thomson Reservoir since 1976 with respect to the reservoir.

The Thomson Reservoir and surrounding region is relatively seismically active by Australian standards. Figure 1 shows the entire catalogue of earthquake activity about the Thomson Reservoir since 1976. The seismicity in the region has been divided into several time periods to demonstrate the spatial and temporal migration of earthquake activity. Figure 2 shows the epicentral distribution of the earthquakes over the designated time periods.

Earthquakes located within the rectangular polygon (see Figure 1) were employed to quantitatively examine earthquake focus migration with depth and are illustrated in cross-sections along the line A to A' (Figure 3). Figure 3a shows earthquake migration with respect to depth for the period of January 1986 to April 1988.

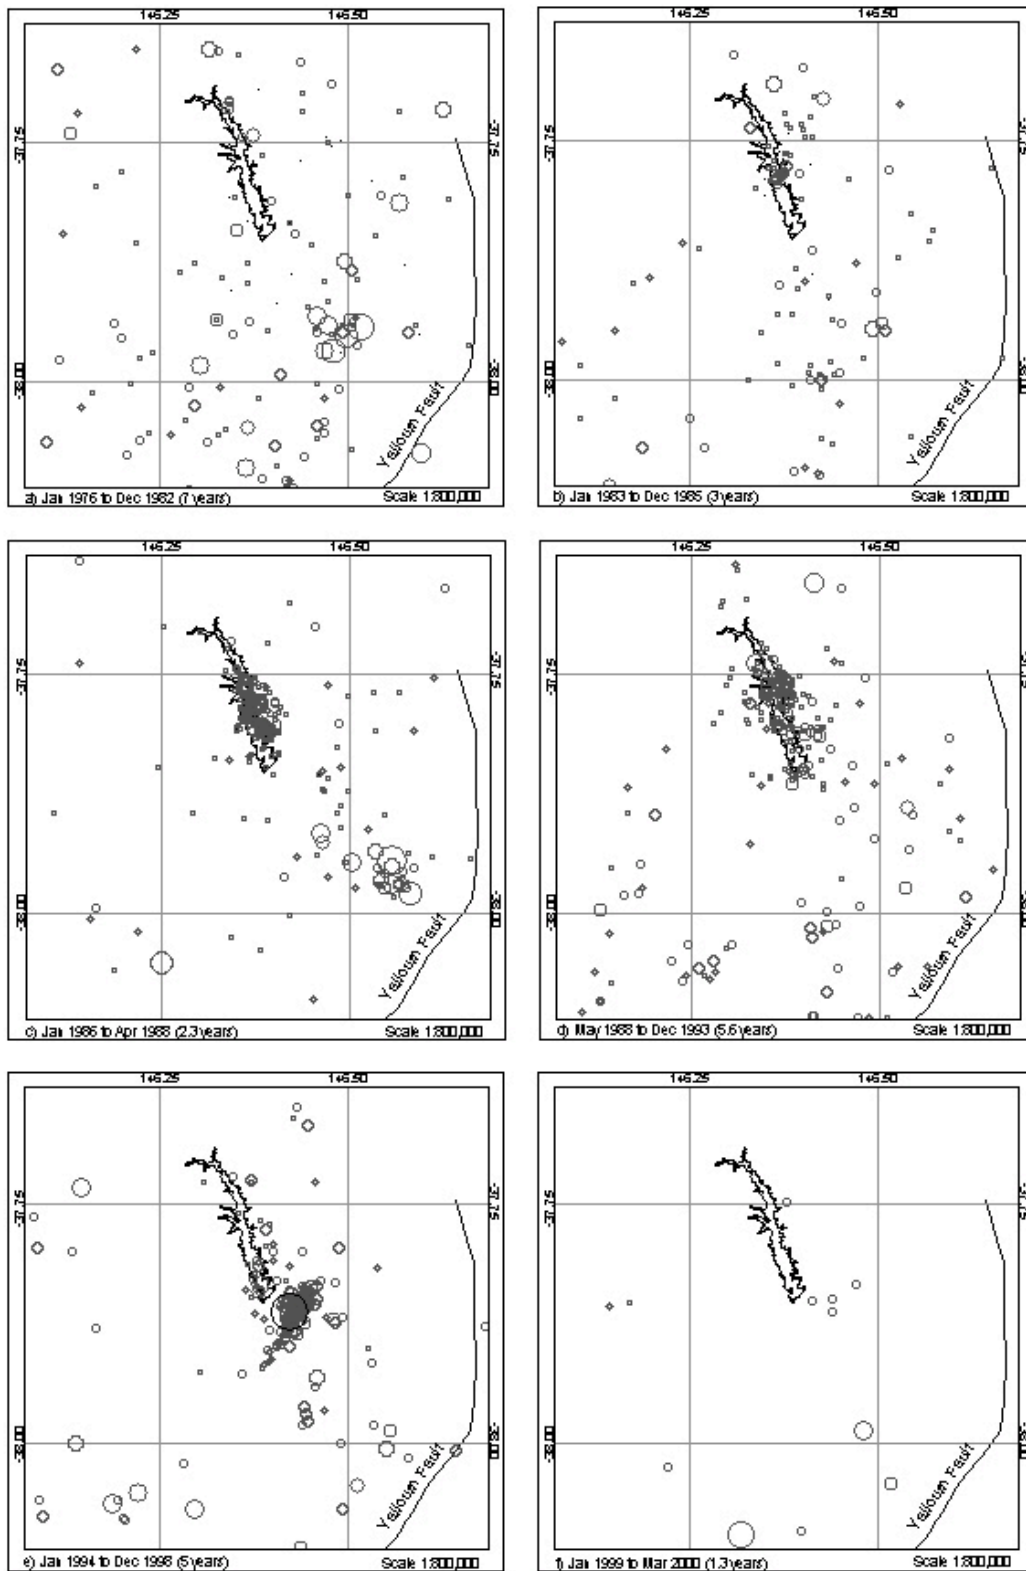
Fig. 2. Seismicity about the Thomson Reservoir since 1976. Circles indicate earthquake location with respect to the reservoir (diameter in mm is equivalent to local magnitude ML).

January 1976 to December 1982: (Figure 2a) Since the beginning of 1976, the SRC has operated and maintained a number of microearthquake seismographs throughout Victoria, permitting the location of even smaller events. In 1976, this allowed the location of three earthquakes with Richter magnitudes greater than 2 in the Moondarra area (Gibson, 1977). With the completion of the Thomson Reservoir network in 1978, it became clear that the Gippsland area possessed a higher level of background seismicity than average for Victoria (Gibson, 1978).

January 1983 to December 1985: (Figure 2b) In 1983, Stage Three of the Thomson River Development was complete, and filling of the reservoir commenced that year. In November of 1983, a swarm of 37 earthquakes occurred in a small volume about 6 km northwest of the Thomson Dam at a depth of about 11 km. They were all very small events, the largest magnitude being about ML 1.5. The occurrence of the swarm so soon after the commencement of filling suggests that there may be some relationship. However, the 11 km depth of these events is much greater than would normally be expected for reservoir-triggered seismicity caused by increased pore fluid pressure. Similarly, a modification of the regional stress field appears to be an unlikely mechanism given the large depth and the small magnitude of the events. In addition, the reservoir was only at 3 per cent of its capacity at that time (Gibson and Wesson, 1983). Hence it follows that the location of the swarm may just have been coincidental. Apart from the cluster, few events occurred in the three years subsequent to commencement of filling, although seismicity was marginally higher than that of pre-filling with an activity rate of a little over one event per week (Gibson and Wesson, 1986). The reservoir level at the end of this period had increased regularly to approximately 40 m below capacity.

January 1986 to April 1988: (Figure 2c) From 1986, shallow earthquakes within 3 km of the surface began occurring immediately under the reservoir, with magnitudes to ML 3, at rates of up to 5 events per week. These events were almost certainly reservoir-triggered, resulting from water diffusion increasing pore fluid pressure beneath the reservoir.

May 1988 to December 1993: (Figure 2d) During the period from 1988 until December 1993, the seismicity near the Thomson Reservoir area migrated to greater depths, down to about 12 km, and away from the reservoir, with decreasing activity levels (Figure 3b). This behavior is typical of reservoirs in their first ten to twenty years, and can be explained by the increasing pore water pressure in the system migrating to greater depths at a relatively slow rate (depending on rock permeability), until arriving at a state of equilibrium.

January 1994 to December 1998: (Figure 2e) From 1994, earthquake activity at the Thomson Reservoir was consistently at depths between 9 and 12 km with further decreasing activity levels.

Since 1998: (Figure 2f) Relatively few earthquakes have been recorded at the Thomson Reservoir since the abatement of aftershocks. Coincidentally, water levels at the reservoir have also decreased significantly since 1996 to a capacity similar to that of the first cycle of filling in 1986.

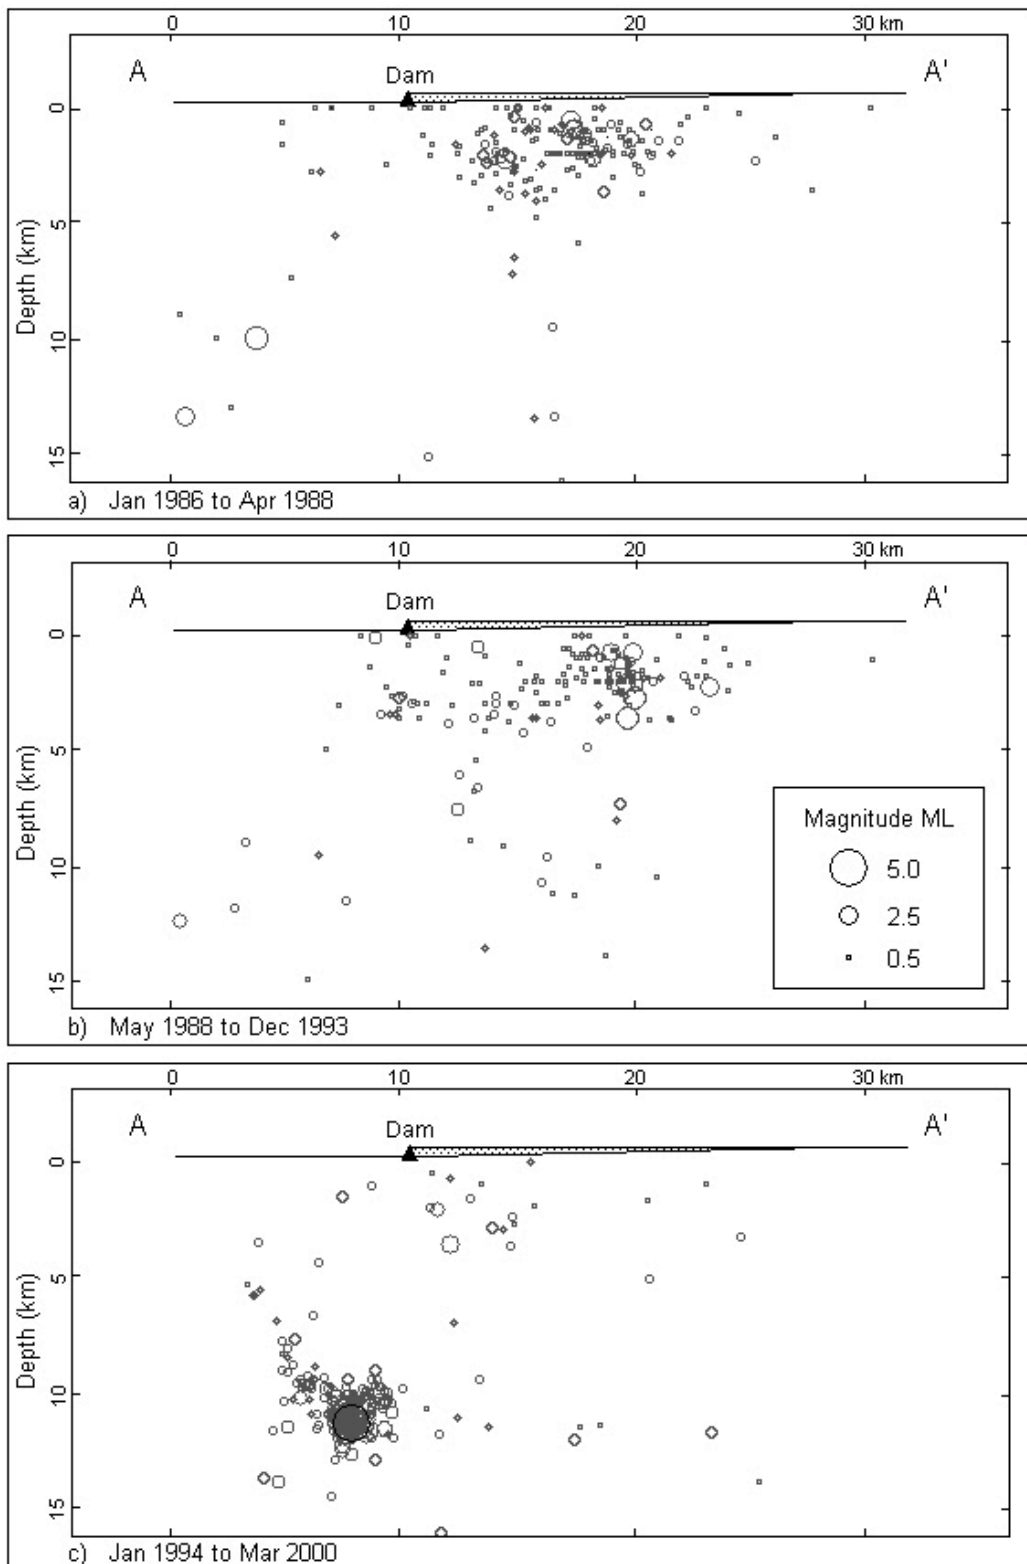
Fig. 3. Earthquake migration beneath the Thomson Reservoir with respect to time. The dam wall and reservoir level have been exaggerated.

The location of the cluster suggests that the earthquakes occurred on the Yallourn Fault at depths between 9 to 12 km adjacent to the reservoir (Figure 3c). These earthquakes can be explained by an increase in water pore pressure in a highly prestressed environment.

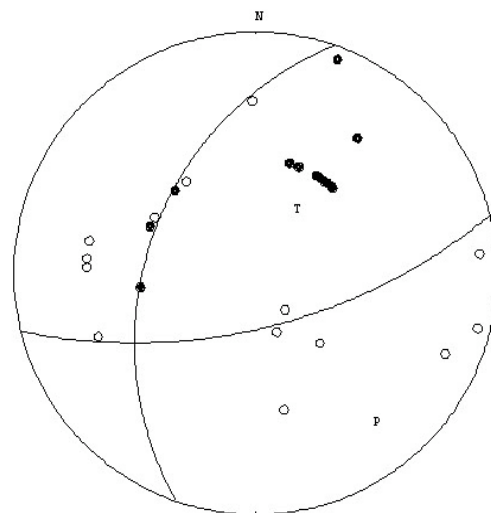
Fig. 4. Focal mechanism for the ML 5.0 Thomson Earthquake plotted on a lower hemispherical projection. The open and filled circles represent dilatational and compressive first motions respectively, illustrating southeast to northwest compression.

The location of the ML 5.0 Thomson earthquake suggests it was most likely on the Yallourn Fault. Plotting the first motions of the direct seismic waveforms on a lower hemispherical projection, the mechanism for the earthquake was observed to possess southeast to northwest compression, consistent with reverse faulting of the Yallourn Fault (Figure 4).
